# Quest and Probe Related to Erosion in the Wrap-Around of an Embankment

R.J.R. Cardia

SYNOPSIS: CESP's divers team found several basalt blocks scattered on the stilling basin of a power plant. Water flowing through bottom outlets was initially supposed to cause erosion in the upstream rip-rap of the wrap-around. Events chronologically reported are: Underwater inspection; removal of materials; monitoring devices behavior; hydraulic tests. Hinder analyses led to recognition of misunderstanding on anomalous mechanism and misconception on the actual sources for the hauled rubbish.

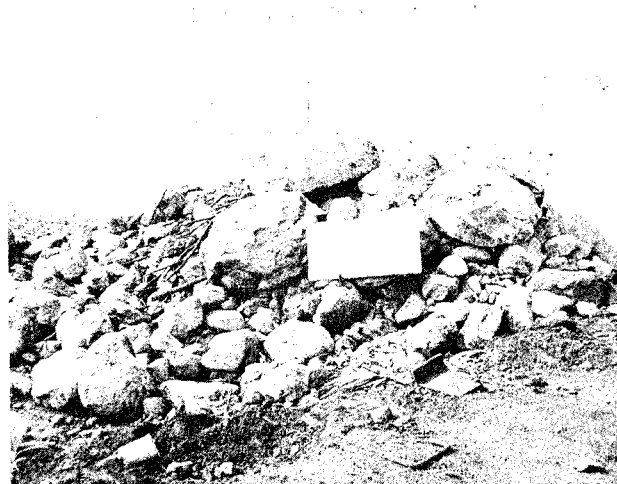
During one of the aforementioned routine underwater inspections (1977), large amount of salt blocks, iron rebars and scaffolding pipes and bracing components were found, scattered over the stilling basin, near the end sill. Initially, those materials were suspected to have been detached and drawn backward from the protected rock-bottom downstream, by recirculating water.

Fig. 4 - Material hauled off the stilling basin by divers.

All debris were then hand removed (NOV77) from the stilling basin by divers, to avoid progression of erosion on the concrete slab surface abrasion.

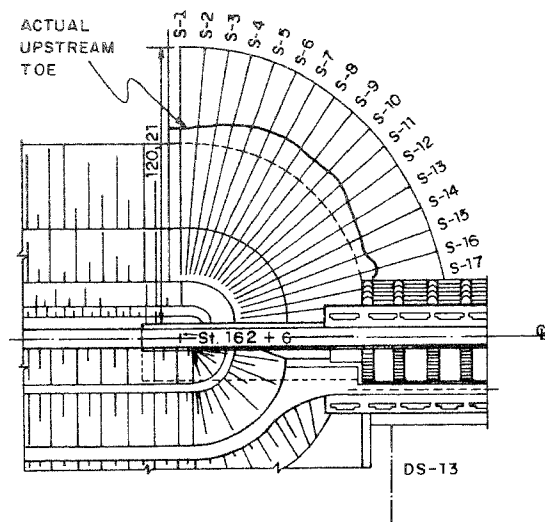
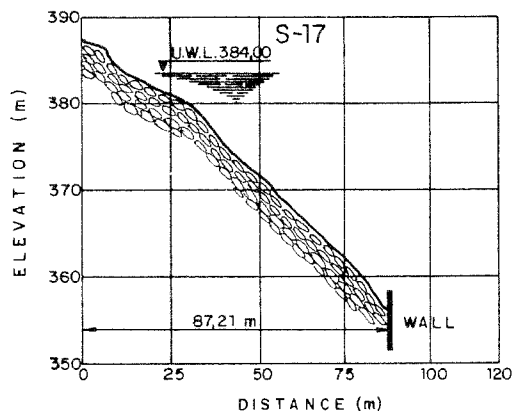
Results of an echo-sounder survey showed that actual position of the right wrap-around's toe could eventually interfere with flow in the opening for the gate nearby.

Fig. 6 - Echo-sounder survey. Plan and S-17 profile.

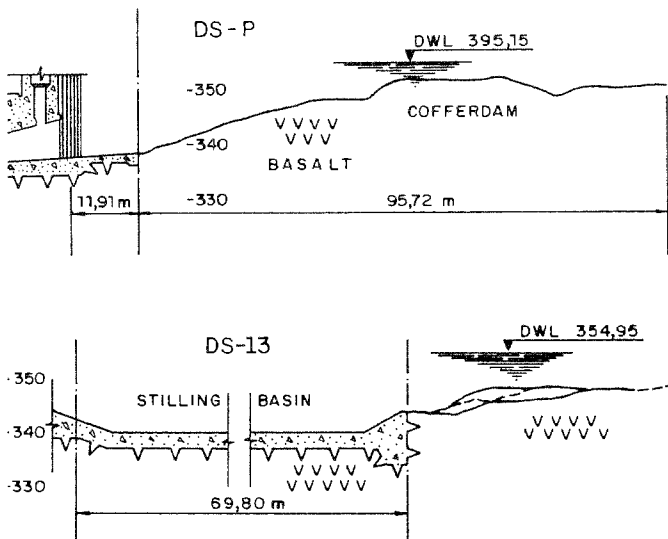
By that occasion a first survey was made with the echo-sounder sailing along the power-house's return channel and downstream river-bed.

Fig. 10 - Echo-sounder survey in the return channel and in the stilling basin

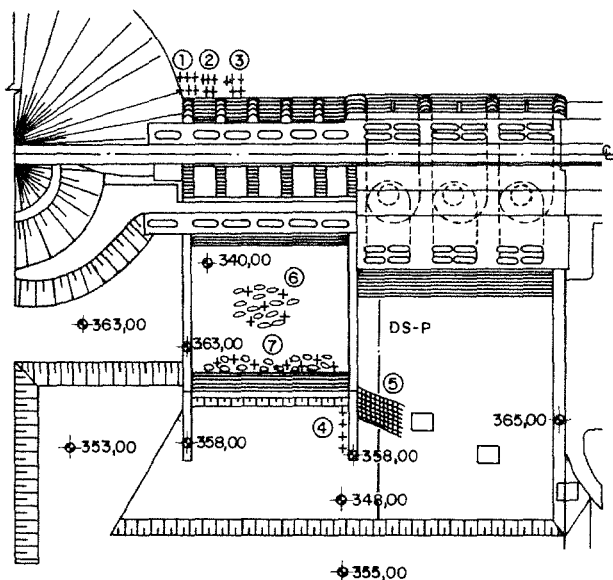
All upstream marked blocks were still standing in the same place without signs of movement, even those identified "in situ" with paint, in the DEC80 tests. It became clearly evident that all debris now found by divers in the central area of the stilling basin, including some blocks identified by gray and yellow strips, had its source in a cofferdam, abandoned at the power-house's return channel (and well upstream of the dividing wall's downstream end).

Third step: all five gates were kept open for 30 minutes (position III; h = 1,5 m) and with that hydraulic symmetrical operation, the water didn't show recirculation. As soon as the gates had been shut, divers were sent to inspect the upstream region and found no alteration at the control blocks. And all the material that was in the stilling basin downstream had been moved, now lying near the end sill. All small sized blocks had been carried away.

Fig. 12 - Result of Hydraulic Tests. Plan

As a result of this test all manevrers of the

gates should be following a hydraulic symmetrical operation, at least until the programmed removal of the downstream cofferdam remnants had been completed.

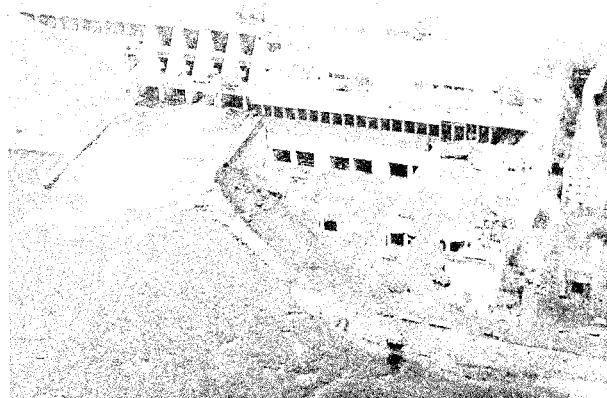
The cofferdam, composed of basalt blocks, a clayey seal and even having some construction debris, was then the actual source of all rubbish found in those underwater inspections of the stilling basin. The materials had been drawn back and sideways by recirculating flow, whenever a non-symmetrical operation of the gates occurred. Topographic situation of the elevated

river-bed downstream in the tail race acted a propitious barrier in establishing the reculating flow.

Fig. 13 - Cofferdam at return channel during construction.
