Quest and Probe Related to Erosion in the Wrap-Around of an Embankment

R.J.R. Cardia

Civil Engineer, Civil Engineering Central Laboratory, CESP, Ilha Solteira, SP, Brazil

SYNOPSIS: CESP's divers team found several basalt blocks scattered on the stilling basin of a power plant. Water flowing through bottom outlets was initially supposed to cause erosion in the upstream rip-rap of the wrap-around. Events chronologically reported are: Underwater inspection; removal of materials; monitoring devices behavior; hydraulic tests. Hinder analyses led to recognition of misunderstanding on anomalous mechanism and misconception on the actual sources for the hauled rubbish.

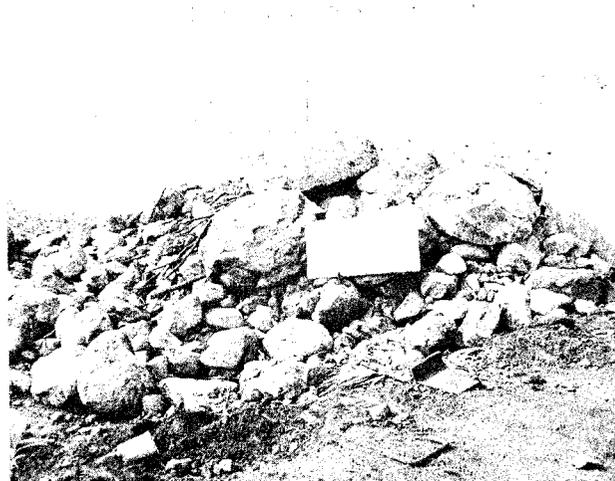
During one of the aforementioned routine underwater inspections (1977), large amount of salt blocks, iron rebars and scaffolding pipes and bracing components were found, scattered over the stilling basin, near the end sill. Initially, those materials were suspected to have been detached and drawn backward from the protected rock-bottom downstream, by recirculating water.

Fig. 4 - Material hauled off the stilling basin by divers.

All debris were then hand removed (NOV77) from the stilling basin by divers, to avoid progression of erosion on the concrete slab surface abrasion.

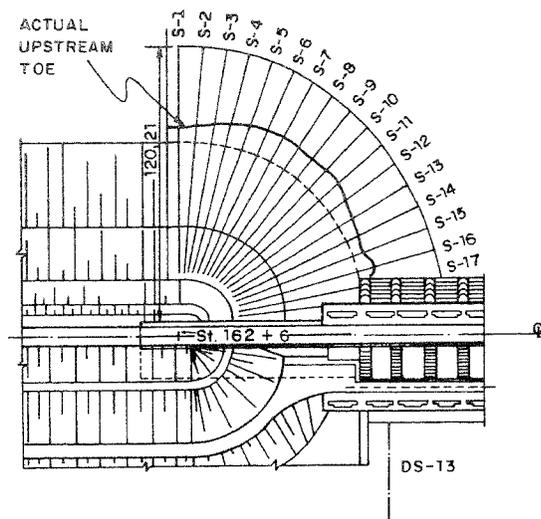
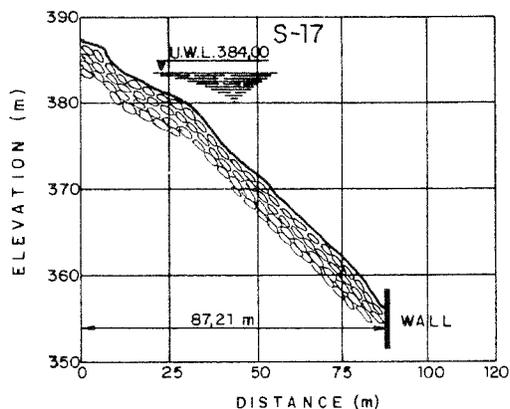
Results of an echo-sounder survey showed that actual position of the right wrap-around's toe could eventually interfere with flow in the opening for the gate nearby.

Fig. 6 - Echo-sounder survey. Plan and S-17 profile.

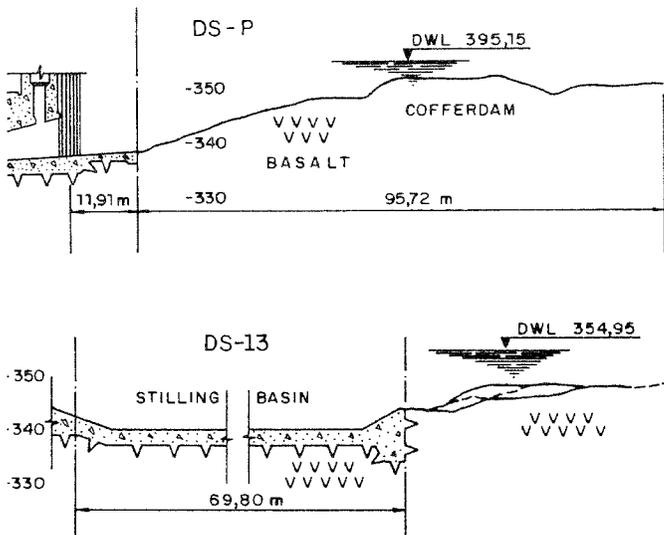
Fig. 10 - Echo-sounder survey in the return channel and in the stilling basin

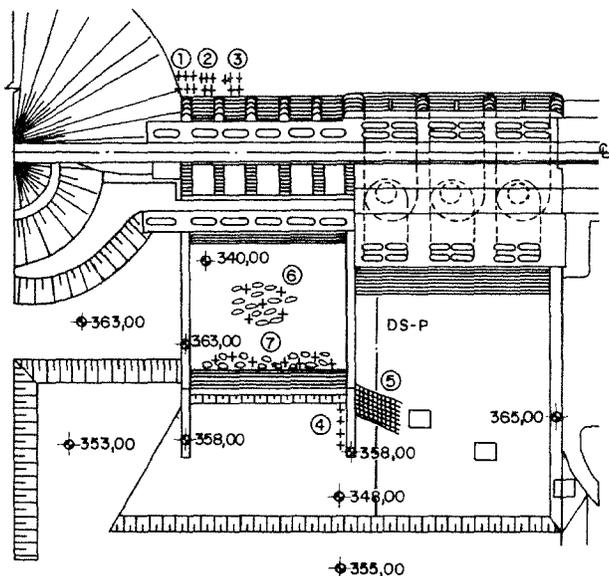
Fig. 12 - Result of Hydraulic Tests. Plan

All upstream marked blocks were still standing in the same place without signs of movement, even those identified "in situ" with paint, in the DEC80 tests. It became clearly evident that all debris now found by divers in the central area of the stilling basin, including some blocks identified by gray and yellow strips, had its source in a cofferdam, abandoned at the power-house's return channel (and well upstream of the dividing wall's downstream end).

Third step: all five gates were kept open for 30 minutes (position III; h = 1,5 m) and with that hydraulic symmetrical operation, the water didn't show recirculation. As soon as the gates had been shut, divers were sent to inspect the upstream region and found no alteration at the control blocks. And all the material that was in the stilling basin downstream had been moved, now lying near the end sill. All small sized blocks had been carried away.

The cofferdam, composed of basalt blocks, a clayey seal and even having some construction debris, was then the actual source of all rubbish found in those underwater inspections of the stilling basin. The materials had been drawn back and sideways by recirculating flow, whenever a non-symmetrical operation of the gates occurred. Topographic situation of the elevated

gates should be following a hydraulic symmetrical operation, at least until the programmed removal of the downstream cofferdam remnants had been completed.
