Lessons from Recent Collapses of Metal Buildings

By David B. Peraza, P.E.
Senior Associate, LZA Technology, New York, NY

This paper presents case studies of three roof collapses of metal buildings, discusses the most significant features of each case, and summarizes lessons learned that can be used to reduce future failures.

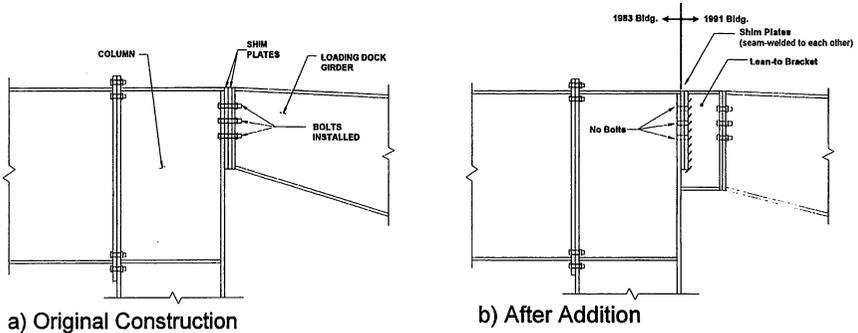
Figure 3: Connection Details at Original Loading Dock

The original loading dock was a "lean-to" structure. The three loading dock rafters attached to the freezer building columns via shim plates, as shown in Figure 3a.

lean-to brackets, and they were erected as shown in as in Figure 3b. The construction of the 1991 freezer was similar to that of the 1983 building.

In addition, three of the lean-to brackets were inadequately fastened to the columns. The engineer overlooked that three of the columns, the ones to which the original loading dock rafters had attached, had shim plates. Originally, these shim plates were bolted to each other. These bolts were removed in order to dismantle the old loading dock, and were not replaced when the lean-to bracket was welded on, as can be seen in Figure 5. The only attachment

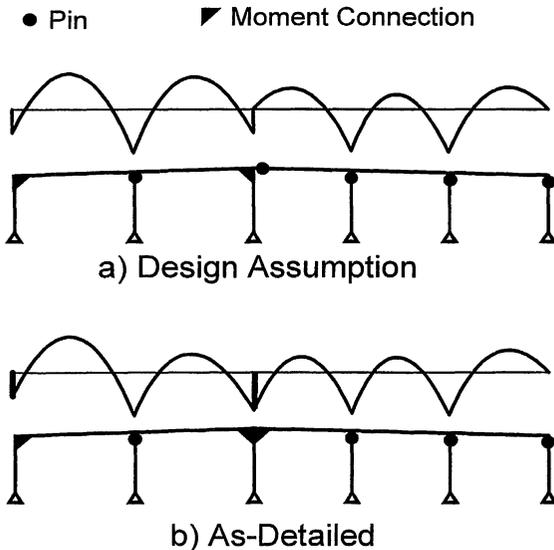
Figure 4 : Moment Diagrams for Frames

Regarding the rafters, serious overstresses were found near each lean-to bracket.

At these locations, the 1983 rafter is overstressed 96% in negative bending, and the 1991 rafter is similarly overstressed 27% for design loads. The severe overstresses are due to the fact that the connections were detailed in a manner inconsistent with the design assumption. The design assumption was that shear connections would be used to attach the new rafters to the original building columns, and therefore the original columns would only have to be designed for the added vertical load. However, the connection was detailed as a moment connection. Figure 4 contrasts these two conditions and the effect on

the negative moment.

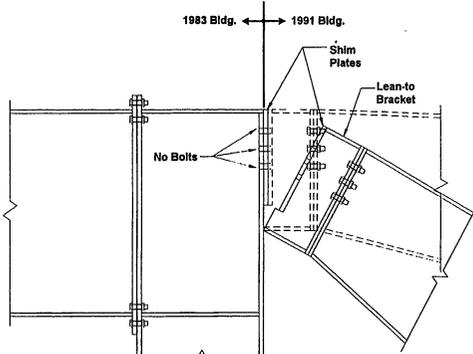
Figure 5: Failed connection.

between the shim plates was then the non-structural “seam welds” around their perimeter. These seam welds had to transfer the shear and the moment from the new rafters. Calculations showed these seam welds, which would never have been relied upon by a design engineer, actually did have substantial strength that prevented the collapse from occurring sooner.

- Make sure that the detailing is consistent with the design assumptions. For example, connections that are assumed to transmit shear should be detailed as such, and connections assumed to transmit moment should be detailed as such.
- Provide clear and explicit erection instructions for special conditions, such as when connecting to an existing structure.
- Research regarding the effect of refrigerated roofs on snow load may be needed. In this case, the measured snow weight was more than twice the values required by code, and this magnitude of load is not explainable from weather records. This may be due to the freezer nature of the facility, which experiences minimal melt-off and

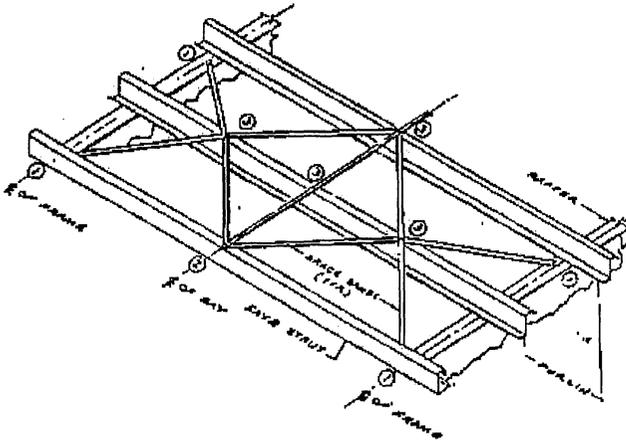
Figure 7: “Isometric View” reproduced from standard detail sheet

An isometric view, reproduced as Figure 7, clearly shows plan bracing along the eaves, anchored the rafters. This arrangement is effective for anchoring the transverse strap that continues up the roof. But what happens to that transverse strap after a few purlins? Does it bend down to the bottom flange of the next purlin, creating the "criss-cross" shown in the elevation? The effectiveness of the bracing provided by such an arrangement is highly questionable, given the interrupted nature of the perpendicular straps and their "anchorage" to tension flanges. Or was it the fabricator's intent to have plan bracing wherever the criss-cross arrangement is indicated? If so, then the arrangement must differ significantly from the plan bracing at the eave, which extends over a pair of purlin bays. And to be effective, the plan bracing would have to be anchored to the rafters, which is not indicated. Or perhaps the intent was to have plan

bracing along the ridgeline. And finally, what exactly is meant by “brace band”? The isometric indicates that the plan diagonals are the brace bands, but a note calls for brace bands at the 1/3 points for a 20 foot span, suggesting that the transverse straps are the brace bands. What this detail sheet means, only the fabricator knows for sure!

Ironically, the transverse bracing would be much easier to erect, and it would be much more effective, if it were simply run continuously from eave to peak, and then down to the other eave, thereby eliminating the criss-crosses.

Engineer/fabricators should carefully review the design assumptions that they make with respect to purlin bracing, and take steps to ensure that the bracing requirements are clearly communicated to the erector.

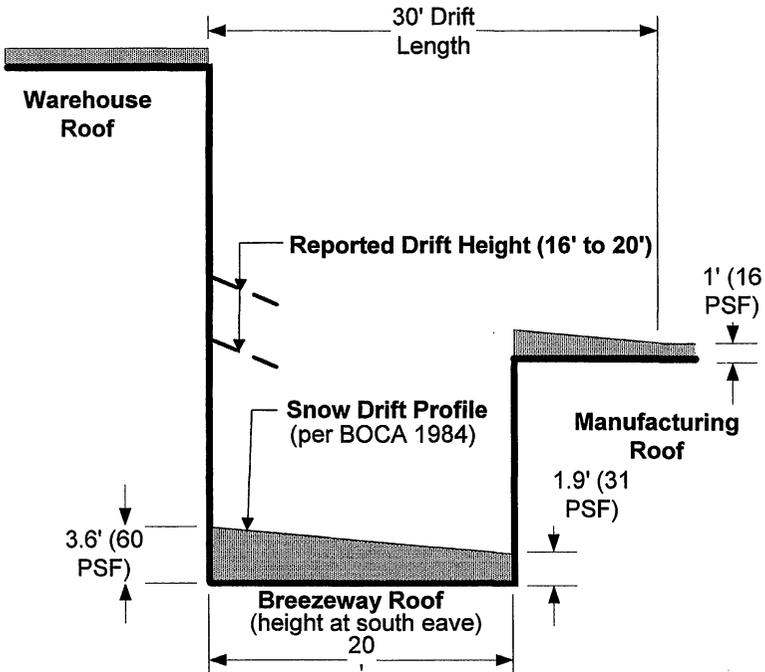
Figure 9: Roof and Snow-load Profiles

Figure 9. The snow heights are based on the BOCA 1996 snow density formula, since BOCA 1984 did not contain a snow density formula.

Anecdotal reports by employees indicated that there was 16' to 20' height of drifted snow on the Breezeway roof at the time of the failure.

In this case, it appears that the failure was caused by a drifted snow load that substantially exceeded the code-mandated values. This is based on the fact that the purlin design was adequate, plus the evidence that the snow loads present exceeded the code design values. Even if the strap bracing had not been installed, the purlins received sufficient incidental bracing from the standing seam roof to safely support the code-required loads. Evidence that the snow load exceeded the BOCA values is provided by meteorological data, published literature, and anecdotal observations by employees of the facility.
