A CASE STUDY OF THE APPLICATION OF LIGHTWEIGHT FILL FOR THE RESTORATION OF AN INTERCHANGE RAMP

Paper No. : 9.10

T.C. Kim
Ministry of Transportation
Ontario, Canada, M3M 1J8

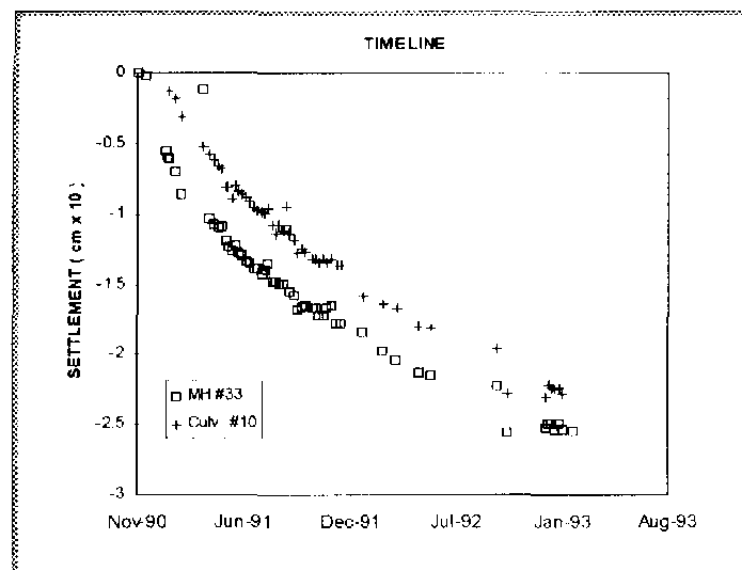
Figure 2: Settlement Plot of MH 33

The Ministry construction office monitored the settlement in that area over a period of 2.5 years. The monitoring results showed some 260mm of settlement of Manhole No 33 as shown on (Figure 2).
