## GEOTECHNICAL AND GEOLOGIC FEATURES OF U.S. 189 IN PROVO CANYON, UTAH

**Thomas S. Lee, P.E., G.E.**

**Steven H. Brandon, P.G.**

Paper No. 5.13

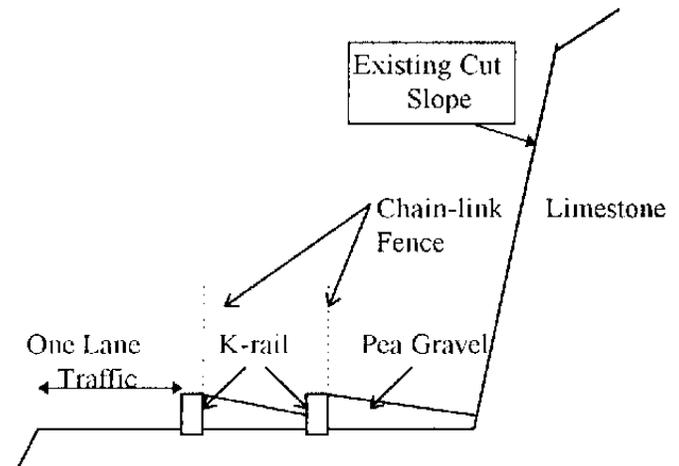
Figure 2. Double Rock Fence System (Schematic)

On March 12, 1997, boulders rolled down from the top of the cut at Station 606+00 (approximately) and hit a truck traveling on U.S. 189. This slide caused a temporary closure of US-189 for several days until a temporary rock fall zone was installed. The temporary rock fall zone consisted of a double rock fence system with aggregates placed from the toe of the cut to the rock fences (Figure 2).

The initial (July 1996) failure is thought to have occurred by the undercutting of shear zones within the rockmass by the planned 0.1(H):1(V) cut. The subsequent failures have been the result of several factors including stress relief of adjacent ground toward the initial slide area, weather (precipitation and freeze-thaw), blast vibrations, timeliness of ground support installation, or a combination of the above. Exploratory holes drilled in the area after the first failure indicated that bedding attitudes are reasonably consistent with a north-northeast strike and dip to the east-southeast at about 60°. The rock is highly fractured likely due to two phenomena:

Stabilization of this slide area consisted of soil nails on a 5 ft. x 5 ft. pattern, 30 to 40 feet long with 24 inch-wide strip drains, and 2-lifts of 3-inch-thick steel fiber reinforced

shotcrete. The excavation was redesigned with 30 foot-high, 0.5(H):1(V) cuts and five foot wide (typical) benches. At the highest point there are seven benches for a maximum cut height of 220 feet.

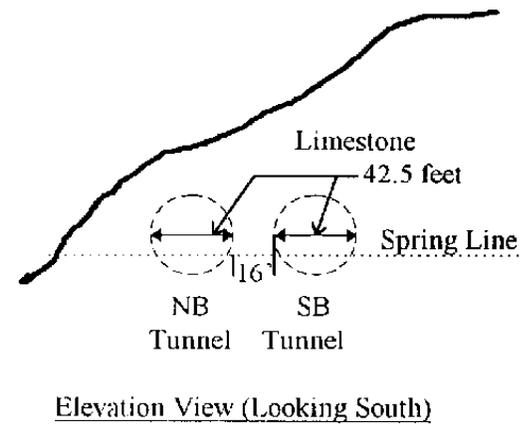
Figure 3 Twin Tunnels at the Narrows Project

Cracks were noticed in December of 1996 forming approximately 20 to 30 feet inside from the north portal face of the twin tunnels. The cracks extended from the crown to the springline of each tunnel. At the time the cracks formed, the northbound tunnel had been completely excavated to the invert subgrade. The southbound tunnel had the top heading, which extended to the springline of the tunnel, excavated for its full length. The lower bench of the southbound tunnel had approximately 60 to 70 feet of excavation remaining to its terminus at the north portal.

The tunnels are both 32 feet tall with a 21.25-foot radius at the springline (Figure 3) and approximately 300 feet long. Support for the tunnel consisted of 12-foot long rockbolts on a typical 4-ft. x 4-ft. pattern with 6-inches of shotcrete for primary support. The tunnels were excavated through shaly limestone of the Oquirrh Formation. There were no notable problems in the driving of the tunnels. The ground was generally massive and presented good tunneling conditions until the time of the cracks forming. After the cracks were noted, all tunnel blasting and excavation were halted by UDOT until the cause of the problem was established.

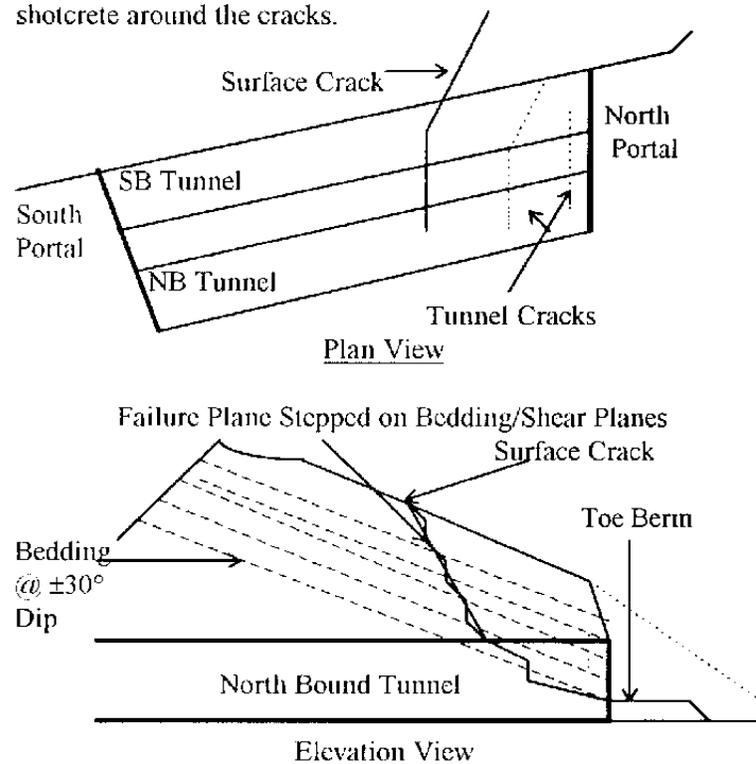
Figure 4. Assumed Failure Plane at the North Portal Cut

Inspection of the northbound tunnel revealed a shear plane dipping approximately 30 degrees toward the north portal cut (Figure 4). This shear plane was assumed to be the base of a wedge that was projected as daylighting through the north portal cut. Cracks were also noted at ground surface above the tunnel and approximately 45 feet behind the portal cut. The postulated failure mechanism is that a stepped failure pattern exists along a series of discontinuities that are oriented parallel with the bedding and dip approximately 30 degrees toward the north portal excavation.

The investigation into this problem consisted of convergence measuring points in both tunnels, drilling five NX-size cores from above the tunnels, and the installation of inclinometers in four of the five bore holes. Monitoring of the inclinometers started before excavation was allowed to resume in order to establish background baseline values. Convergence measurements were taken on number of chord locations across the tunnel openings on a daily basis. Throughout the period of monitoring, no movement was recorded in the inclinometers and only minor changes were noted in the convergence measurements. These were likely attributed to the thermal expansion and contraction in the shotcrete around the cracks.

The stabilization of the portal cut was accomplished by the installation of 40-foot long untensioned rebars (1.375 inch diameter) installed on a 5-ft. x 5-ft. pattern across the cut

face. Excavation of the southbound tunnel was allowed to continue once the support was in place. Monitoring of the convergence points and inclinometers continued until after all tunnel and portal excavation was completed and no further movements have been recorded.

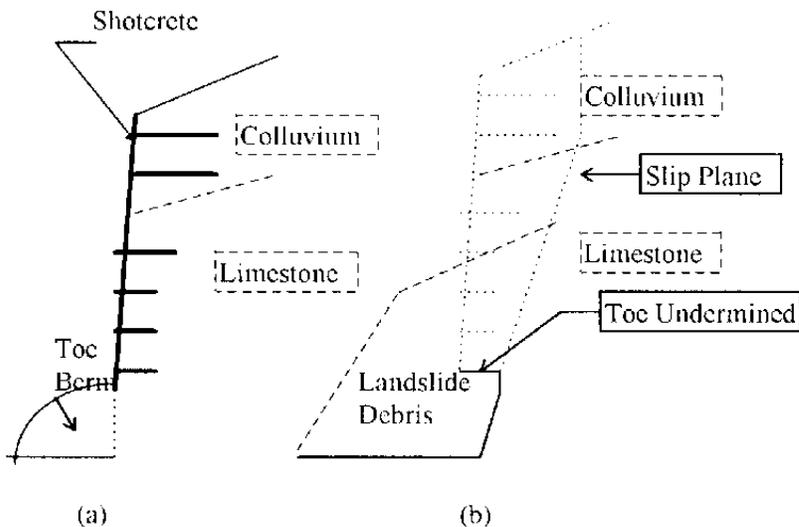
Figure 5. Cut Slope at Station 599+80 Before and After Failure (Schematic Diagrams)

A cut slope at Station 599+80 for a length of about 100 feet failed on April 17, 1997, two weeks after a toe berm was removed to the proposed final grade. The 90 foot-high cut has 10 to 25 feet of colluvial overburden overlying bedrock (Figure 5a). The overburden soil was supported by soil nails of lengths varying from 10 to 20-ft long on a 4-ft x 4-ft pattern. The bedrock was reinforced by 5-ft x 5-ft patterned 15-ft long rock dowels. The design cut angle for this portion of the project is a 0.1(H):1(V) (~84 degrees).

Inspection records indicated a block of rock (approximately 10 feet long x 5 feet deep x 4 feet in height) was dislodged five feet from the toe of the cut after the toe berm was removed (Figure 5b). No rock dowels and/or steel fiber reinforced shotcrete were in place at the toe of the cut before the failure.

Post failure reconnaissance showed that the cut slope at Station 599+80 was triggered by progressive failure starting from the toe of the cut where the block of rock was dislodged, progressing upwards along subvertical and daylighting joints within the rock mass and then extending upwards to the unreinforced soil mass (i.e., beyond the soil nailed portion). At the time of failure, the following observations were made:

- The soil nailed wall came down as one whole mass, indicating the slip surface actually passed beyond the reinforced mass.
- Grout did not stick to the epoxy-coated reinforcing bars. Grout was only present on the centralizers of the rebar.
- No seepage of water was noticed at the failure scarp and the soil/rock debris were moist but not wet.
- Discontinuities dipped at approximately 65 to 75 degrees out of the cut face and were smooth and occasionally slickensided.

Slide stabilization work consisted of laying back the cut slope to 0.5(H):1(V) with soil nails and rock dowels. The final cut face was covered with steel fiber reinforced shotcrete and weeps to facilitate water seepage.

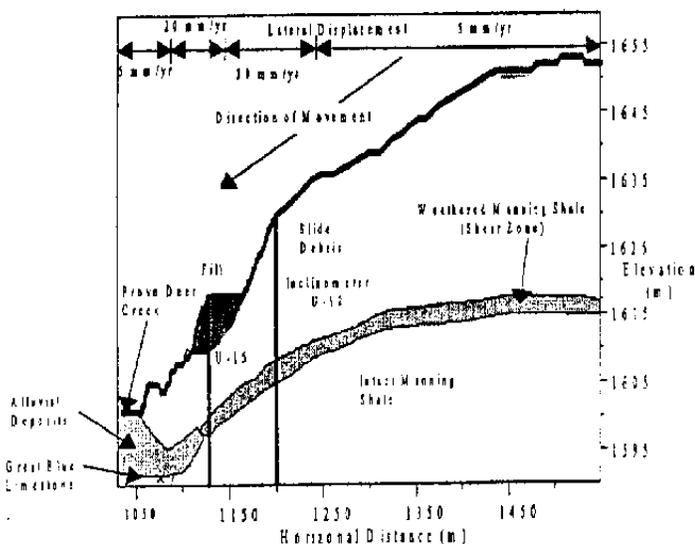
Figure 6. Inferred Geologic Cross Section at the Canyon Meadows (PBQ&D, 1995)

*Canyon Meadows:* Three of the five landslides on existing US-189 are found near the Canyon Meadows housing development. Based on the inclinometer data, two sliding planes appear to exist in each of these three landslides. One slide plane is located at the interface between the fill and the landslide debris (herein called the upper slide), the other slide is in the weathered Manning Canyon Shale (which is called the lower slide) as shown in Figure 6. The upper slide occurs primarily where fills have been placed on top of ancient clayey landslide debris which is derived from the underlying shale. This upper slide is the most active and moves on the average of 0.5 to 1.5 inches per year. The deeper sliding zone is the base of the ancient landslide debris where it overlies highly weathered Manning Canyon Shale. The shale weathers rapidly when exposed to the atmosphere and

becomes highly plastic when wet. The weathering process appears to have been accelerated by the presence of springs along the thrust fault zone. The shales have been weathered to a soil consistency to a depth of 16 to over 65 feet in this area.

The data from inclinometers in the Canyon Meadows slide area revealed that the upper slide is creeping at a rate of about 0.5 to 1.5 inches per year towards the river in a southeasterly direction, while the lower slide is moving very slowly at a rate (about 0.1 to 0.5 inches per year) generally to the southeast to south (toward the Provo River) as shown in Figure 7. The rate of ground movement on the downslope side of the highway increases as a result of the increased amount of road fill on the weak slide material as well as the close proximity to the river and high pore water pressures. Additional road fill is placed almost every year by UDOT as part of a maintenance program for the creeping highway. A boring drilled on the existing US 189 near Canyon Meadows encountered 15 ft of asphalt.

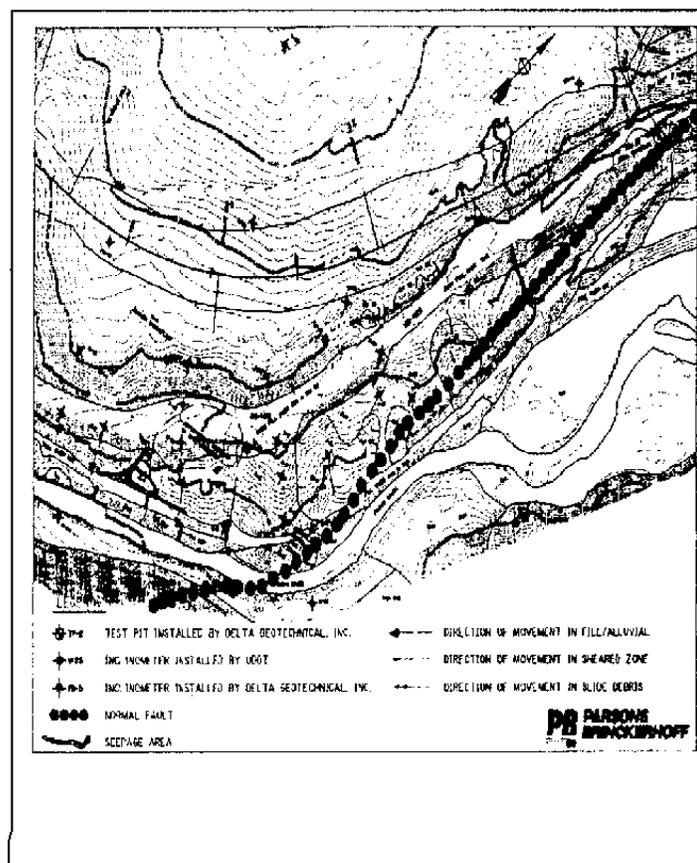
Figure 7 Movement Directions Recorded in the Canyon Meadows Area

In the northern part of the slide inclinometers indicate that movement is deflected to the south-southeast as a result of the presence of a resistant limestone unit called the Great Blue Limestone, which acts as a buttress to movement of the slide material. In the southern portion of the slide area where Manning Canyon Shale is present at the bank of the river, there is no buttress, and thus the toe of the slide has continued to erode over time because there is little resistance to

downslope movement within the alluvial soils in the river (Figure 7).

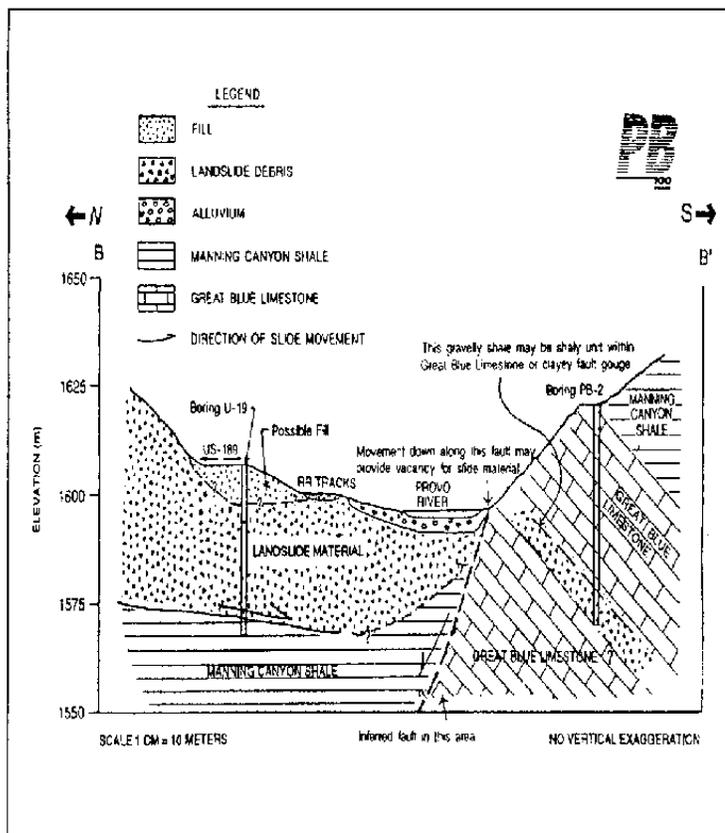
Figure 8. Inferred Geologic Cross Section at the North of Horseshoe Bend

2. In the northern portion of Horseshoe Bend (west side of the river in Figure 8), the weak Oquirrh Formation rock mass is resting on a plastic, sheared clay gouge that represents the top of the Manning Canyon shale. This weak Oquirrh Formation appears to be the result of landslide material that has slid

downslope toward the Provo River. The Oquirrh Formation has a high secondary permeability due to the fractured and weathered state of the rocks that allows water to percolate easily down through the unit. When the groundwater reaches the top of the Manning Canyon shale, which is nearly impervious, it saturates the shear zone as well as the top layers of the shale. Thus, the strength of this already weak zone is further reduced by the pore pressures created along the contact. Pore pressures may also be building in the clayey shales below the sheared contact zone. The saturated state of the shear plane probably also results in further chemical weathering of the shale, which gradually reduces its shear strength as discussed above.

Subsequent filling of a valley located in the northern portion of Horseshoe Bend in the 1930's has further accelerated movements in this local area as evidenced by inclinometer readings, resulting in roadway cracking. The cause of the movement appears to be due to subsurface groundwater flow at the interface between the fill and landslide debris as confirmed by the presence of localized springs at the toe of the fill slope below US-189 (Figure 8). Groundwater tends to exert pore pressure and weaken the shear resistance of the surrounding soils to slides. The movements are the greatest during the spring when snowmelt occurs.

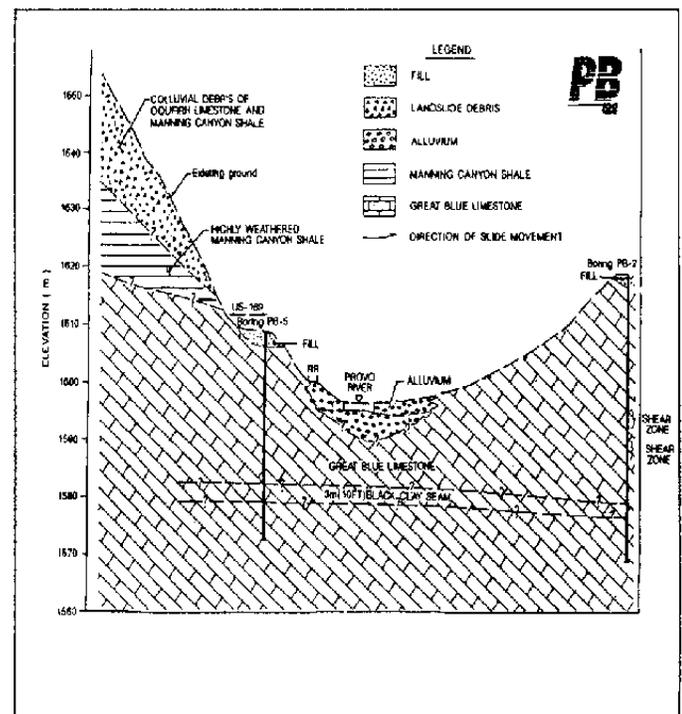
Figure 9. Inferred Geologic Cross Section at the South Horseshoe Bend

3. The southern portion of the Horseshoe Bend area has distinctly different subsurface conditions as evidenced in borings PB-2, and PB-5 (Figure 9). After movement along the Deer Creek thrust, a normal fault trending east-west is postulated to have formed at Horseshoe Bend with the downthrown side on the north (upstream) side of the fault (Lee & Brandon, 1995). The upthrown block is composed of Great Blue Limestone, which crops out on both sides of the Provo River and the block dips to the south-southeast. A normal fault with the Great Blue limestone on the upthrown side would explain the cause for the Horseshoe Bend feature. The river deflects sharply to the west due to the hard resistant limestone at this location.

The geologic conditions in the southern portion of Horseshoe Bend are complex, as exemplified in the presence of overturned bedding in a southbound roadcut on US-189 at drill hole PB-5 (Figure 9). At this time, no reliable explanation of the geologic structure of the southern portion of Horseshoe Bend has been determined.

A shallow slide has occurred at the southern portion of Horseshoe Bend and is believed to have resulted from formation of local piping in the fill that connects to a 7-foot-deep sinkhole located about 5 feet south of drill hole PB-5. The formation of this sinkhole is attributed to groundwater flow within the loose fill that daylight in the slope downhill of the roadway.
