# A Field Study and Dynamic Finite Element Analysis of Railway Retaining Structures Damaged by the Hyogoken-Nambu Earthquake (1995)

Yoshinori Nagayama

The seismic damage to embankments and retaining walls caused by the Hyogoken-nambu Earthquake (1995) was reviewed, rather focusing on railway structures. Nearly eight kilometers of damaged retaining structures were divided into five structural types, such as gravity-type walls, leaning-type walls, embankments, geo-textile-reinforced earth walls, and reinforced concrete walls, and into three categories of the damage, such as collapse, tilt, and crack. It was observed that the damage to gravity-type and leaning-type walls was greater than that to embankments, geo-textile-reinforced earth walls, and reinforced concrete walls, when they are lower than five meters. But some leaning-type walls higher than seven meters remained un-collapsed. In a smaller limited section, damage analyses of stone masonry walls of gravity type were carried out including undamaged ones. The percentage of heavy damage to stone masonry walls with slopes was nearly twice larger than that without slopes. Moreover, two-dimensional dynamic non-linear finite elemen

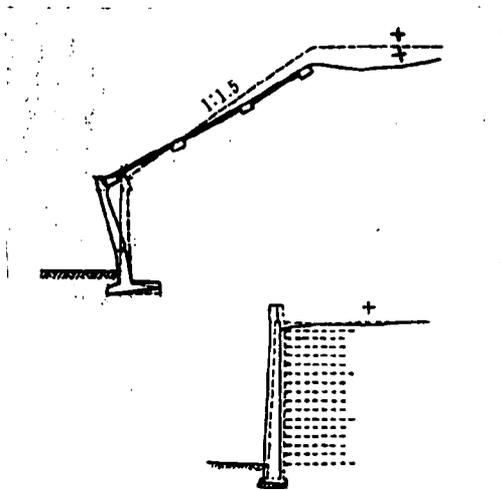
Fig.1. Collapse of RCW (above) and tilt of GRW (below)

some examples of combination of structural type and degree of damage. That is, the above figure shows an example of collapse of RCW, and the below an example of tilting of GRW.

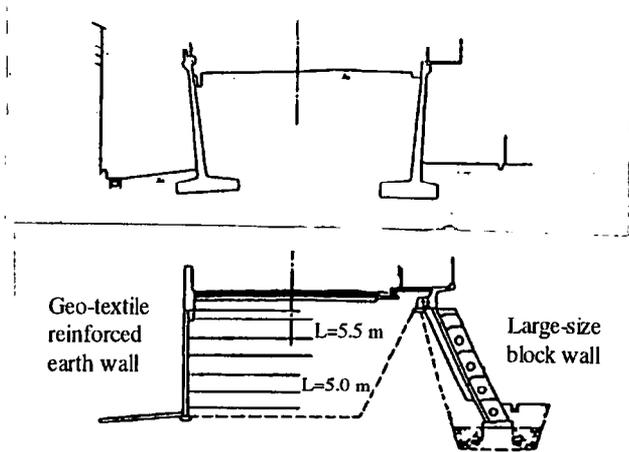
Fig.2. Restoration of a highway embankment: before (above) and after (below)

Restoration of damaged retaining walls of a municipal highway was conducted, using a geo-textile-reinforced earth wall and a large-size block wall, as shown in Fig.2.

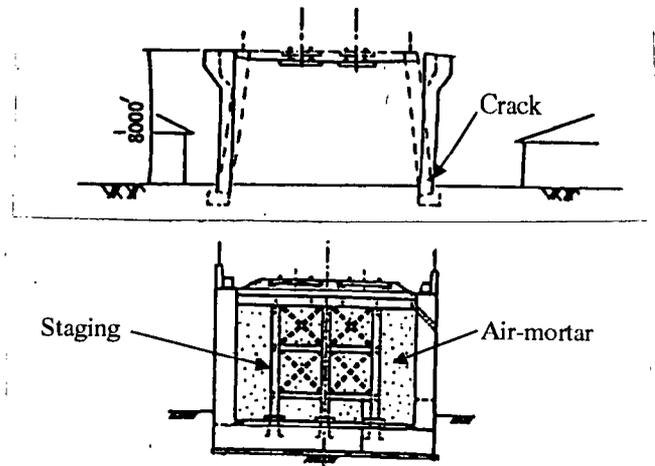
Fig.3. Restoration of a Hankyu Railways leaning-type wall: before (above) and after (below)

Collapsed retaining walls of Hankyu Railways are shown in Fig. 3. As for the restoration, the damaged walls were removed, the railway tracks were temporarily supported by staging, then a U-shaped concrete wall was constructed, and finally air-mortar was poured into the space inside the U-shaped wall.

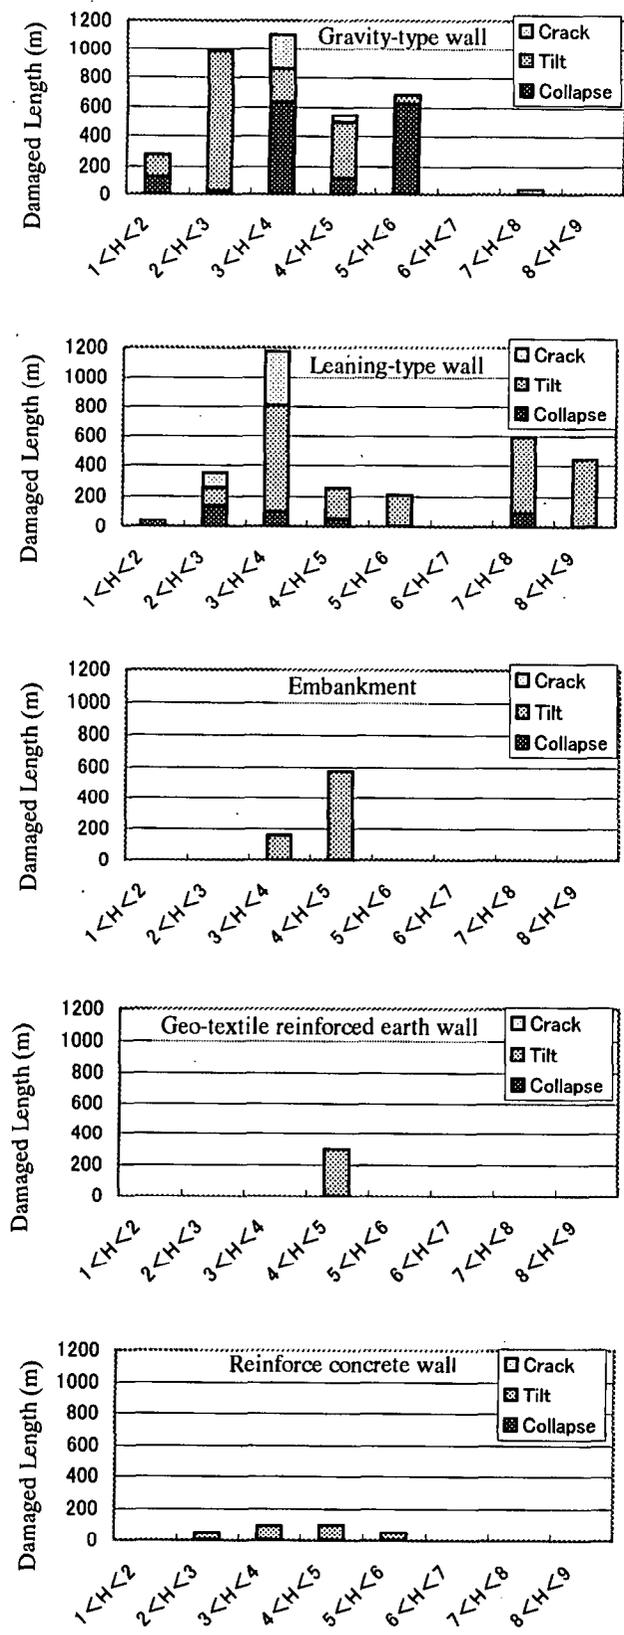
- Damage to embankments, GRWs, and RCWs was smaller than that to gravity-type or leaning-type walls,
- RCWs suffered internal damage but had no external damage, and
- Gravity-type walls of higher than 5 meters tend to collapse but leaning-type walls of higher than 7 meters remained tilted without collapse.

Fig.4. Degree of damage according to the height H (m) and type of retaining structures

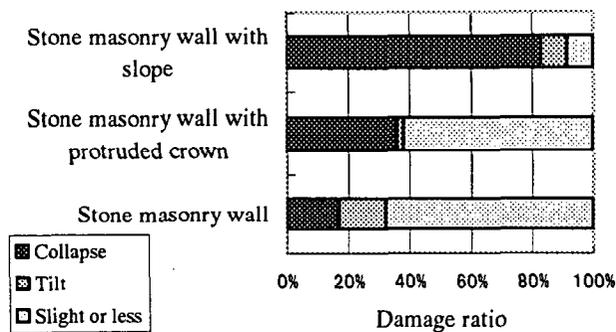
In a smaller limited section, all stone masonry retaining structures including non-damaged ones were analyzed, and the damage ratio was calculated. The retaining structures in this section were composed from stone masonry wall, stone masonry wall with protruded crown, and stone masonry wall with slope as shown in Fig.5. Figure 6 shows that the damage ratio of stone masonry wall with slope is twice greater than that without slope. The ratio of collapse in stone masonry wall with protruded crown is nearly twice greater than stone masonry wall. But even if tilted structures are included to the collapsed, the damage ratio with protruded crown does not change so much. From this figure, it is suggested that in the

applied aseismic design of retaining walls with slope, seismic active earth pressure can be estimated to be too small. Figure 7 shows the assumed slope for calculating seismic earth pressure in the applied seismic design. The shaded triangular soil mass over the assumed slope is considered to slide during earthquake, and neglected in the calculation of seismic earth pressure. This underestimation of seismic earth pressure may contribute to the large ratio of collapse. Moreover, some other factors such as slope protection works might accelerate the damage.

Fig.6. Damage ratio of stone masonry walls

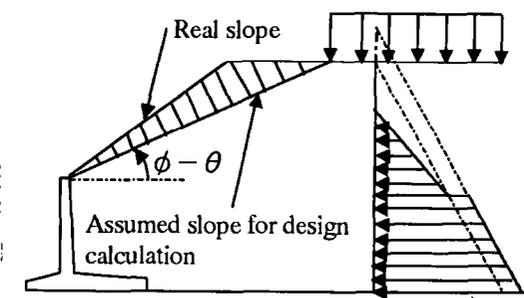
Fig. 7. Assumption of slope for applied aseismic design of retaining wall with slope

Aseismic design codes for railway structures were revised in 1999, and the concept of sliding soil mass in the calculation of seismic active earth pressure to retaining walls with slope was abandoned. The necessity of this revision coincides with the findings presented in this paper.

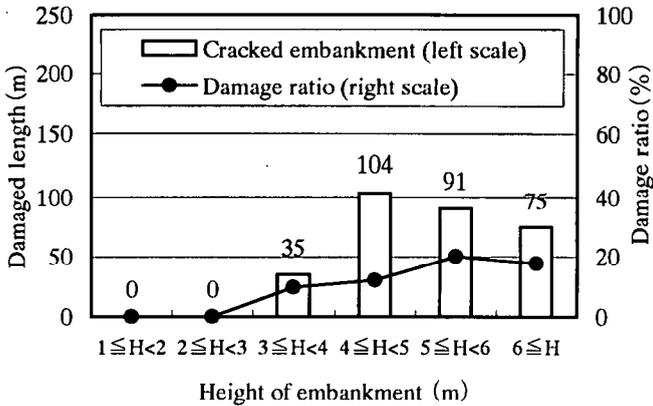
Damage to embankments of national highways was analyzed. Figure 8 shows the relationship between height of embankment and damaged length or damage ratio. The damage ratio is found to become greater as increasing the height of structures (Kunitomi *et al* 1998).

Fig.8. Damage to highway embankment

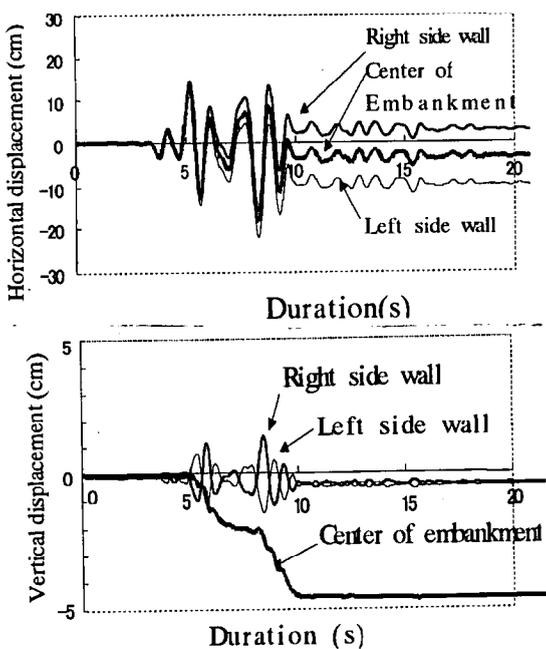
Figure 12 shows response of the gravity-type wall and the backfill. The gravity-type walls and the backfill horizontally oscillate in the same phase as shown in the upper figure of Fig.12. But, as shown in the lower figure of Fig.12, the settlement of backfill accumulates from the earlier stage, and the surface of embankment can not hold the original level.

Fig.12. Response of the gravity-type wall and the backfill: horizontal (above) and vertical (below)

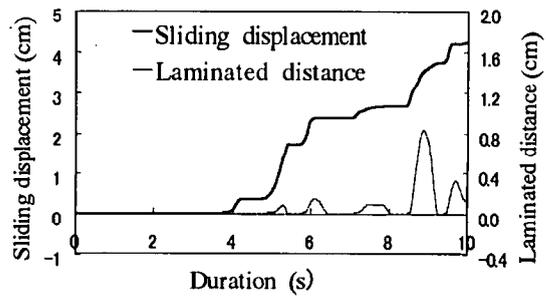
The gravity-type walls develop de-lamination at the contact plane to backfill as shown in Fig.13. This soil-wall slippage displays non-reversible character. This type of relative displacement is also developed in the leaning-type walls.

Fig.13. Relative displacement between the gravity-type wall and the backfill

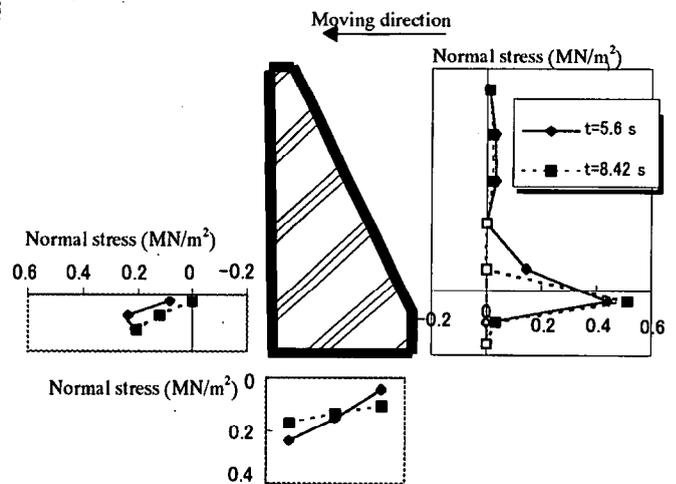
Figure 14 shows stress distribution at the contact face between gravity-type wall and backfill. The gravity-type wall develops earth pressure when the whole structure is moving from backfill side to wall side as shown in Fig. 14, but has no earth pressure when moving the other way around. This means that the gravity-type wall suppresses the movement of the backfill.

Fig.14. Stress distribution at the contact face between gravity-type wall and backfill

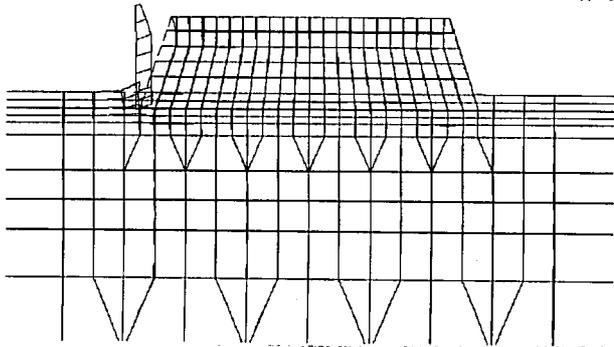
Figure 15 shows displacement of leaning-type wall at 9.7 seconds. The leaning-type wall does not develop any earth pressure at the contact face with the backfill whether it is moving right or left. It moves as if it was on the side slope of the embankment and toppled after as shown in Fig.15.

Fig.15. Displacement of leaning-type wall at 9.7 seconds

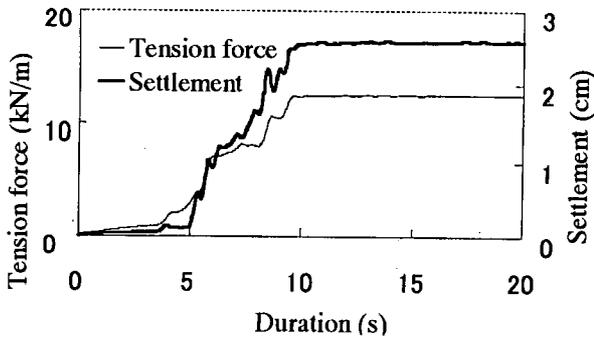
Figure 16 shows tension force in the geo-textile and settlement of reinforced embankment. The geo-textile material develops tension force in accordance with the settlement of backfill as shown in Fig.16. The distribution of the tension force in geo-textile does not change so much

Fig.16. Tension force in the geo-textile and settlement of reinforced embankment

whether the wall is moving right or left. Therefore, the tension force is not directly caused by the horizontal movement of the wall, but by the settlement of backfill. This tension force suppresses sliding of the wall. Figure 17 shows the distribution of tension force when the whole structure is moving from the left to the right.
