## Landslides on Shale in Southern Illinois

## LANDSLIDES ON SHALE IN SOUTHERN ILLINOIS

Paper No. 2.53

This paper presents the case histories of two landslides in southern Illinois. The first landslide presented occurred along a highway cut at Ford's Hill on Illinois Route 3 near Chester, Illinois. The second landslide occurred in the embankment of a large retention pond in southern Illinois. Both failure planes were along the surface of the weathered shale bedrock in response to excess pore pressures. Backfigured strength at the time of failure was low and at the residual strength of the weathered shale.

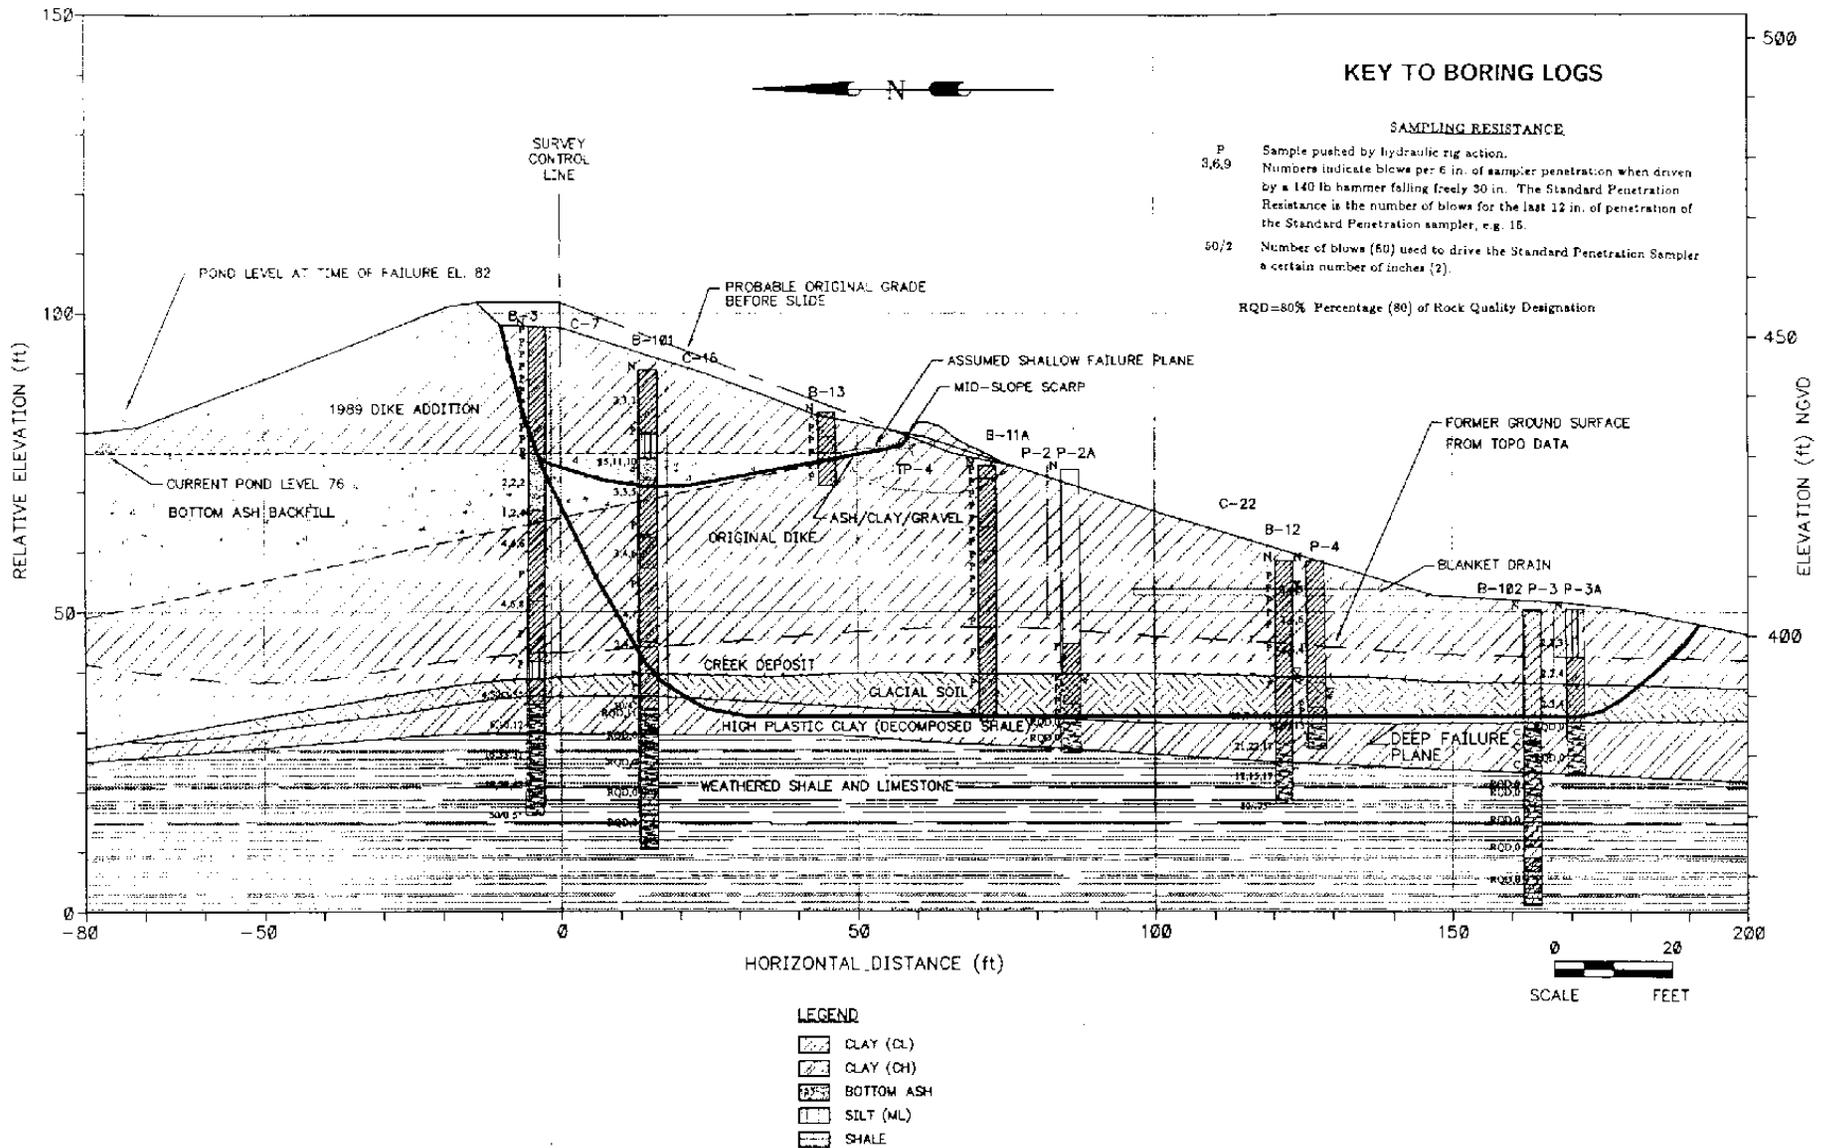
Fig. 3. Retention Pond Slide Generalized Cross Section

The overall slide consisted of two portions; shallow and deep. The deep slide occurred first 70 feet below the crest at about the top of the high plastic clay noted above. A generalized section through the center of the failure is shown in Figure 3. It was hypothesized that movement of the dike on the deep failure plane then formed a crack that extended through the clay dikes and bottom ash. As the crack widened, it created a void that was filled by soil and bottom ash migrating into it. This resulted in the upper dike settling. Concurrently the bottom ash and granular haul road at the top of the original dike permitted hydrostatic pressure equal to the pond head to develop beneath the toe of the upper clay dike. This water pressure lifted the toe allowing the upper clay dike to move laterally. Finally rainwater in the tension cracks of the failed upper dike aggravated further movement. Lowering of the pond by 6 feet reduced the rate of movement significantly.

The deep slide was not visually apparent at first, but was detected by deep instrumentation (inclinometers). The pond level was raised approximately 6 feet four months prior to the visual existence of the slide. When the pond level was raised, the deep failure was believed initiated by water pressure in the pervious water-washed zone directly above the high plastic clay.

The backfigured friction angle along the failure plane assuming no cohesion was 14.5°. This low friction angle was consistent with laboratory measurements of residual (large displacement) friction angles measured in fissured or slickensided high plastic clays and shale found in this area. An interim repair which was performed in the summer of 1995 has arrested movement of the slide. The interim repair consisted of removal of about 20 feet of soil at the crest of the dike for about 600 lineal feet to reduce the driving forces of the slide. A cutoff wall and a drainage wall has been designed as a permanent repair if the dike is to be reconstructed.
