## Repair of Scour Holes and Levees After the 1993 Flood

## Repair of Scour Holes and Levees after the 1993 Flood

Paper No. 2.26

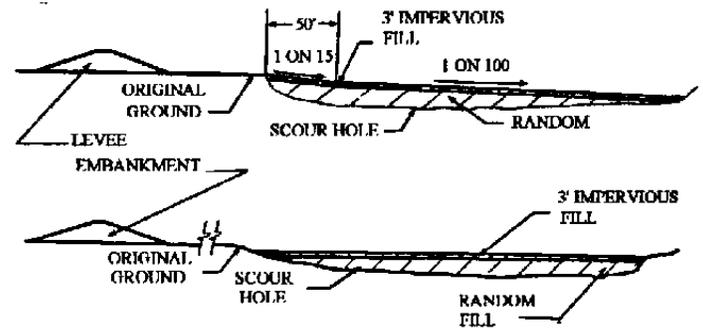
**Levee Unit L-400.** L-400 is located on the left bank between river miles 385 and 391.2, near Waldron, Missouri. The height of the levee varies between 12 and 20 feet. The levee was designed for a 100-year flood event with 2 feet of freeboard. During the 1993 flood, the levee was overtopped along the lower approximately 1,800 feet of its length causing breaches at three locations and erosions and scouring of the riverside levee slopes, foreshore and landward toe areas. The riverside scour hole cut through the pre-existing borrow area traverses, resulting in a scour approximately 200 feet wide and up to 35 feet deep that extended to within 50 feet of the riverward levee toe. The impervious blanket at this location consisted of lean clay approximately eight feet thick outside of borrow pits and five feet thick within borrow pits.

Fig. 1 MRLS L-400, Sta. 233+17 to 267+17. Complete backfill of riverbank scour hole.

Two repair alternatives were analyzed. One was to construct a rockfill dike 100 feet from the levee centerline, having 1(V) on 1.5 (H) side slopes and a ten-foot wide crown. Granular material was proposed as backfill between the rockfill dike and levee slope. The upper five feet was to be constructed of compacted impervious material. A variation of this alternative was to replace the rockfill dike with granular material, constructing a platform to 160 feet from the levee toe that would be overlain with a five-foot thick layer of impervious material. A second alternative, selected as the most efficient, was to backfill the entire width of the scour hole with granular material on 1(V) on 100(H) slope and to reconstruct a three-foot thick impervious blanket on top of the sand backfill. Underseepage analysis required 140 feet wide underseepage berms along 350 feet of the landside toe. The repair of this scoured levee required 64,000 cy of cohesive material for the impervious blanket and the riverside levee slope, 157,000 cy of sand for the backfill of the scour hole, and an additional 3,000 cy of random material for the underseepage berm. Cross sections of the selected alternative are presented in Fig. 1.

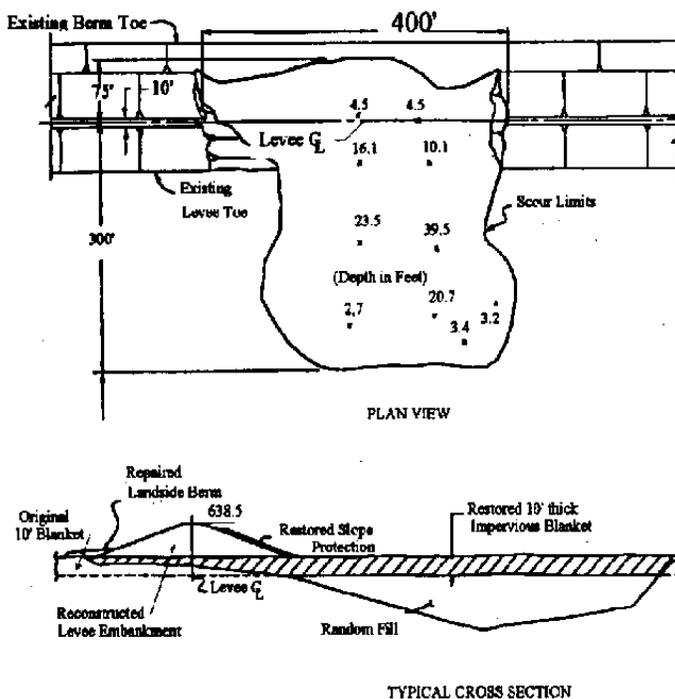
A breach at Missouri River mile 240 on L-246 created a 400-foot long scour hole that extended 300 feet riverward and 75 feet landward of the levee centerline. The maximum depth of the scour was 40 feet. The selected alternative for repair was to backfill the scour hole and reconstruct the levee embankment to its original geometry. Underseepage analysis, followed by economical analysis, determined the optimum thickness of the reconstructed impervious blanket, considering different widths of landside berm. The plan view of the scour hole and the repaired cross section are shown in Fig. 2.

Fig. 2 MRLS L-246, Levee Breach Stations 674+20 to 678+20

The repair required 4,500 cy of impervious material in the levee embankment, 24,500 cy of impervious material in the blanket, 23,600 cy of granular fill underneath the blanket, and 3,500 cy of random fill for the reconstruction of the existing underseepage berm.

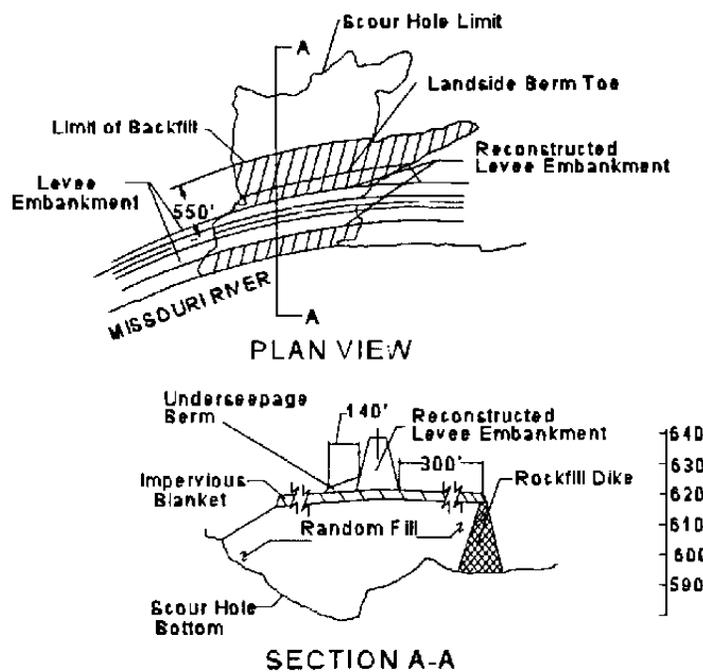
**Lower Chariton River Levee Unit.** This levee extends approximately five miles along the left bank of the Lower Chariton River, then downstream along the Missouri River left bank between river miles 227.5 and 238.7 and then five miles upstream along the right bank of the Little Chariton River. The levee was designed for a 25-year flood event. The levee breached at two locations along the Missouri River main stem. The upstream levee breach removed 1,250 linear feet of levee and scoured the foundation to significant depths. The scour hole extended 1,400 feet landward of the centerline and 300 feet riverward the entire foreshore width. Soundings indicated scour hole depths of 60 feet on the riverside of the levee and 50 feet on the landside. Two alternatives were studied for repair: (1) realignment of the levee landward of the scour hole, and (2) reconstruction of the levee along its original alignment on a platform created by partial backfilling of the scour hole.

Fig. 3 Lower Chariton River Levee. Backfill of the Scour Hole and Reconstruction of the Levee at the Original Location

was used for the rehabilitation. The platform was extended to the riverbank and 550 feet landward of the levee centerline. A rockfill dike was constructed at the riverbank between the upstream and downstream end of the scour hole. The rockfill dike has 1(V) on 1.5(H) side slopes and a five-foot wide crown. Sand dredged from the river was used for backfilling the scour hole behind the rockfill dike. Underseepage analysis determined the thickness of the impervious blanket constructed above the dredged sand platform and the width of the underseepage berm. The analysis indicated the need for a 140-foot wide landside berm and a blanket thickness of three feet. The blanket was constructed of silty clay from the nearby borrow areas. Random material used within the levee embankment and seepage berm consisted of the silty sand that was deposited by overbank flood flows. Seepage through the embankment was controlled with a five-foot thick impervious face on the riverside slope and a three-foot thick impervious cap on the levee crest. The riprap slope protection was reconstructed on the entire riverside slope of the levee. The alternative is shown in Fig. 3.

The repair required 8,000 cy of impervious fill and 25,000 cy of random material for reconstruction of the levee embankment and landside underseepage berm, 6,200 tons of riprap and 2,000 tons of bedding material to reconstruct the levee slope protection, 300 tons of aggregate surfacing for reconstruction of the levee crest road, 700,000 cy of dredged sand for backfilling the scour hole, 360,000 cy of impervious material for reconstruction of the impervious blanket on the top of the dredged sand, and approximately 8,000 tons of quarry run rock for construction of the riverside rock dike.

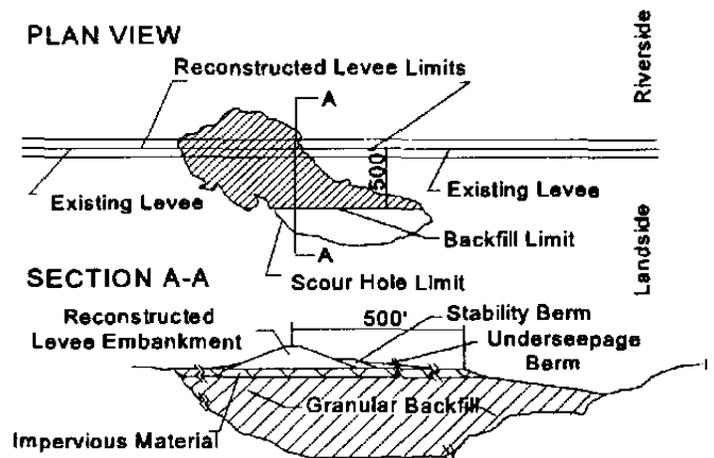
**Levee Unit R-471/460.** This MRLS levee is located on the right bank of the Missouri River between river miles 441.7 and 456.6 across the river from St. Joseph, Missouri. The levee is 13.8 miles long with an average height of 14.8 feet and protects 11,000 agriculture acres and 2,300 urban acres including the city of Elwood, Kansas, the St. Joseph Municipal Airport, and the Missouri Air National Guard Base. The design elevation was established to protect against a 100-year flood event with a two-foot freeboard. During the flood of 1993, the levee was overtopped and the embankment eroded and breached at two locations. In addition to the loss of 1,100 feet of levee embankment at the upstream breach, the flood waters scoured the embankment foundation to depths up to 46 feet over a 26-acre area. Two alternatives were considered for repair of the breach: (1) construct a levee realignment landward of the scour hole, and (2) construct the levee to its original alignment. Although the realignment alternative proved to be less costly than the original alignment alternative, the levee sponsor paid the cost difference and the original alignment was selected.

Fig. 4 R-471/460. Backfill of the Upstream Scour Hole and Reconstruction of the Levee at Original Alignment

The selected alternative, constructed to the original alignment, is shown in plan view and cross section on Fig. 4.

The scour hole was filled from its riverward extent to a distance of 500 feet landward of the levee alignment's centerline to ensure an acceptable gradient factor of safety. Although it was acknowledged that partially filling the scour hole would increase the seepage quantity on the protected side of the levee, the increased seepage would flow into designated ponding areas. The scour hole fill consisted of 501,500 cy of Missouri River dredge sands and 128,300 cy of hillside loess to reconstruct to the original four-foot thick impervious blanket. The original 180-foot wide underseepage berm and the 45-foot wide combination stability and underseepage berm were reconstructed to their original limits.

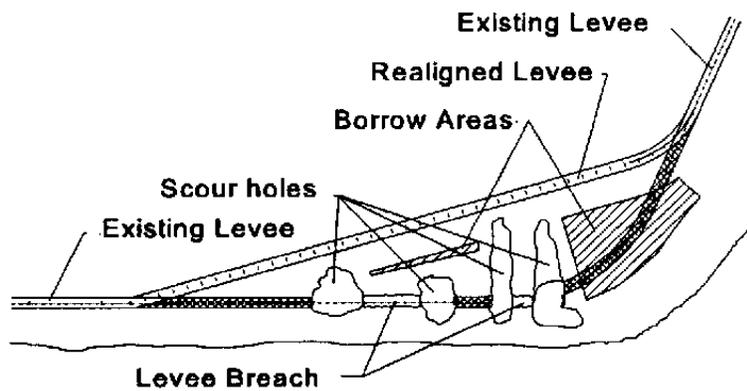
**Levee Unit L-246.** At river mile 250, L-246 sustained a series of breaches and scours along a 1,740-foot length of embankment. A scour hole at the upstream limit of the breach measured 340 feet long, up to 41 feet deep, and extended landward 250 feet and riverward 100 feet. At the downstream end of the breach a second 200-foot long scour hole with a maximum depth of 36 feet extended 175 feet riverward and 600 feet landward from the levee centerline. Two other shallow scour holes, approximately six and ten feet deep were present on either side of a remaining segment of the embankment. Various combinations of backfilling scour holes and reconstructing the embankment along the original alignment were studied. However, landward realignment was chosen as the most economical solution. The realignment began 1,220 feet upstream of the breached area and tied back into the existing levee approximately 1,850 feet downstream of the breached area. Because this realignment cut off a pre-existing

Fig. 5 MRLS L-246. First Levee Realignment Around the Scour Holes on the Upstream Breach.

Underseepage analysis determined the minimum setback distance of 125 feet from the landside edge of the scour hole. The realignment left approximately 45 acres of previously protected land on the riverside of the setback alignment. The riverside slope of the reconstructed levee was protected with a two-foot thick layer of quarry-run rockfill on the downstream 1,200-foot reach. Quarry-run rock was also placed on the landward bank of the scour hole for erosion control. Remnants of levee embankments riverward of the realignment were used as borrow material for the reconstruction. The repair required 30,000 cy of impervious material and 45,000 cy of random fill for construction of the realigned levee embankment.

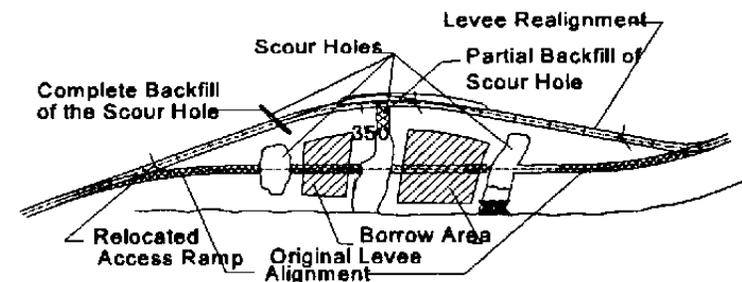
Three additional levee breaches occurred on L-246 between stations 316+15 and 359+00. The first 450-foot wide breach was associated with numerous scours holes. One scour hole through a breach was a maximum of 50 feet deep and extended 400 feet riverward and 350 feet landward of the levee centerline. Another narrow scour hole, a maximum of 20 feet deep, was located 600 feet farther landward.

A second 300-foot wide breach approximately 3,000 feet downstream created a scour hole up to 42 feet deep and 400 feet wide. The scour hole associated with this breach extended from the riverbank 1,650 feet landward, where it narrowed to a width of approximately 250 feet. A third 1,050-foot wide breach occurred 300 feet farther downstream. At this location the scour hole through the breach was 41 feet deep and 400 feet wide and extended 300 feet riverward and 1,200 feet landward from the levee centerline. Numerous shallow erosions of the foreshore occurred between the riverward limit of the scour hole and the existing rockfill dike along the Missouri River channel. Backfilling of the three scour holes through the breaches and reconstruction of the embankment along the original alignment was studied. However, underseepage analysis indicated that

Fig. 6 MRLS L-246. Second Levee Realignment Around the Scour Holes.

backfilling a minimum of 500 feet from the landside levee toe would be necessary to ensure the safe performance of the levee foundation and to maintain underseepage quantities at acceptable levels. Consequently, levee realignment landward of the three breaches was chosen as the most economical solution. The realignment tied into the original levee embankment 4,300 feet upstream of the first breach and 2,300 feet downstream from the edge of the third breach. The realigned levee is 9,760 feet long and is constructed to the same height as the original levee. Based on underseepage analyses, the minimum setback of the realignment from the landward edge of the scour holes was 300 feet for the upstream hole and 125 feet for the two downstream holes. Rockfill slope protection was constructed at areas where higher velocities could occur as a result of the realignment. Approximately 125 acres of land between the original alignment and the realigned levee were left unprotected by the realignment. The portions of the original levee embankment between the upstream and downstream ends of the realignment were used as a borrow source for the realignment. Quantities required for the repair of the levee at this location included 100,000 cy of impervious soil and 230,000 cy of random fill. The plan view of the repair is shown in Fig. 6.

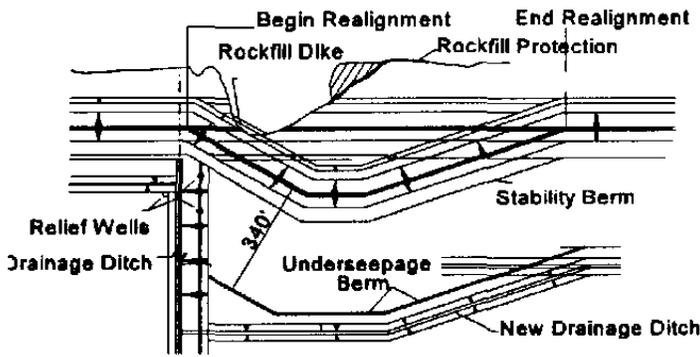
Another 400-foot long breach of the L-246 embankment occurred on the downstream tie back along the lower Chariton River. The scour hole extends from the riverbank 400 feet landward with depths up to 45 feet. A levee realignment landward of the scour hole was chosen as the most economical alternative. The realignment distance from the original levee centerline was limited by a drainage structure 185 feet upstream of the scour hole. A rockfill toe was necessary on the upstream end of the scour hole to assure the minimum stability safety factor of 1.5 because of the realignment's proximity to the scour hole edge. Underseepage calculations required construction of a 340-foot landside underseepage berm along the entire realignment. Two relief wells were also required on both sides of the drainage ditch to the structure. The necessary quantities for repair of this reach were 18,000 cy of impervious material, 80,000 cy of random material, and 6,000 tons of rockfill. A plan view of the repair is shown in Fig. 7.

Fig. 7 L-246, Chariton River Right Bank Tie Back Levee. Levee Realignment.

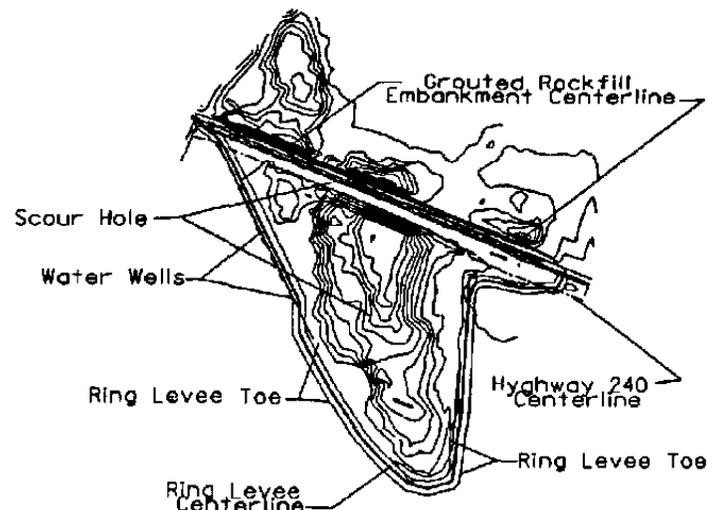
**Cambridge Levee.** The Cambridge levee, a non-federally constructed and operated agricultural levee, ties into a railroad embankment as high ground. This railroad embankment that was breached during the 1993 flood is located along the Missouri River's right bank between Slater and Glasgow, Missouri. At the location of the scour hole the railroad embankment consisted of random material with an impervious riverside slope protected with rockfill. The height of the levee corresponds to 10-year flood stage providing protection for farmland and a portion of State Highway 240 between Slater and Glasgow, Missouri, and the well field for Slater, Missouri. During the 1993 flood, about 2,200 linear feet of railroad embankment was breached at river mile 231 along the Cambridge Bend. The flood scoured holes down to bedrock, up to 70 feet deep, washing away the railroad embankment and the adjacent highway that had served as part of the flood protection. The scour hole extended 2,000 feet landward from the railroad embankment toe and the entire foreshore to the river.

During a May 1996 flood, seepage through the embankment demonstrated that ungrouted "windows" still remained in the cut-off wall. Parametric seepage analyses were conducted with the head and tailwater conditions experienced during the floods before and after the grouting to quantify the amount of seepage reduction that had been accomplished by the grouting and whether additional grouting was justified. This analysis indicated that the grouted wall had significantly reduced the seepage through the embankment by as much as 70 percent and that further reduction was possible with additional grouting. However, no assurance could be made that additional grouting would reduce the seepage to a level acceptable to the local landowners. Consequently, other alternatives were examined that could assure a higher degree of confidence. These included partially backfilling the scour hole with dredged granular material and reconstructing a ten-foot thick impervious blanket on both sides of the railroad embankment. This alternative would have reduced the seepage through the embankment but was extremely expensive.

Fig. 8 Cambridge Levee and Glasgow-Saline Railroad. Grouted Rockfill Embankment and Landward Ring Levee.

The most economical solution studied was to construct a ring levee landward of the scour hole that tied into the railroad embankment outside the limits of the breach. As part of the construction in 1997, Highway 240 will also be raised to the height of the ring levee. The plan view of the ring levee is shown in Fig. 8.

The average height of the ring levee will be 14 feet, with a ten-foot crown and a 1(V) on 3(H) side slope. The ring levee will be constructed of random fill material consisting of silty sand

deposited by the river downstream of the scour hole with a five-foot thick impervious layer on the scour hole side and a three-foot thick impervious layer at the crest. Underseepage calculations determined the setback distance of the ring levee from the scour hole edge to eliminate the necessity of landside underseepage berms. The estimated quantities for the ring levee are 55,000 cy of impervious fill and 86,000 cy of random fill.
