Repair of Scour Holes and Levees After the 1993 Flood

Repair of Scour Holes and Levees after the 1993 Flood

Paper No. 2.26

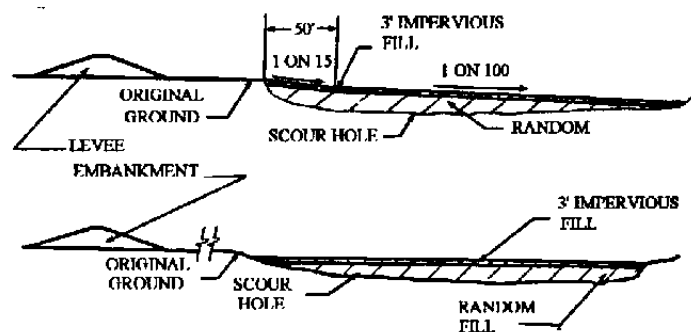
Levee Unit L-400. L-400 is located on the left bank between river miles 385 and 391.2, near Waldron, Missouri. The height of the levee varies between 12 and 20 feet. The levee was designed for a 100-year flood event with 2 feet of freeboard. During the 1993 flood, the levee was overtopped along the lower approximately 1,800 feet of its length causing breaches at three locations and erosions and scouring of the riverside levee slopes, foreshore and landward toe areas. The riverside scour hole cut through the pre-existing borrow area traverses, resulting in a scour approximately 200 feet wide and up to 35 feet deep that extended to within 50 feet of the riverward levee toe. The impervious blanket at this location consisted of lean clay approximately eight feet thick outside of borrow pits and five feet thick within borrow pits.

Fig. 1 MRLS L-400, Sta. 233+17 to 267+17. Complete backfill of riverbank scour hole.

Two repair alternatives were analyzed. One was to construct a rockfill dike 100 feet from the levee centerline, having 1(V) on 1.5 (H) side slopes and a ten-foot wide crown. Granular material was proposed as backfill between the rockfill dike and levee slope. The upper five feet was to be constructed of compacted impervious material. A variation of this alternative was to replace the rockfill dike with granular material, constructing a platform to 160 feet from the levee toe that would be overlain with a five-foot thick layer of impervious material. A second alternative, selected as the most efficient, was to backfill the entire width of the scour hole with granular material on 1(V) on 100(H) slope and to reconstruct a three-foot thick impervious blanket on top of the sand backfill. Underseepage analysis required 140 feet wide underseepage berms along 350 feet of the landside toe. The repair of this scoured levee required 64,000 cy of cohesive material for the impervious blanket and the riverside levee slope, 157,000 cy of sand for the backfill of the scour hole, and an additional 3,000 cy of random material for the underseepage berm. Cross sections of the selected alternative are presented in Fig. 1.
