# A Case Study on Expansive Soils and Rocks of Al-Khod in Northern Oman

## A CASE STUDY ON EXPANSIVE SOILS AND ROCKS OF AL-KHOD IN NORTHERN OMAN

Paper No. 1.05

The paper presents a brief damage case study of house number 18 based on its damage assessment made in October 1996. The aims of this investigation are to study the mechanism of structural damage to the building, to establish the cause of such damage, and to recommend the appropriate measures to be taken for construction of buildings founded on expansive soils and rocks.

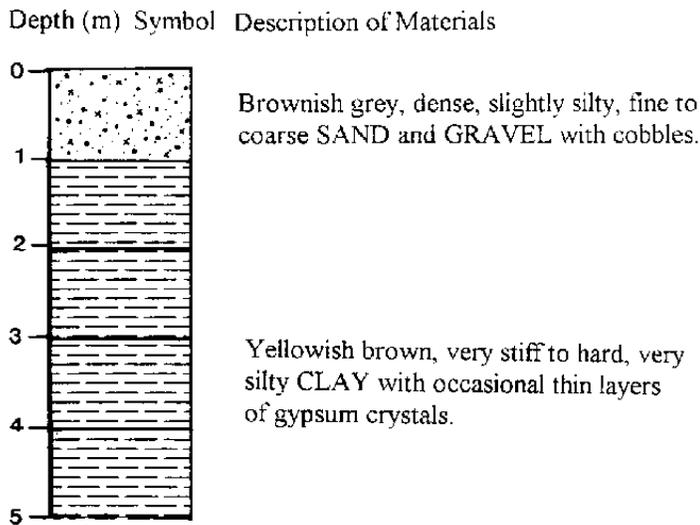
Fig. 1 Typical soil profile.

A soil survey was carried out by COWIconsult (1988) to investigate the soil conditions and determine the cause of cracking in the houses. Two deep trial pits were excavated to recover samples for laboratory testing. Two boreholes were carried out by Yahya Costain (1988) near house numbers 19 and 20. The soil profile of the two boreholes is similar, therefore, a typical bore log is shown in Fig. 1.

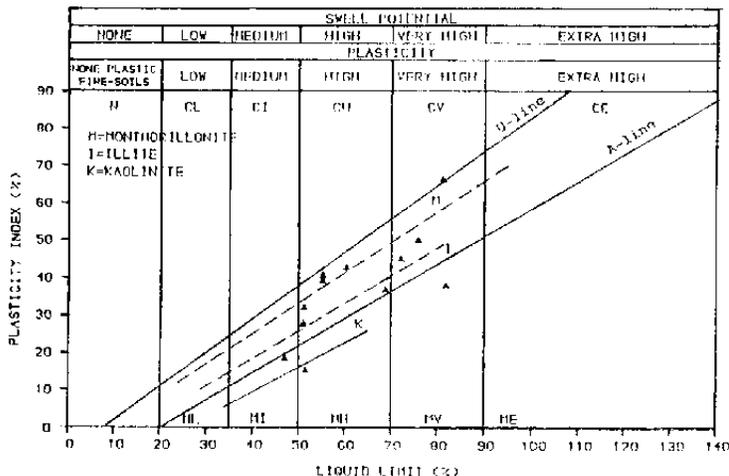
Fig. 2 Swelling potential classification (Dakshanamurthy and Raman, 1973) and mineralogical classification chart (Holtz and Kovacs, 1981).

From the chart, it is seen that samples MQV1, MQV2 and MQV4 were found to be located in the kaolinite zone, and sample MQV3 in the illite zone. On the other hand, samples MQV5, MQV6, MQV7 and MQV9 are located in the zone between illite and

Atterberg limits have been employed in this paper to determine indirectly the swelling potential using the criteria developed by Dakshanamurthy and Raman (1973). From the results shown in Fig. 2, it is seen that with the exception of one or two samples, all samples were found to be located in the *high* to *very high* ranges of swelling potential.

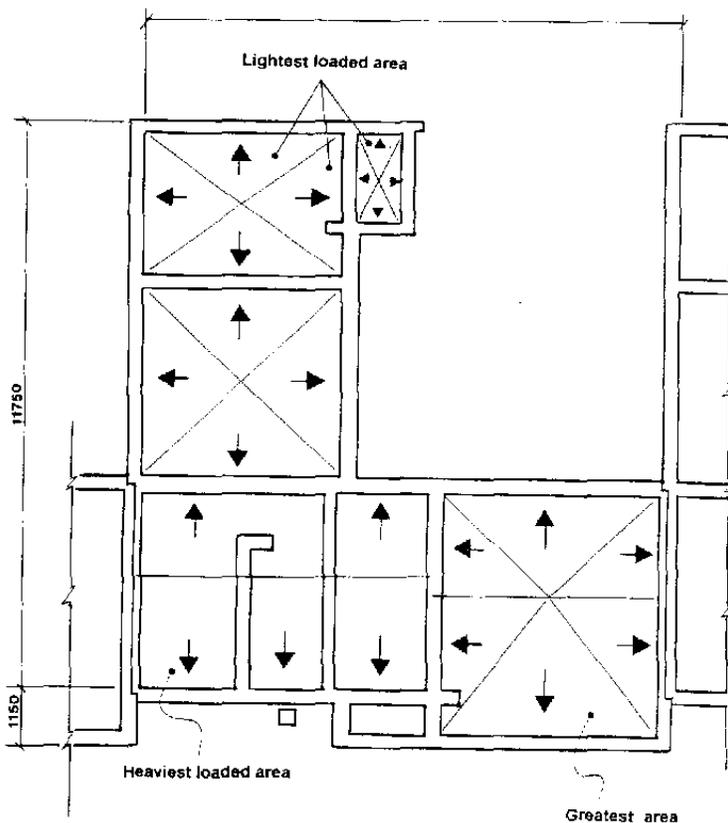
Fig. 3 Plan of house number 18.

It was observed that almost all the exterior walls are free from the cracks except a few hairline cracks. It seems that there is negligibly small changes in the moisture content of the soil under the walls in the front face of the structure and the front walls are carrying heaviest loads on them due to the largest rooms and the highest walls as shown in Fig. 3.

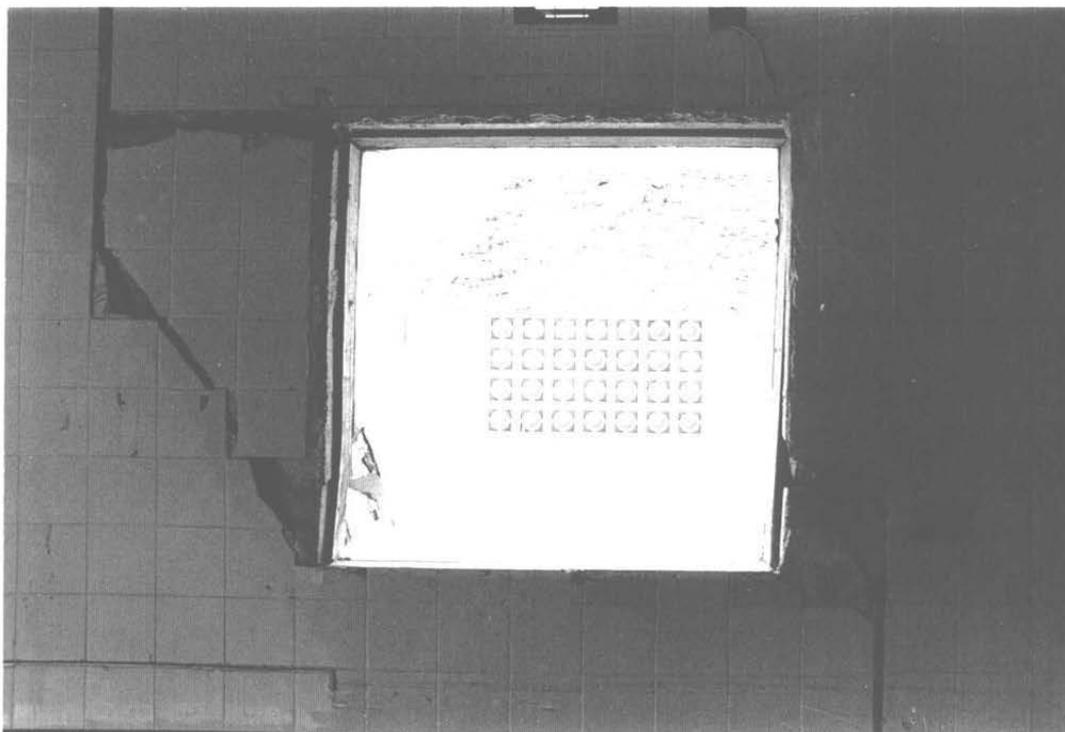
Very severe cracks have developed to the walls of the kitchen (on the ground floor) and of the W.C and bath room (on the first floor above the kitchen) as shown by Figures 4 to 6. It is very surprising to note from Fig. 4 that the width of the same cracks of the wall located at the first floor vary from 30 to 50 mm. Figure 4 shows that the window frame has loosened and moved slightly away from the wall due to severe cracking around the window opening. Generally, width of most of the cracks lie within a range of 20 to 30 mm.

*Fig. 4 Very severe cracks in the kitchen wall.*

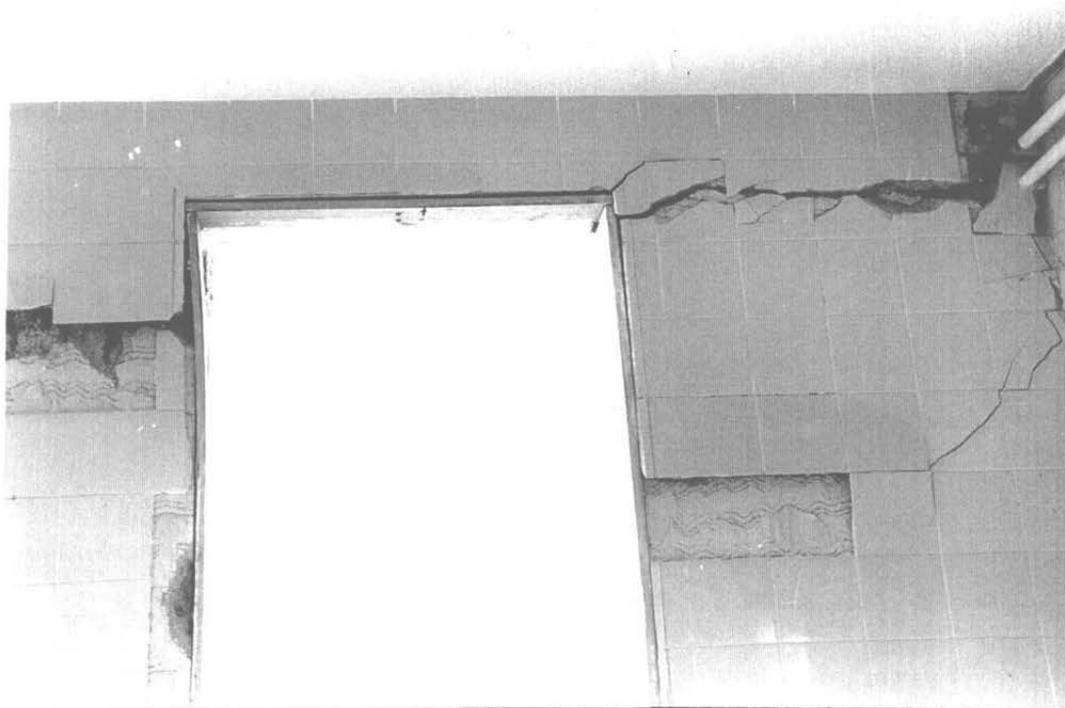
Figure 5 shows a combination of the horizontal, predominantly diagonal and vertical cracks. Generally, the width of the cracks measured is between 10 to 30 mm. The kitchen walls show the worst damage in comparison with the damages to the majority of the walls of the building. It is most likely that the problem has been aggravated by the defects in the water supply in the kitchen itself. The wall cracks are classified as very severe degree of visible damage in accordance with BRE (1981) classification. Very severe diagonal cracks are observed from the backyard face of the same wall (Fig. 6) varying between 30 to 75 mm.

*Fig. 5 A close up view of the kitchen wall showing diagonal and horizontal cracks.*

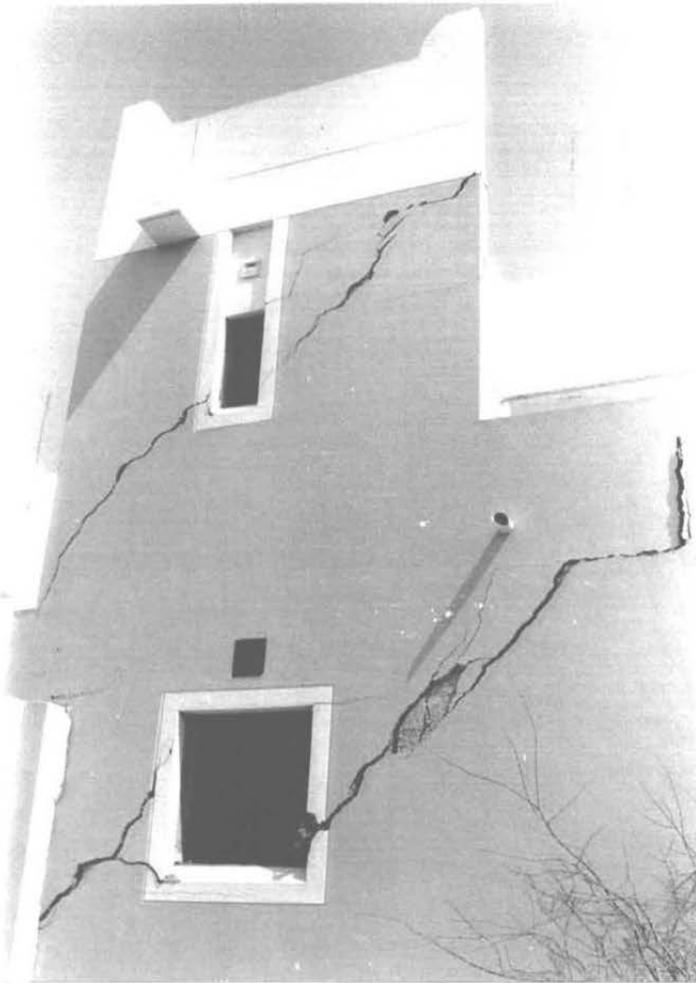
It turns out from the damage assessment of these walls that extensive damage has occurred to the walls facing the backyard. This sustained significant damage to the walls has occurred due to the differential foundation heave caused by non-uniform change in soil moisture content. The backyard has been subjected to considerable watering for shrubs and plants throughout the year. Since, the walls were not designed to resist the stresses developed by additional bending moment and shear force due to the interaction between the expansive foundation soil and the structure, consequently the distress has been relieved in the forms of cracks in the walls.

Fig. 6 Back elevation of house number 18 showing extensive damage to the wall.

1. Surface drainage must be provided all around the building and the ground surface should be graded.
2. Horizontal moisture barriers should be constructed around the building preferably in the form of concrete and/or asphalt apron to prevent excessive intake of the surface moisture.
3. The interior plumbing including sewer and water supply lines should be checked for leakage periodically.
4. All house gardens should be paved, to prevent the effects of over-irrigation.
5. No shrubs or ground coverplants should be retained or introduced in future within 3 m of house structure gable ends and no trees planted within 5 m of house foundation pads.
6. Prompt investigation of any reported structural damage which if found to be associated with expansive strata must include identification and removal of any water sources.
