Emergency Underpinning and Repositioning of a Four-Story Office Building

EMERGENCY UNDERPINNING AND REPOSITIONING OF A FOUR-STORY OFFICE BUILDING

ABSTRACT

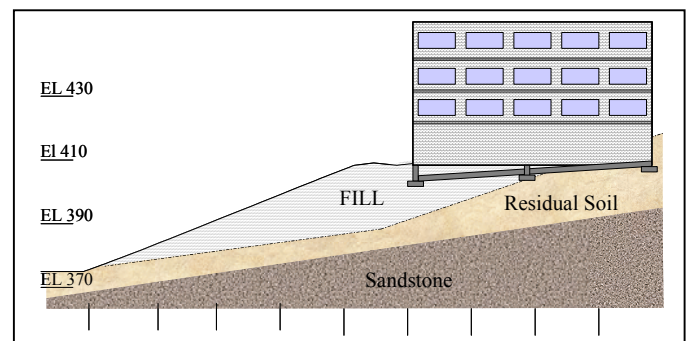
The structure is steel frame with brick and glass veneer, as well as cast in place concrete walls in below-grade areas (see Fig. 1). The ground surface slopes from the front of the building to the back with a change in elevation of about 14 ft.

Available construction records included a preconstruction geotechnical investigation, and limited construction testing reports. According to civil site plans, the original ground surface before construction of the building was about EL 391 at the present location of the southeast corner of the structure.

Fig. 1. Interpreted subsurface conditions.

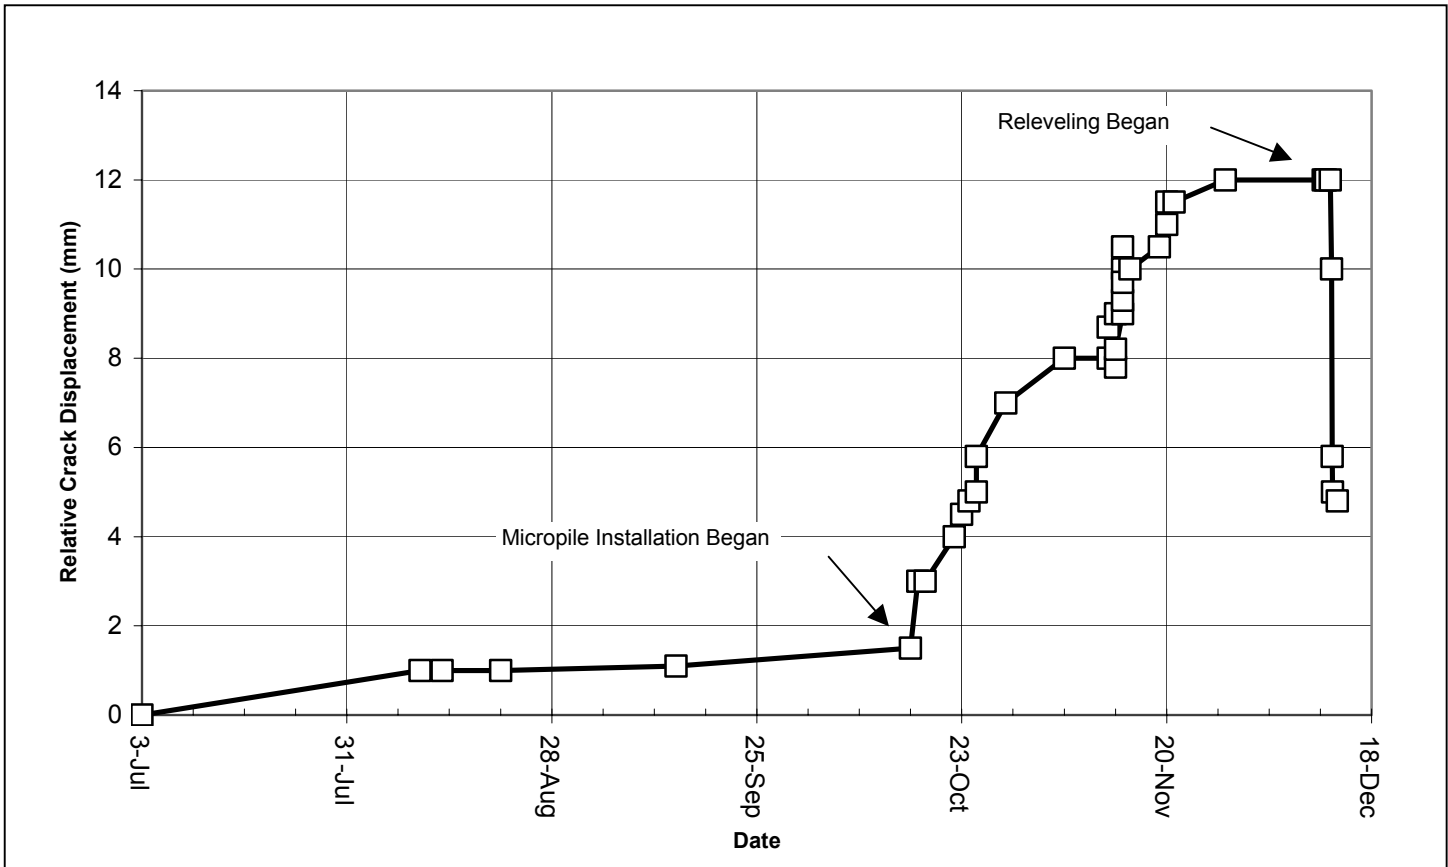
Six standard crack monitor gauges were installed to supplement several already installed by the structural engineer for the project. A graph of typical data is shown in Fig. 3.

In addition to the crack monitors, spot checks on the level of the first floor interior and exterior were made from the basement area. Based on measurements of the vertical crack widths inside the building, the total settlement of the southeast corner was estimated to range between 3 and 3½ inches. Optical observation of the southern and eastern exterior walls suggested that settlements of two to 2½ inches may have occurred after installation of the brick veneer. Given these measurements, it appears as though there was an original settlement of about one inch shortly after construction of the wall, and an additional two to 2½ inches of settlement since placement of the brick veneer.

Fig. 3. Crack monitoring data.

Total settlement recovery measured by the survey was approximately one inch at the southeast column, and ¼ inch at the south column location. The recovery is depicted in the deflection plot of Fig. 3.

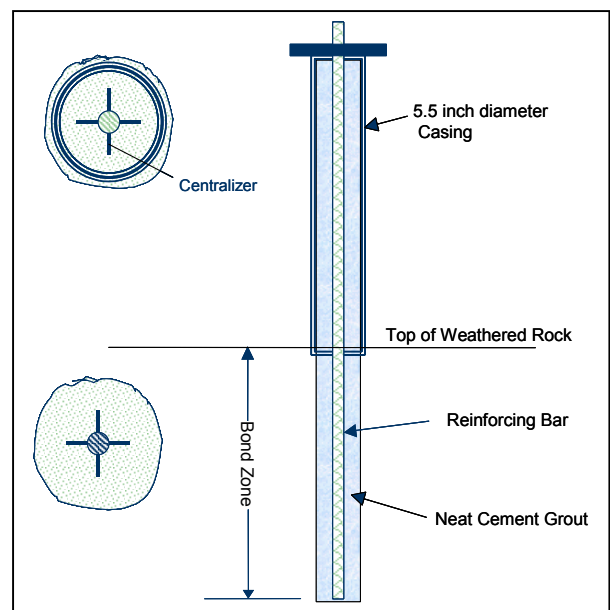
Drilling of each micropile was accomplished by end of casing flushing a 5.5 inch diameter casing under air pressure until reaching top of rock. Drilling through rock was performed with a downhole hammer to create a 4.5 inch diameter bond zone. The micropiles were filled by the tremie method with a neat water-cement grout with a specific gravity of about 1.8 and a design strength of 5,000 psi. Each of the micropiles was reinforced through the bond length with two No. 8 bars, Grade 60 ksi, with centralizers spaced at approximately 10 ft centers. Figure 4 shows a typical Case I (Bruce, 1988, 1989) micropile used for this project.

Fig. 4. Case I micropile (adapted from Bruce, 1988).

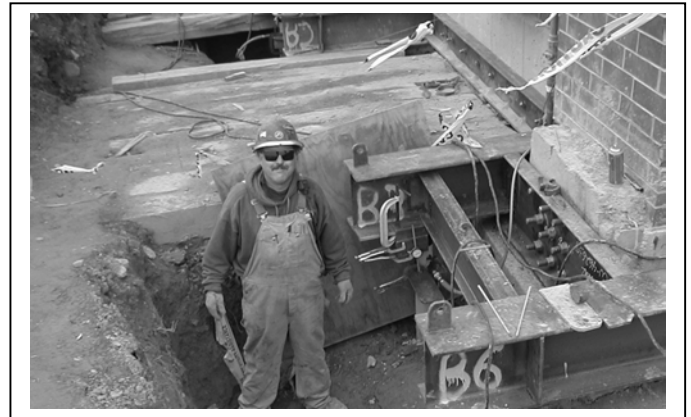
A grill made of steel channel sections was designed to be slid under the existing wall and span across the top of the new piles (see Fig. 5). These channels were then bolted to the existing column pedestal. Steel bearing plates and steel keeper rings were welded to the top of the micropile and bottom of the steel channel at each micropile location. Twenty-five ton capacity hydraulic jacks were installed at each micropile location (see Fig. 6). Jacking manifold circuits were installed at each group of piles.

Fig. 5. View of completed piles and steel grillage.

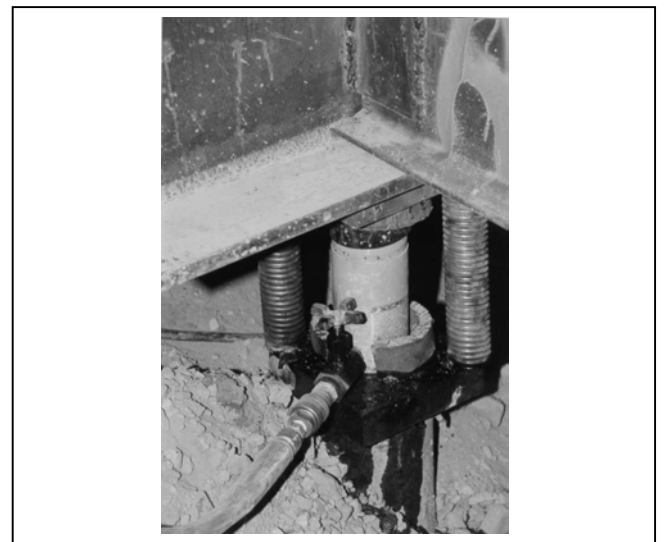
Fig. 6. Twenty-five ton jack after repositioning and lock-off.

The jacking operation was considered complete after reaching the above settlement recovery values. No further jacking was attempted once the jack loads exceeded the estimated loads transmitted by the structure. The valves were closed on all of the pile jacks and two Williams All-Thread bars were welded between each pile bearing plate and the steel grillage to serve as a temporary lock-off mechanism until concrete was placed around the connection beams (see Fig. 6). The reinforcing steel was installed for the new pile cap, and concrete placement proceeded.
