## Emergency Underpinning and Repositioning of a Four-Story Office Building

## EMERGENCY UNDERPINNING AND REPOSITIONING OF A FOUR-STORY OFFICE BUILDING

A three-story office building was located above a 35-ft slope and was supported on spread footings. The corner of the building nearest the crest of the slope experienced several inches of settlement. A subsurface exploration revealed that this portion of the building was founded on recently placed, soft fill soils. Apart from being easily noticeable on the brick veneer façade, the distress also caused serious concerns on the part of the occupants and owner regarding the continuous operability of the structure, which served as a main hub for wireless communications.

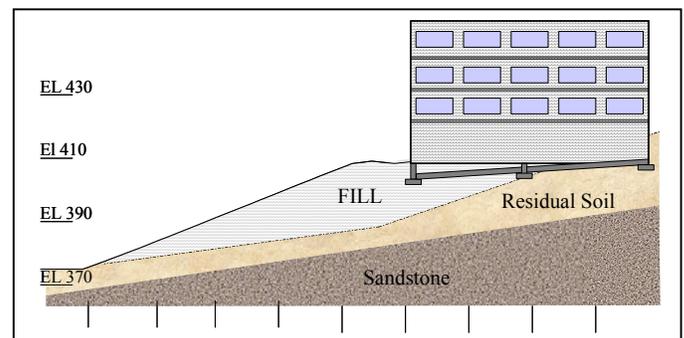
The structure is steel frame with brick and glass veneer, as well as cast in place concrete walls in below-grade areas (see Fig. 1). The ground surface slopes from the front of the building to the back with a change in elevation of about 14 ft.

Fig. 1. Interpreted subsurface conditions.

A cast-in-place concrete wall on the east side of this building supported one edge of the first floor slab. This wall was supported on a shallow strip footing independent from the column footings. Therefore, differential settlement was taking place between the wall and the rest of the structure. This caused deformation and loss of support of the first floor slab.

It is conceivable that, due to the soft condition, the fill materials may have compressed over time inducing the observed movements of the structure. During such a process, lateral movements may be a natural consequence of compression of the unconfined fill lying on the inclined incompressible substratum. Lateral displacements may be similar in magnitude to the vertical compression of the fill. Configuration of the connections of structural elements may have also contributed to the observed horizontal movements.

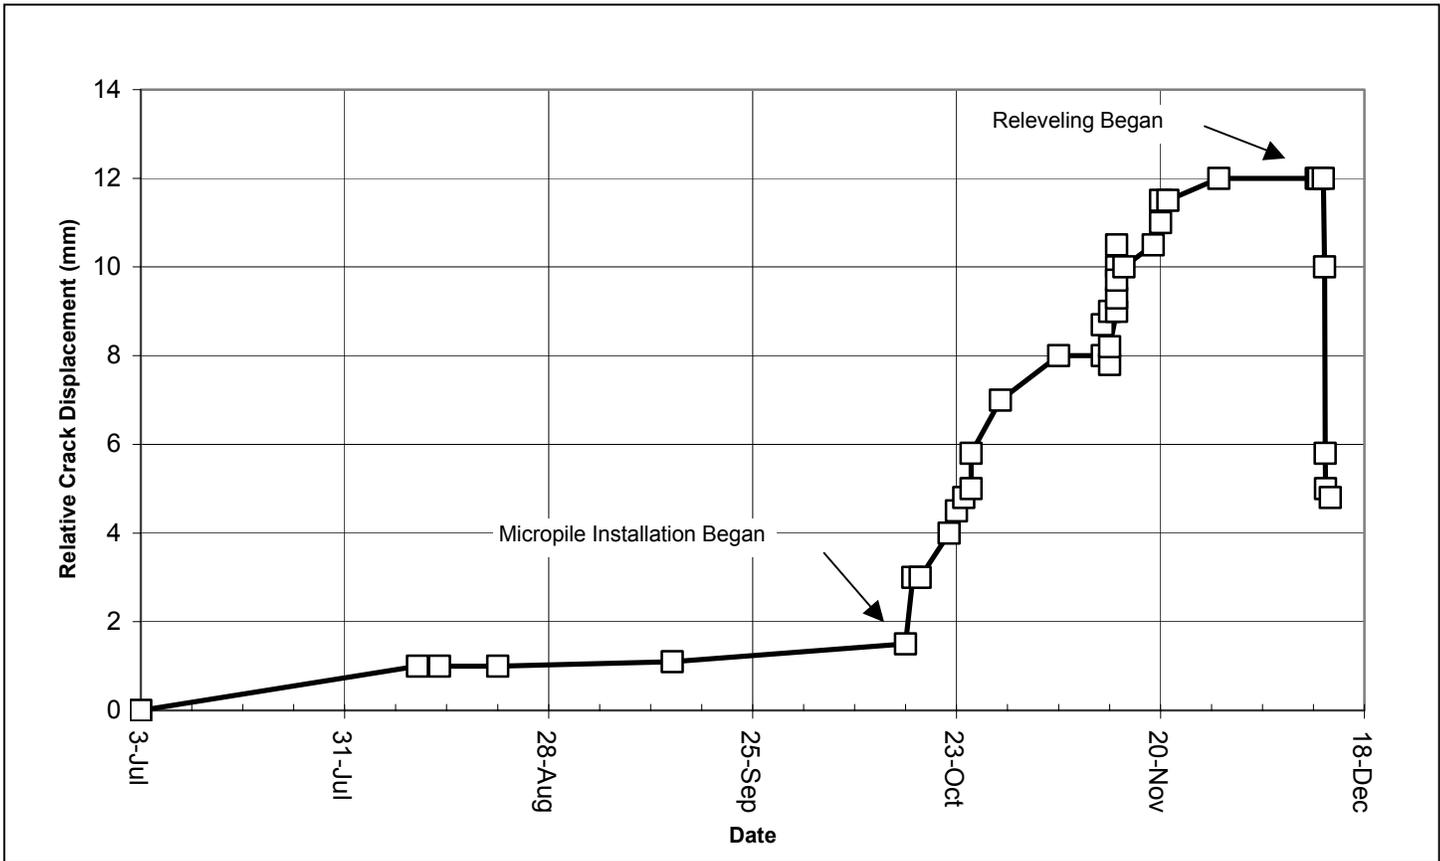
Six standard crack monitor gauges were installed to supplement several already installed by the structural engineer for the project. A graph of typical data is shown in Fig. 3.

In addition to the crack monitors, spot checks on the level of the first floor interior and exterior were made from the basement area. Based on measurements of the vertical crack widths inside the building, the total settlement of the southeast corner was estimated to range between 3 and 3½ inches. Optical observation of the southern and eastern exterior walls suggested that settlements of two to 2½ inches may have occurred after installation of the brick veneer. Given these measurements, it appears as though there was an original settlement of about one inch shortly after construction of the wall, and an additional two to 2½ inches of settlement since placement of the brick veneer.

Fig. 3. Crack monitoring data.

Crack gauge measurements revealed that lateral movement of the top of the east wall had apparently accelerated during installation of micropiles. In addition, some of the existing cracks in the brick veneer on the east wall had visibly opened farther. It is possible that micropile installation may have impacted the rate of settlement of the wall, and consequently increased the loss of lateral restraint provided by the first floor slab. However, the reasons for this accelerated movement were not fully known. Consequently, temporary bracing and shoring were installed to limit further movements of the east wall.

Total settlement recovery measured by the survey was approximately one inch at the southeast column, and ¼ inch at the south column location. The recovery is depicted in the deflection plot of Fig. 3.

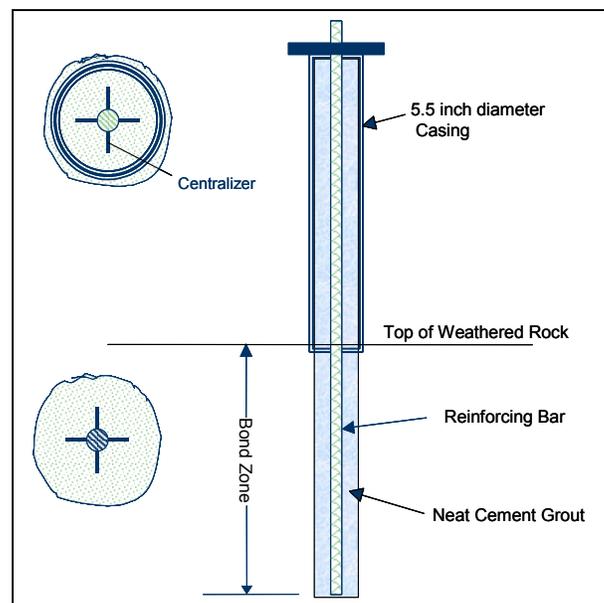
Drilling of each micropile was accomplished by end of casing flushing a 5.5 inch diameter casing under air pressure until reaching top of rock. Drilling through rock was performed with a downhole hammer to create a 4.5 inch diameter bond zone. The micropiles were filled by the tremie method with a neat water-cement grout with a specific gravity of about 1.8 and a design strength of 5,000 psi. Each of the micropiles was reinforced through the bond length with two No. 8 bars, Grade 60 ksi, with centralizers spaced at approximately 10 ft centers. Figure 4 shows a typical Case I (Bruce, 1988, 1989) micropile used for this project.

During drilling of the first micropile on the exterior of the east wall, the cuttings observed suggested that the upper 10 ft of rock were highly weathered and fractured. Given this information, micropile bond length was extended to 20 ft into rock since there was not a test program to confirm micropile capacities.

Fig. 4. Case I micropile (adapted from Bruce, 1988).

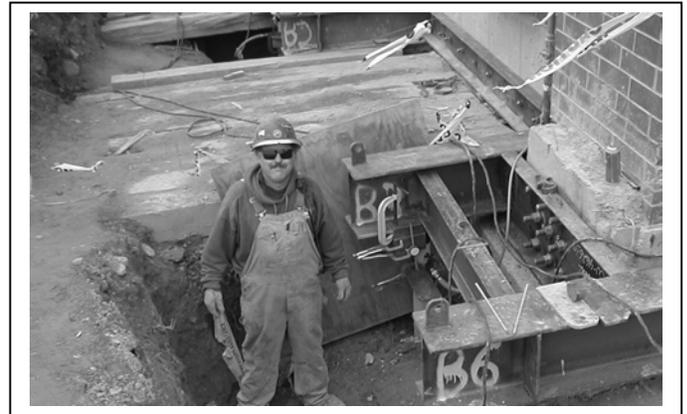
*Fig. 5. View of completed piles and steel grillage.*

A grill made of steel channel sections was designed to be slid under the existing wall and span across the top of the new piles (see Fig. 5). These channels were then bolted to the existing column pedestal. Steel bearing plates and steel keeper rings were welded to the top of the micropile and bottom of the steel channel at each micropile location. Twenty-five ton capacity hydraulic jacks were installed at each micropile location (see Fig. 6). Jacking manifold circuits were installed at each group of piles.

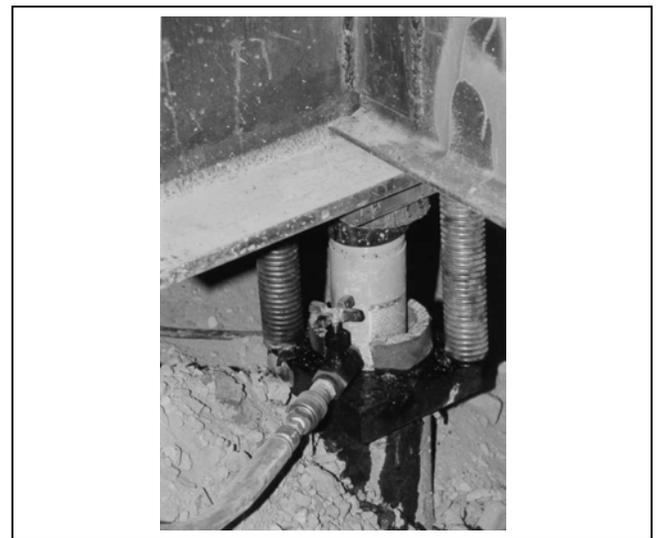
*Fig. 6. Twenty-five ton jack after repositioning and lock-off.*

The jacking operation was considered complete after reaching the above settlement recovery values. No further jacking was attempted once the jack loads exceeded the estimated loads transmitted by the structure. The valves were closed on all of the pile jacks and two Williams All-Thread bars were welded between each pile bearing plate and the steel grillage to serve as a temporary lock-off mechanism until concrete was placed around the connection beams (see Fig. 6). The reinforcing steel was installed for the new pile cap, and concrete placement proceeded.
