Case Study on the Foundation and Site Geotechnical Evaluation for the Rehabilitation of an Emergency Hospital Building

CASE STUDY ON THE FOUNDATION AND SITE GEOTECHNICAL EVALUATION FOR THE REHABILITATION OF AN EMERGENCY HOSPITAL BUILDING

ION VLAD

Technical University of Civil Engineering
Bucharest, Romania

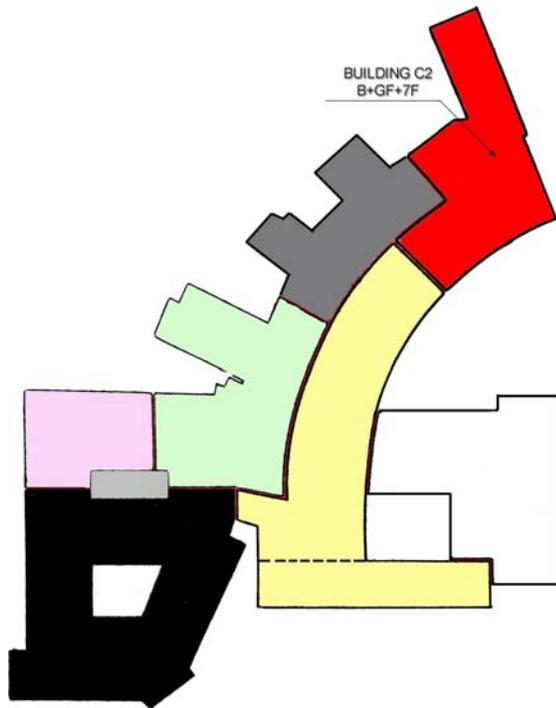
- after the 1977 strong motion, very severe damage was reported, and the works consisted in strict local repairing of damaged elements (without having a general concept of strengthening);
- the body “C2” has an unfavorable plan layout (Fig. 2), elastic and inertial dissymmetry;
- a general state of visible damage was present (cracks and fissures);
- the building was designed in 1967, by applying the first Romanian seismic standard approved in 1963 at that time.

Fig. 2 General drawing of the buildings belonging to the Bucharest "Emergency Hospital"

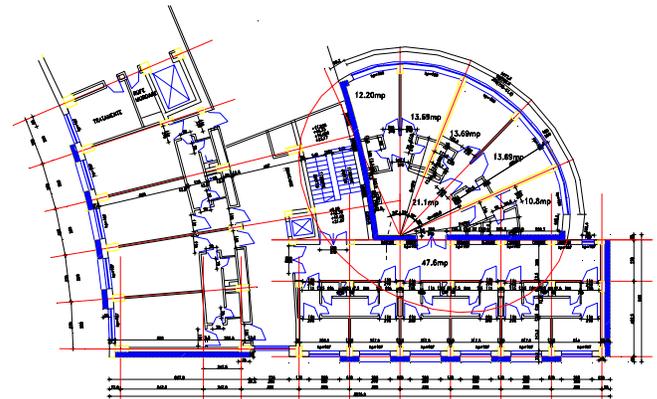
Fig. 3 Architectural drawing of the building "C2" (strengthening solution by extension)

As the activity of the hospital was not to be disturbed, the most reliable solution for strengthening of the building was the execution of an extension on the N-W corner of the existing building, where to place the main structural walls, necessary to strengthen the building on both directions (Fig. 3).

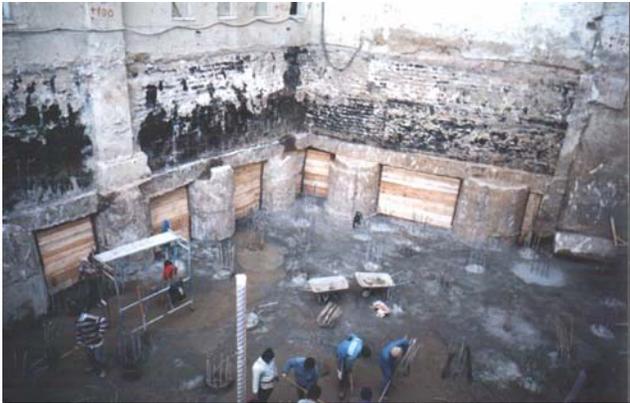
Fig. 6 Photo of the foundation of the existing building

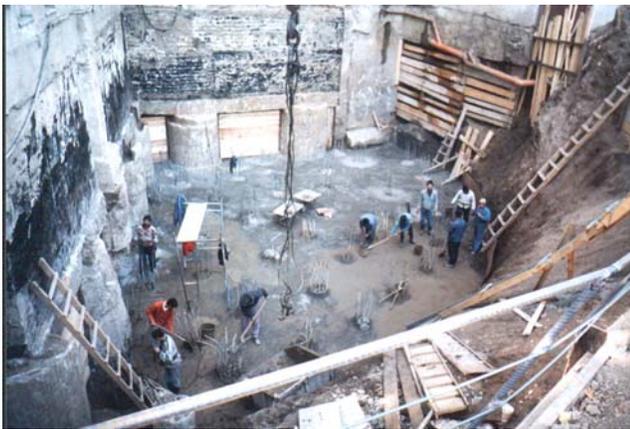
Fig. 7 Photo after the execution of the piles

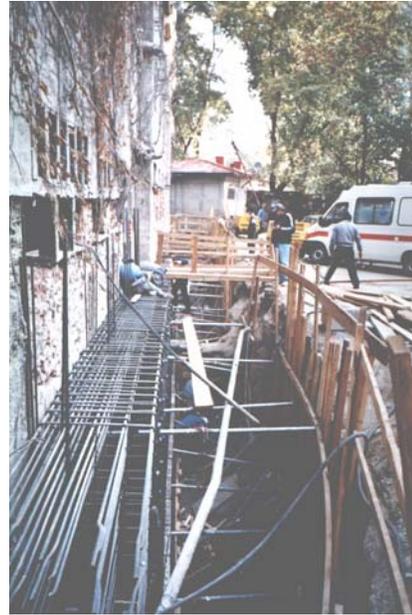
Fig.8 Photo during the execution of the foundation beam (axis “A”)

1. The strengthening reinforced concrete structural walls of the superstructure, positioned in the axes "1", "A", "12", "C", "7", "14" and "15", have a common base, being tied together under the $\pm 0.00\text{m}$ level by foundation beams, having the same height as the basement (Fig. 8). The foundation beams mainly rest on new footings, in order to assure the necessary resting surface on soil, taking into account the special combination of loads, together with the loads produced by the seismic actions, and also on the existing foundations.
