Case Study on the Foundation and Site Geotechnical Evaluation for the Rehabilitation of an Emergency Hospital Building

CASE STUDY ON THE FOUNDATION AND SITE GEOTECHNICAL EVALUATION FOR THE REHABILITATION OF AN EMERGENCY HOSPITAL BUILDING

ION VLAD

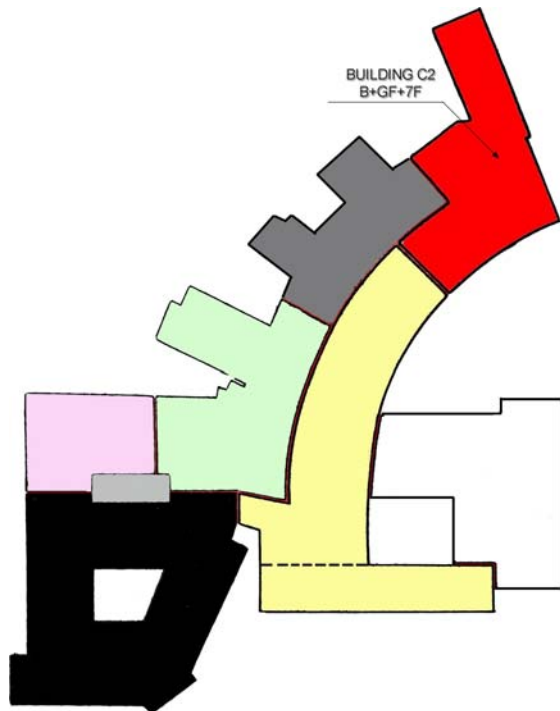
Fig. 2 General drawing of the buildings belonging to the Bucharest "Emergency Hospital"

- after the 1977 strong motion, very severe damage was reported, and the works consisted in strict local repairing of damaged elements (without having a general concept of strengthening);
- the body “C2” has an unfavorable plan layout (Fig. 2), elastic and inertial dissymmetry;
- a general state of visible damage was present (cracks and fissures);
- the building was designed in 1967, by applying the first Romanian seismic standard approved in 1963 at that time.
