A CASE HISTORY OF SITE INSTABILITY DUE TO THE PRESENCE OF A SHALE LAYER ABOVE SLOPING BEDROCK

ABSTRACT

A study conducted for St. Louis County of Missouri, United States of America classified several areas of the county as unstable for any type of construction because of the presence of high plastic shaley clay or clayey shale on sloping bedrock. These areas are considered to have a potential for site instability to occur due to any change in natural conditions that may increase the moisture content of the high plastic shaley clay or clayey shale. A two-story parking garage, founded on shallow foundations, constructed in one of the potentially unstable zones, showed some movement after several years of its construction. After movements in the structure were observed, further review of the subsurface conditions revealed that as a result of construction at the site, the clayey shale layer became exposed, thus, creating easy access for water to enter this layer. Infiltration of water caused softening of the clayey shale layer, which in turn caused movements in the structures constructed on the site. This paper presents the detailed information about the subsurface conditions and type

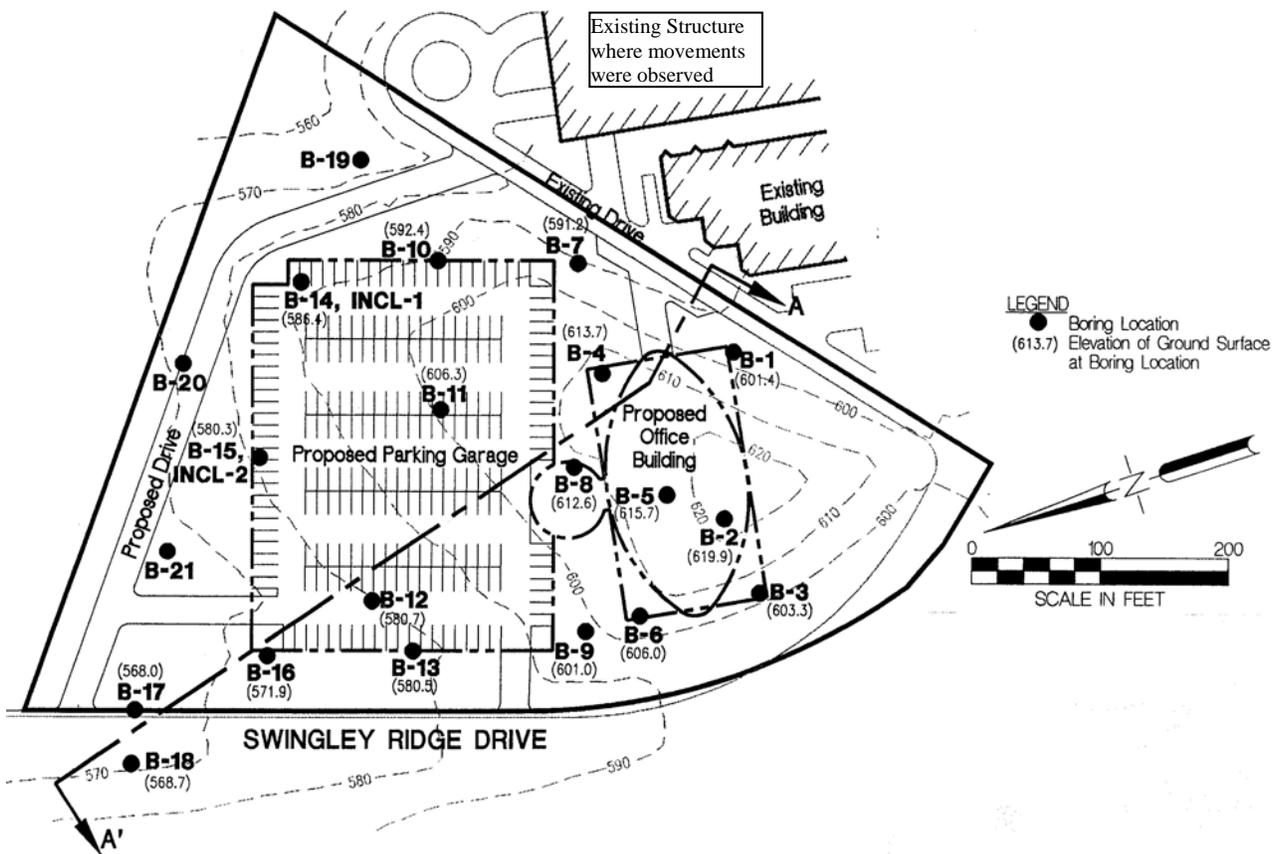
The site topography map is shown in Figure 2. The site is located on a hill with the highest elevation on the south end

being 620 feet above the mean sea level. The site slopes down to the north to an elevation of 560 feet. Several borings were drilled as a part of the subsurface exploration. Boring locations are shown in Figure 2. The soil borings revealed limestone bedrock exposed near the south end of the site and in other borings a clay layer, approximately 20 to 30 feet thick, was encountered as the surface stratum. The clay layer is underlain by an approximate 3-foot thick shale layer, which in turn is underlain by sloping limestone bedrock. Subsurface profile along a cross section A-A' (Refer to Figure 2 for location of A-A') is shown in Figure 3. Figure 3 shows the shale layer sloping down (towards the north) at an angle of approximately 10 degrees. Observations made from this site indicated a possibility that the shale layer is exposed in a dry creek bed at the far end of the site. The adjacent site and the site under discussion appear to share this dry creek bed.

Figure 2 Topography Map including profile line AA' developed by Geotechnology, Inc.

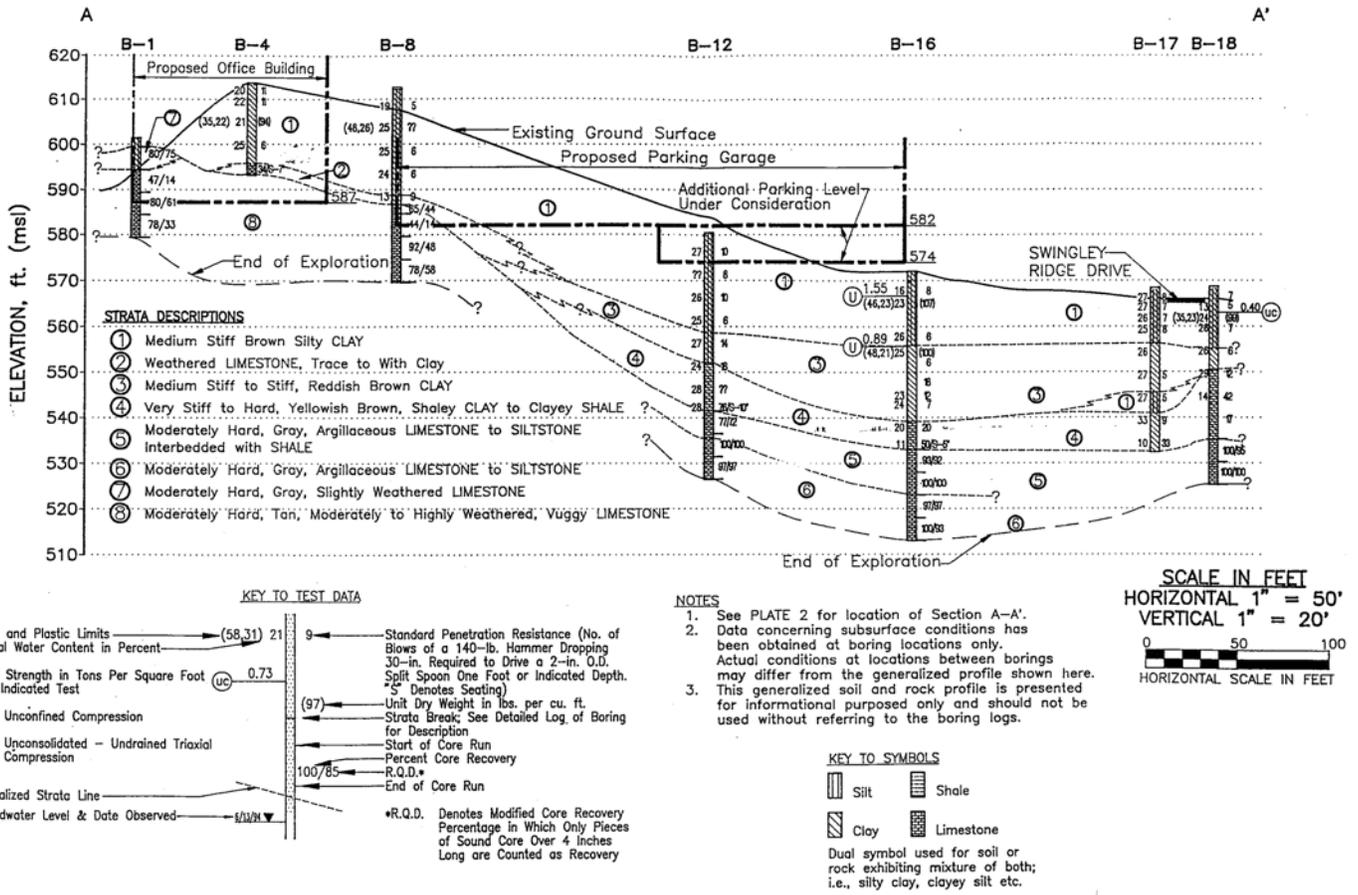
The subsurface profile (Figure 3) shows that the geology at this site was consistent with the geology indicated in the study conducted by Lutzen & Rockaway (1971). Based on the subsurface conditions observed in the borings and the information from the study performed by Lutzen & Rockaway (1971), a conceptual sketch shown in Figure 4 was developed to represent the subsurface conditions at the site. Modifications to the site consisted of construction of a five-story office building and an attached two-story parking garage. The office building was supported on drilled shafts and shallow foundations bearing on bedrock whereas the parking garage was constructed on shallow footings bearing in soil. The finished floor elevations for the office building and the parking garage were such that the site required a cut at the highest point on the site and fill underneath a part of the garage. A conceptual sketch of the modified slope profile is shown in Figure 5, which also shows the modifications planned for the site. To achieve the required finished floor elevations, the site was cut within the footprint of the office building and part of the parking garage, and was filled under the north end of the parking garage.

Figure 3 Subsurface Profile Developed by Geotechnology, Inc.

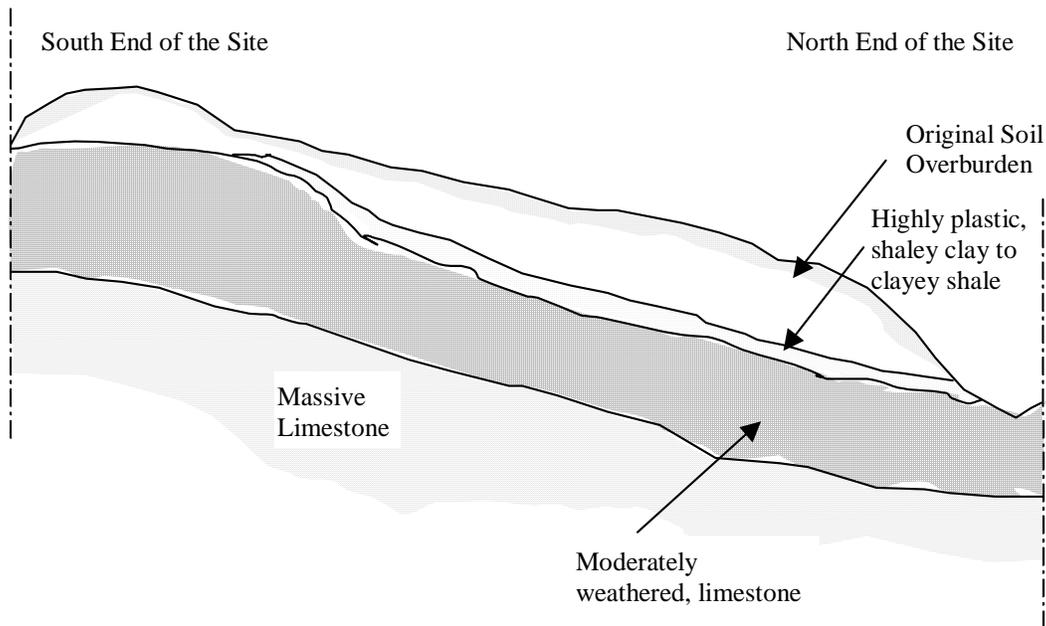
Figure 4. Conceptual sketch of the existing surface and subsurface conditions at the site.

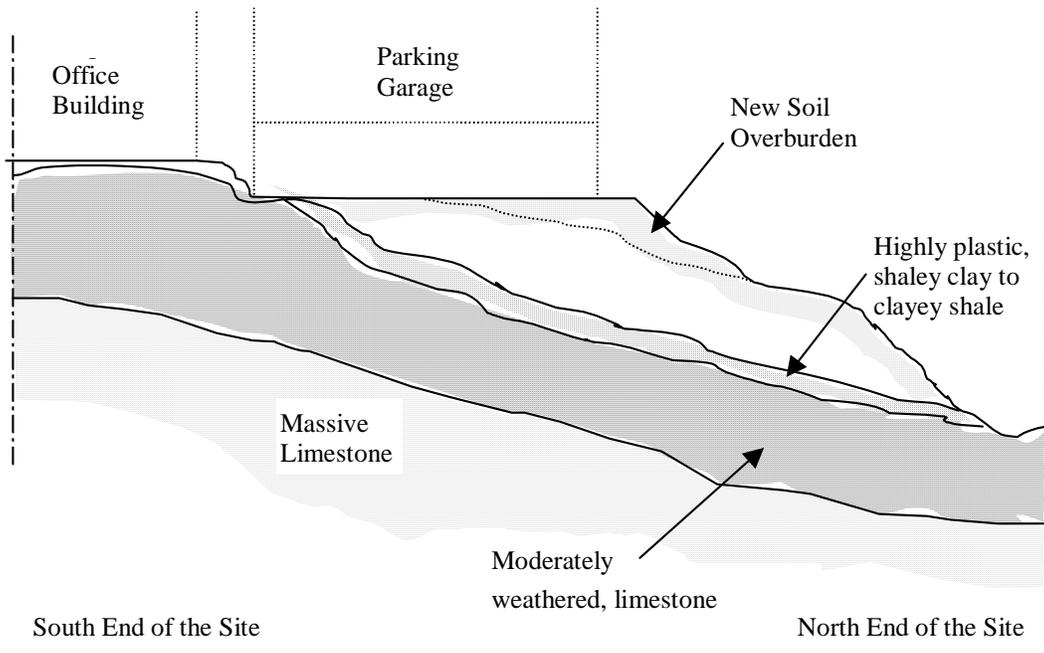
Figure 5. Conceptual sketch of the modified surface and subsurface conditions at the site.

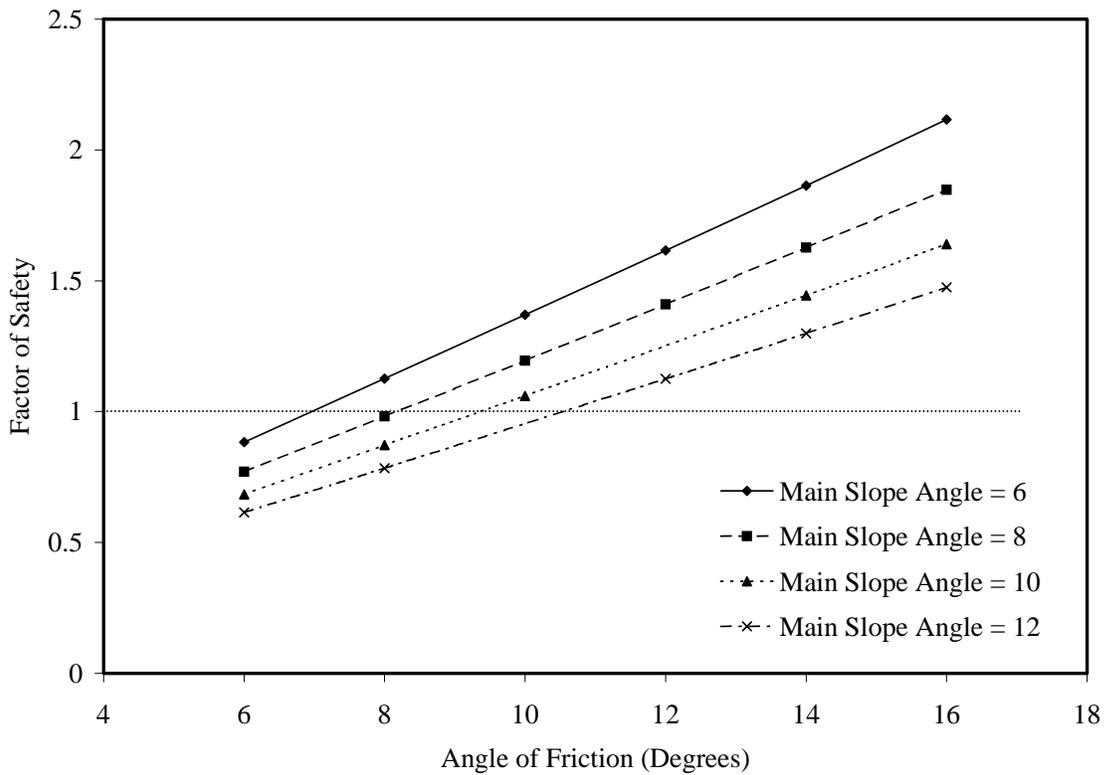
Figure 7 Variation of Factor of Safety with Angle of Internal Friction of Shale
