A CASE HISTORY OF SITE INSTABILITY DUE TO THE PRESENCE OF A SHALE LAYER ABOVE SLOPING BEDROCK

ABSTRACT

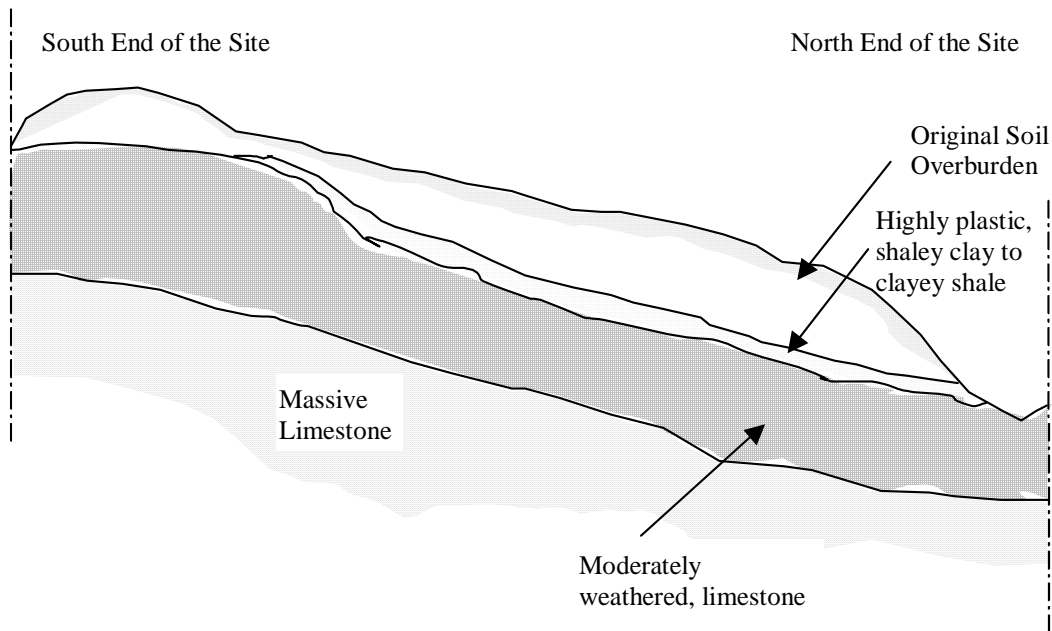
The subsurface profile (Figure 3) shows that the geology at this site was consistent with the geology indicated in the study conducted by Lutzen & Rockaway (1971). Based on the subsurface conditions observed in the borings and the information from the study performed by Lutzen & Rockaway (1971), a conceptual sketch shown in Figure 4 was developed to represent the subsurface conditions at the site. Modifications to the site consisted of construction of a five-story office building and an attached two-story parking garage. The office building was supported on drilled shafts and shallow foundations bearing on bedrock whereas the parking garage was constructed on shallow footings bearing in soil. The finished floor elevations for the office building and the parking garage were such that the site required a cut at the highest point on the site and fill underneath a part of the garage. A conceptual sketch of the modified slope profile is shown in Figure 5, which also shows the modifications planned for the site. To achieve the required finished floor elevations, the site was cut within the footprint of the office building and part of the parking garage, and was filled under the north end of the parking garage.

Figure 4. Conceptual sketch of the existing surface and subsurface conditions at the site.

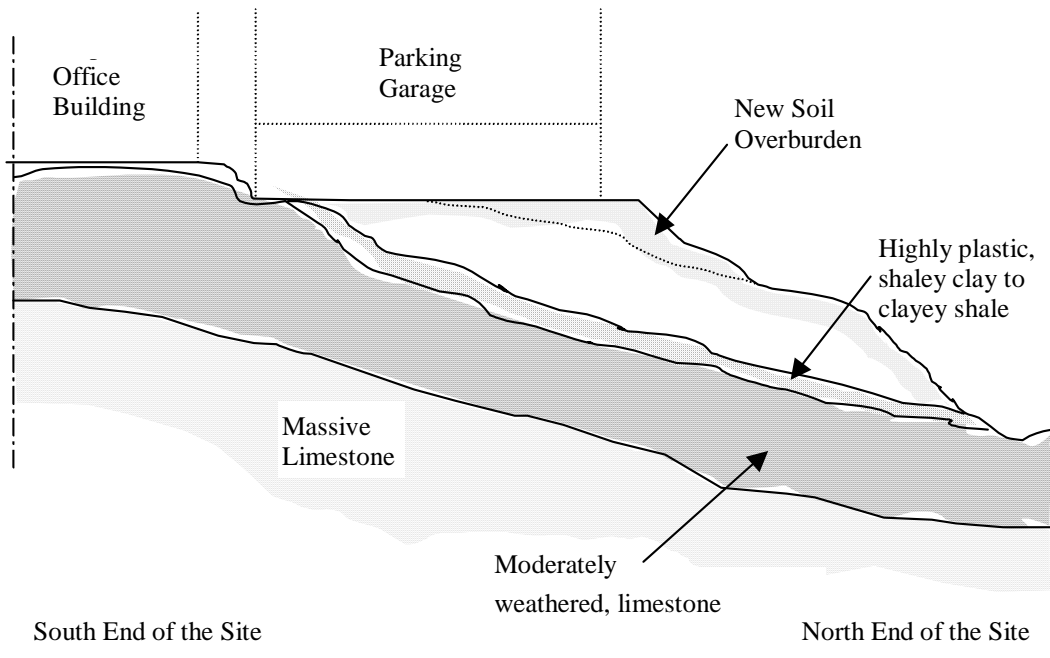
It is believed that the construction at the site where movements were observed in the structure caused easy access for water to enter the shale layer. As reported by Lutzen & Rockaway (1971), a site within Unit VI has potential of becoming unstable due to any change in natural conditions that may increase the moisture content of the high plastic shaley clay or clayey shale. In order to study the effect of variation of angle of internal friction of clay layer on the stability of the site slope, a parametric study was conducted. The parametric study was performed for various angles of the main slope. Soil and rock properties were estimated from typical values available in the published literature. For the purpose of performing the parametric study, the parking garage was considered to be on shallow foundations at an allowable bearing pressure of 2,500 pounds per square foot (psf). Although, 2,500 psf pressure would be transferred to

Figure 5. Conceptual sketch of the modified surface and subsurface conditions at the site.
