The Role of Geotechnical Factors in Northridge Earthquake Residential Damage

THE ROLE OF GEOTECHNICAL FACTORS IN NORTHRIDGE EARTHQUAKE RESIDENTIAL DAMAGE

On three projects, one a class action law suit and two involving readjustment of insurance claims, we evaluated the impact of the 1994 M_w 6.7 Northridge, California earthquake on over 1,600 residential properties. For each of the properties, we reviewed previous reports on the condition of the site immediately after the earthquake, undertook a site visit to observe current conditions, undertook site-specific geotechnical investigations, as appropriate, and documented our findings on the impact of long-term and earthquake-related geotechnical factors on property damage. We have identified the following significant geotechnical factors that contribute to residential earthquake damage: (a) *hillside sites*; (b) *cut/fill transitions*; (c) *expansive soils*; (d) *liquefied sandy soils*; and (e) *deep soft soils*. This paper summarizes and presents our findings regarding these factors for five representative case histories of residential damage in the Northridge earthquake.

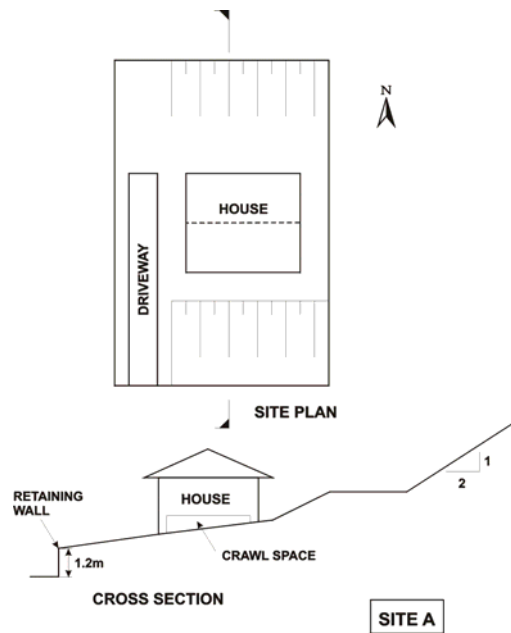
The house is a single-story wood-framed structure founded on perimeter and interior concrete stem walls with cripple walls and isolated interior footings consisting of concrete pedestals, wooden caps, and wooden posts. The house was constructed circa 1920. An approximate location of the property is indicated in Figure 3 (Case History "A"). A plan view and a cross section through the property are shown in Figure 4.

According to the property owner, as a result of the earthquake, the stem walls cracked, the floor level was "changed," the flatwork cracked, the front retaining wall broke and leaned over, the exterior stucco cracked, and interior wall and ceiling finishes were damaged. According to the property owner, after the earthquake, new stem walls were installed on the north and east sides on the house, floors were re-leveled, and some stucco and interior surface cosmetic damage was repaired.

Based upon the property owner interview and our observation of site conditions, we concluded that there was no plausible geotechnical mechanism by which the earthquake caused a change in the bearing capacity of the soils at this site, the ability of the soils to support the house foundations, or of the rate of soil creep at the property. We recognized that the damage to the front retaining walls, and increase of moisture ingress through cracked flatwork, and leaking pipes were earthquake impacts that could, however, have resulted in increased localized soil creep. In conjunction with a structural engineer, we concluded that the stem wall cracks predated the earthquake and that both the stem wall cracking and pre-earthquake soil creep probably rendered the house susceptible to earthquake-induced structural and cosmetic damage. Furthermore, replacement of the downslope stem wall after the earthquake probably introduced a relatively rigid and unmovable foundation member that caused further cosmetic damage to the house. A subsequent revealed that cracked foundations continued to move downslope and push the house flooring and other structural components against the relatively unyielding components above the new stem walls.

Fig. 4. Representative Hill-Side Site

Some of the conditions at this property were typical of many we saw where long-term slope creep had affected the position and level of the house and the integrity of foundation components. In the earthquake, such structures were more vulnerable than otherwise to seismic-induced disturbance as a result of their distortion and compromised foundations. In many cases post-earthquake soil creep appeared to have been accelerated by leakage from pipes broken by the earthquake, cracked flatwork and retaining walls, and the fact that post-earthquake precipitation was generally higher than in the decade or so before the earthquake. We also saw properties where post-earthquake partial replacement of old or

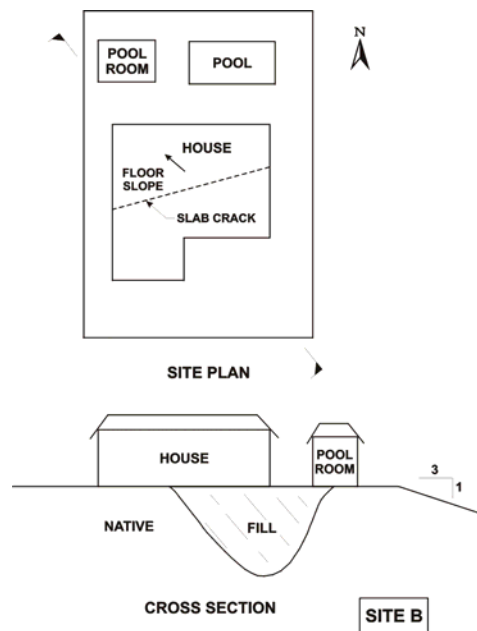
The house is a single-story wood-framed structure constructed in 1957. The house foundation is a concrete perimeter footing and concrete slab-on-grade floor. An approximate location of the property is indicated in Figure 3 (Case History “B”). A plan view and a cross section through the property are shown in Figure 5.

The property owner told us that the house floor became unlevel as a result of the earthquake, that the courtyard paving to the north of the house was “deformed” after the earthquake, and that the pool shell “went down” to the southwest as a result of the earthquake. We lifted the carpets throughout the house during our site visit to inspect the slab-on-grade floor. In the west bedroom that straddles the reported change of grade of the floor, we observed a 10 to 15-mm wide crack with up to 5 mm of vertical offset across the crack. The crack had been filled with what appears to be a mortar grout; the grout filling had been placed in such a way to smooth out the vertical offset. The crack appeared to have opened no more than about 5 mm since the filling was placed. We noted that the slab crack appears to line up with the tile cracking in the entryway and the general floor slope changed along the slab crack.

Fig. 5. Representative Cut/Fill Transition Site

On the basis of the property owner’s statement that the carpets had been installed before the earthquake and not subsequently lifted, we concluded that the slab cracking clearly predated the earthquake and similarly that the slope of the floor to the northwest of the crack also predated the earthquake. On the basis of the reported cosmetic cracking of the tiles and wall

finishes in the earthquake, we believe that some transient and possibly permanent fill deformation occurred as a result of the earthquake, but that this earthquake-induced deformation was not the predominant cause of the unlevel floors, the floor slab crack, or the vertical offset across the crack. We believe that the greater part of fill settlement and floor slope was the result of fill consolidation following original house construction.

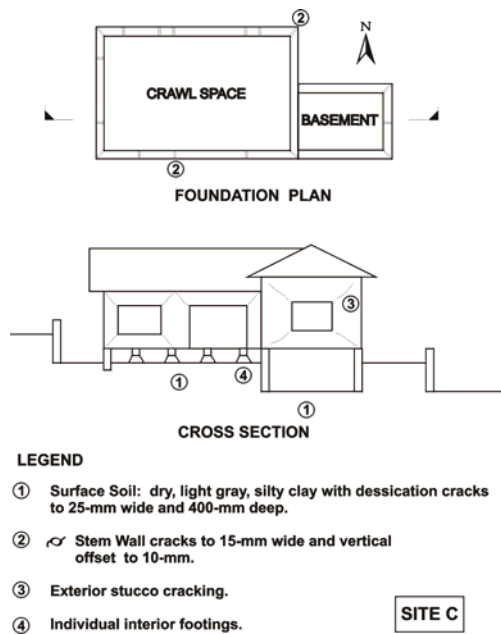
The house is a single-story wood-framed structure founded on perimeter and interior concrete stem walls with cripple walls and isolated interior footings consisting of concrete pedestals, wooden caps, and wooden posts. The house was constructed circa 1950. An approximate location of the property is indicated in Figure 3 (Case History “C”). A plan view and a cross section through the property are shown in Figure 6.

Fig. 6. Representative Site on Expansive Soils

We noted a direct correlation between the presence of expansive soils ($EI \geq 75$) and damage to the structure and finishes of the house. At this site and many others that we

visited that are founded on expansive soils, we noted significant stem wall cracking, deformation of the stem walls, and a correlation between reported interior cosmetic damage and the more desiccated soils at the site. For example, at the property shown in Figure 6, the structure and cosmetic finishes over the crawl space and particularly the north stem walls were significantly damaged in the earthquake.

The soil we observed beneath the stem walls of this house were dry and extensively desiccation cracked; the cracks were as wide as 25 mm, as deep as 400 mm, and were generally spaced at between 150 and 200 mm. It is as though the concrete stem walls were sitting on a series of isolated soil columns. Clearly, the long-term soil desiccation-induced deformation had stressed and in many instances cracked and displaced the stem walls relative to each other.

At this house, as at many we visited that are founded on expansive soils, the property owner had undertaken post-earthquake repair of cosmetic finishes only to be frustrated by the recurrence of stucco cracks, drywall plaster cracking, and deformed moldings. Obviously, ongoing seasonal soil swelling and shrinkage continue to move the foundations and to affect the structure and its cosmetic finishes. This process is exacerbated by the tendency to patch stucco and drywall cracks rather than remove and replace them – with even minimal seasonal movement of the foundation soil, the crack location makes itself known through paint and other overlays.

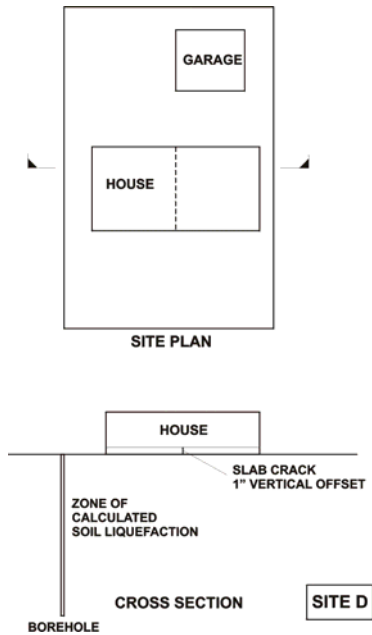
The house is a single-story wood-framed structure constructed between 1950 and 1960. The house foundation is a concrete perimeter footing and concrete slab-on-grade floor. An approximate location of the property is indicated in Figure 3 (Case History “D”). A plan view and a cross section through the property are shown in Figure 7.

The property owner told us that he was sitting in the living room at the time of the earthquake, unable to sleep because of back pain. He told us that in the earthquake the living room floor appeared to “plunge and snap.” He said that the width of the crack in the floor slab was about 50 mm immediately after the earthquake but appeared to close to about 30 mm in the days following the earthquake. Other earthquake damage described by the property owner included broken windows and door, cracking of exterior and interior wall finishes, and a significant “tilting” of the bathroom. He noted that as a general observation “most things fell to the south.”

When we observed the crack its width was about 30 mm and the vertical offset across the crack was about 25 mm, with the north slab segment being higher than the south slab segment. We observed that house floor slab to the north of the living room floor crack was generally level. The floor slab to the south of the crack generally slopes down to the south at an inclination of approximately one vertical in 100 to 200 horizontal. Laboratory testing of soil samples from test pits indicated that the upper site soils are silty sand with a unit

weight ranging from 14.6 to 16.5 kN/m³. Boreholes indicate that the local water table is about 5 m below the surface and that the soils to about 20 m are interbedded silty sand and sandy silt. Soil liquefaction-induced sand boils were observed in relative vicinity of the site (see Figure 3). A site-specific soil liquefaction analysis showed that two 1.5-m thick layers at about 10 and 15 m below the ground surface may have liquefied in the earthquake and the estimated site-specific PHGA of 0.62 g. Calculations indicated that up to 74 mm of liquefaction-induced soil settlement could have occurred at the site.

Fig. 7. Representative Site on Liquefied Soils

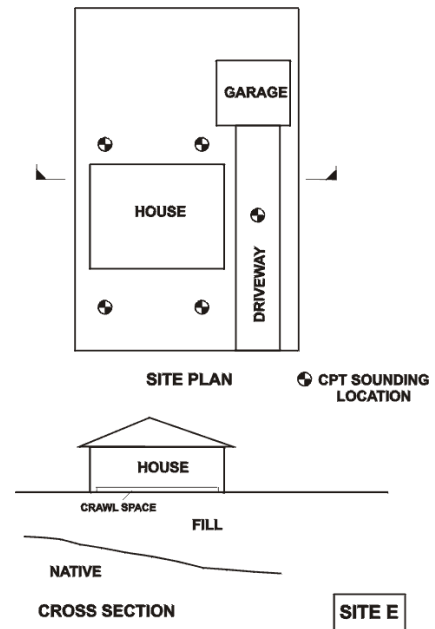
The house is a single-story wood-framed structure constructed in 1924. The house foundation was originally cast-in-place concrete slab on grade, large parts of which had been removed in 1960 and replaced with Concrete Masonry Unit (CMU) perimeter and interior footings. An approximate location of the property is indicated in Figure 3 (Case History “E”). A plan view and a cross section through the property are shown in Figure 8.

This house was unlevel, the walls tilted, and the ceilings sloped in the same direction and to the same degree as the floors. We advanced five CPT soundings with discrete soil sampling™. This established the upper three to five feet of soil was a variable mix of clayey silt and sand. Beneath this was a soft clay layer that varied from 5-m deep on the north side of the house to 8-m deep on the south side of the house. We concluded that the house had probably experienced considerable differential settlement ever since construction and that the Concrete Masonry Unit (CMU) stem walls had been installed before the earthquake in an attempt to correct house tilting. We believe that there was no significant earthquake-induced soil deformation at this site.

Fig. 8. Representative Site on Deep Fills of Variable Depth
