# Observations and Performance of a Soil Nail Shoring Wall in Seattle Silts and Clays

## OBSERVATIONS AND PERFORMANCE OF A SOIL NAIL SHORING WALL IN SEATTLE SILTS AND CLAYS

### ABSTRACT

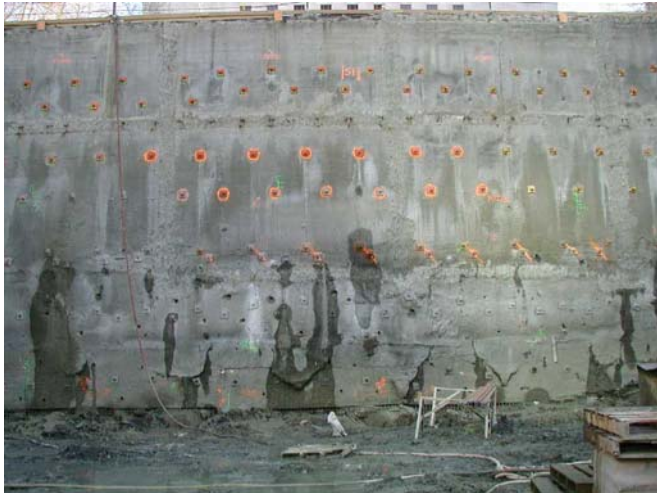
*Fig. 1. Photograph of east wall during construction.*

Numerous issues occurred during Phase III construction of the east shoring wall, particularly when the existing wall was undermined to extend the excavation deeper. The existing wall dropped vertically over 1 inch when the footing was initially undermined. Additional vertical support was provided by installing micropiles. By the end of construction, the east wall had dropped vertically over 2.6 inches, with over 0.5 inches occurring after the micropiles were installed. Additionally, significant lateral movement of the wall began to occur as excavation below the wall footing occurred. The total horizontal movement of the east wall that occurred during construction was 4 inches. A significant amount of this movement occurred along planes below the bottom of the excavation, generally within 4 to 12 feet of the current excavation bottom. This type of movement is consistent with stress relief within the Lawton Clay, resulting in the opening of fractures and movement along planes of weakness (Peck, 1963; Palladino, 1971). Water, which tended to collect in the fill behind the existing wall, may have exacerbated the lateral wall movements on the weak planes.

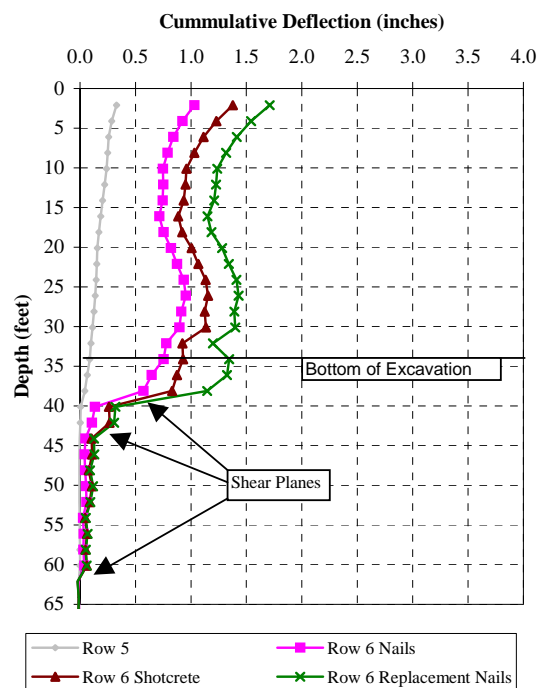
Significant horizontal and vertical wall movements were measured on both the optical survey points and the inclinometer when the north half of the existing wall was undermined (row 6 nails). The vertical and horizontal movements of the east wall were about 1.2 and 0.6 inches, respectively, as shown in Table 1. The inclinometer data, as shown in Fig. 4 and Table 2, showed that almost all of the incremental horizontal wall movement occurred 6 feet below the bottom of the excavation.

Fig. 4. East wall inclinometer data after completion of row 6.

When the shotcrete for row 6 had been completed, the total wall movement was 1.2 inches horizontal and 1.6 inches vertical (see Table 1 and Fig. 4). The proof tests were then completed on the row 6 soil nails. All four of the proof test nails failed in pullout (between 65 and 130 percent of the design pullout of 3.5 kips/foot). Because the design required a factor of safety of 2 on the pullout, replacement soil nails were installed. The replacement nails were installed in between the original nails. With the additional of the replacement soil nails, the effective nail spacing was reduced from 5 feet to 2.5 feet. The replacement nails were installed through the existing shotcrete facing. A rock hammer was used to break through the existing shotcrete. The vibrations of the rock hammer resulted in an additional 0.4 inches of horizontal wall movement and 0.4 inches of vertical wall movement. Proof testing of the replacement nails indicated that 4 out of 5 nails failed in pullout (again between 65 and 130 percent of the design pullout of 3.5 kips/foot), but the sum pullout capacity of the initial nails plus the replacement nails met the required row 6 pullout capacity.

At the completion of row 6, the total vertical and horizontal wall movements were 1.9 inches and 1.6 inches, respectively. At the inclinometer, the total horizontal movement was 1.7 inches, of which 1.1 inches occurred on three shear planes located at depths of 6, 10 and 28 feet below the bottom of the excavation (depths of 40, 44 and 62 feet below the top of the wall)(see Table 2 and Fig. 4).

As a result of the rapid movement of the wall, the southern half of the wall was shotcreted using a staggered excavation approach. Each excavation, or slot, was approximately 20 feet in length. The slots were spaced such that the adjacent slots were either protected by a soil drill berm or completed shotcrete wall.

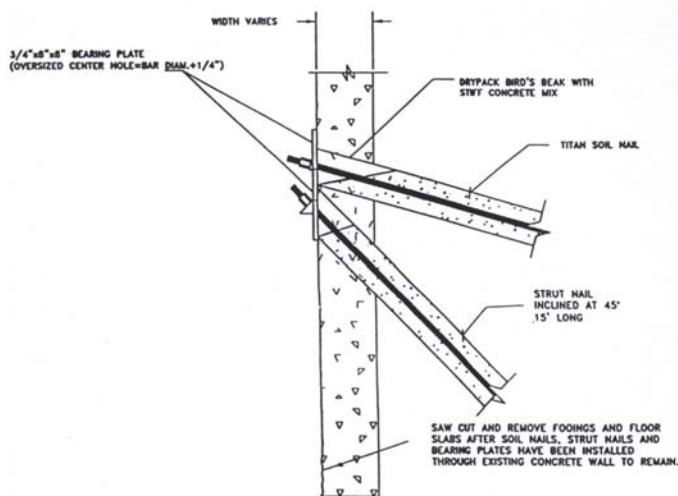
During the shotcreting of the southern half of the wall, a visual survey of the wall and 5<sup>th</sup> Avenue was completed. The survey revealed that the several of the row 1 through 5 soil nail nuts were loose. In addition, the accessible strut nail locations were observed to determine if the strut nails had been damaged as a result of the vertical movement. A detail of the strut nail connection is shown in Fig. 5 (strut nail is shown inclined at 45 degrees from horizontal). Half of the strut nails evaluated showed either relative slipping/movement between the grout and wall or very weak grout connection (soil/grout mixture) that could easily be removed with hand tools. The relative movement was small and did not account for the 1.2 inches of vertical wall movement measured, but did call into question the integrity of the connection of the strut nails to the existing wall.

Fig. 5. Strut nail connection to the existing concrete wall

During the installation of core holes in the existing wall, it was observed that the gravel drain at the base of the wall was partially filled with grout. It appeared that the neat cement grout from the strut nail installation had contaminated the gravel drain, contributing to the buildup of groundwater behind the existing wall (the continuity of the drain pipe had already been compromised as discussed above). This also may have contributed to a poor structural connection between the strut nail and the existing wall. Without a continuous grout column around the strut nail, the nail would not be able to support the weight of the existing wall by functioning as a compression member as intended by the design. It is the author's opinion that this poor structural connection led to the

failure of the strut nail system and the resulting vertical wall movement. In essence, the soil nails (both regular and strut nails) were supporting the existing wall in a bending mode (similar to nails supporting a picture frame on a wall).

Row 7 Observations. Because of the continued vertical movement of the wall, the contractor proposed installing a series of micropiles to replace the strut nails. The micropiles were installed at the bottom of the row 6 shotcrete. The micropiles consisted of near vertical, 6-inch diameter, 32-foot long, post-grouted nails. After installation of the micropiles, the vertical wall movements slowed significantly, but did not stop.

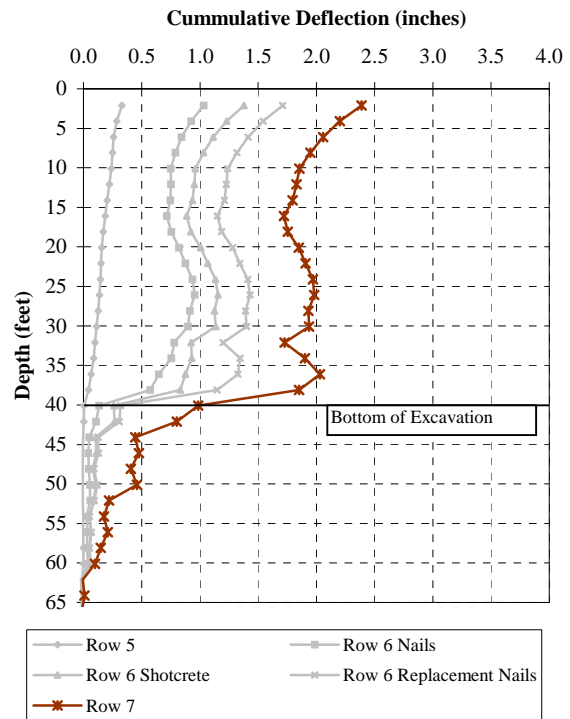
During construction of row 7, the movement of the wall continued. The wall moved vertically approximately 0.3 inches, for a total cumulative movement of 2.2 inches. The horizontal wall movement increased from 1.6 inches to 2.1 inches. As with row 6, a significant amount of the additional movement occurred below the bottom of the excavation. A fourth shear plane also developed 12 feet below the excavation (52 feet below the top of the wall) and accounted for about one-half of the horizontal movement observed during row 7 installation, as shown in Fig. 6.

Fig. 6. East wall inclinometer data after completion of row 7.

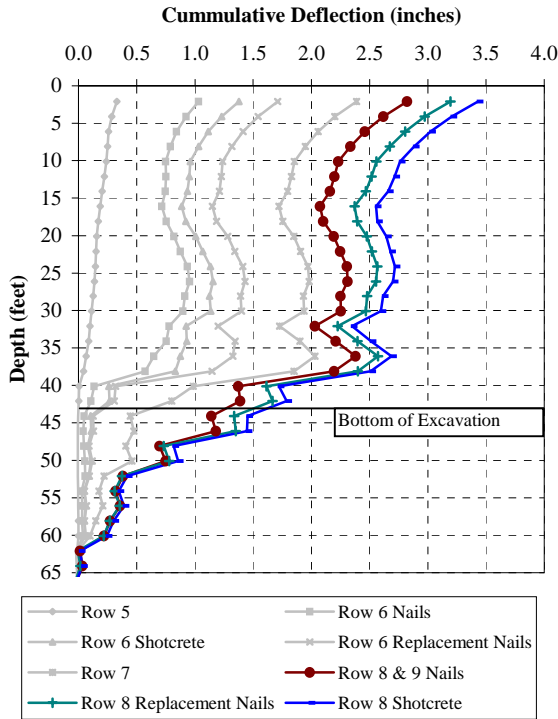
During the replacement nail installation, a significant amount of grout communication occurred. As discussed previously, the soil plug that tended to form during drilling would hinder

the grout return. It appeared that the grout would then pressurize and begin flowing through the cracks and fractures within the Lawton Clay. Grout was observed flowing from the wall face through fractures in the silt as far away as 25 feet from the drilling location. Based on the survey and inclinometer data (Tables 1 and 2 and Fig. 7), approximately 0.4 inches of horizontal wall movement occurred during installation and grouting of the replacement nails. Approximately one-half of this movement occurred below the bottom of the excavation.

Fig. 7. East wall inclinometer data after completion of row 8.

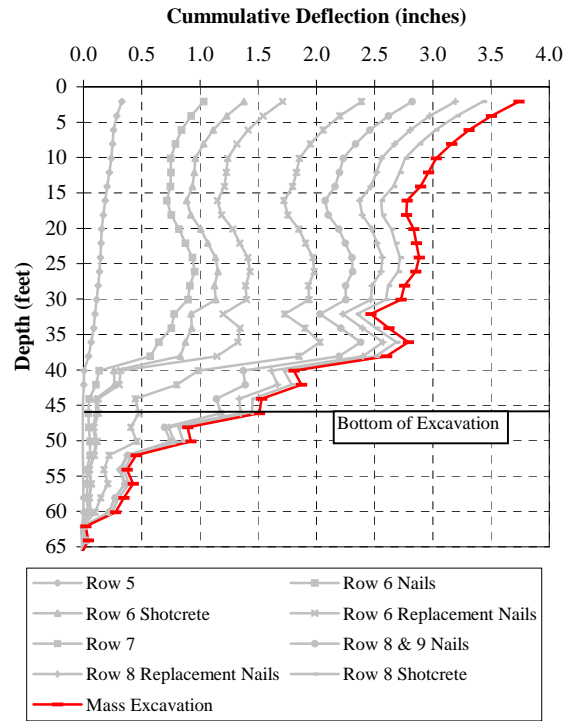
Once the shotcrete was installed in the trench slots, mass excavation of 6 feet of soil in front of the wall occurred to bring the site grade down to the bottom of wall elevation. This mass excavation occurred between 0 and 50 feet in front of the wall and resulted in an additional 0.25 inches of horizontal movement and 0.1 inches of vertical movement, as presented in Tables 1 and 2 and Fig. 8.

Fig. 8. East wall inclinometer data after completion of mass excavation to bottom of wall elevation.

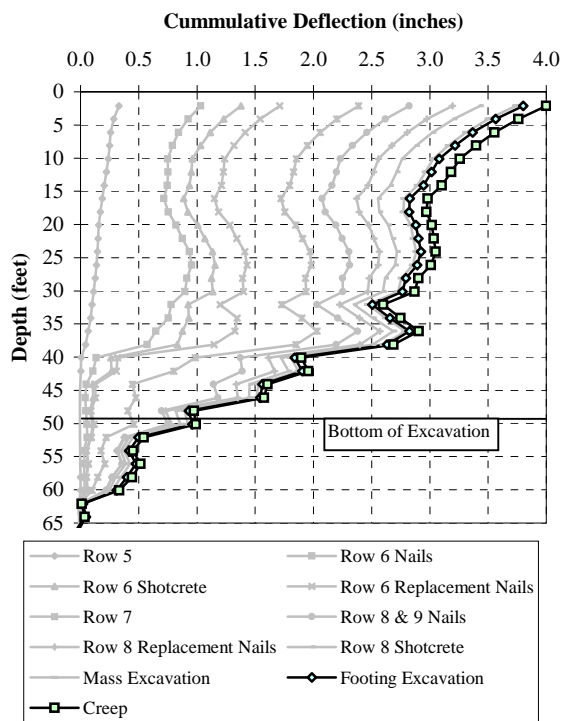
**Following Construction.** Movement of the east wall, both horizontal and vertical, continued to occur after all earthwork construction activities were completed in front of the wall. Movement was measured over a period of several months. The movement essentially stopped when enough building structure (i.e. permanent walls and floor slabs) had been constructed in front of the shoring wall. The horizontal and vertical wall movements that occurred during this period were 0.36 inches and 0.12 inches, respectively (see Tables 1 and 2 and Fig. 9). Very little of the horizontal movement (0.03 inches) occurred below the bottom of the excavation. The majority of movement was outward rotation of the wall.

These movements were occurring with little or no additional load being applied to the wall, which is the definition of creep movement.

Fig. 9. Final east wall inclinometer data.

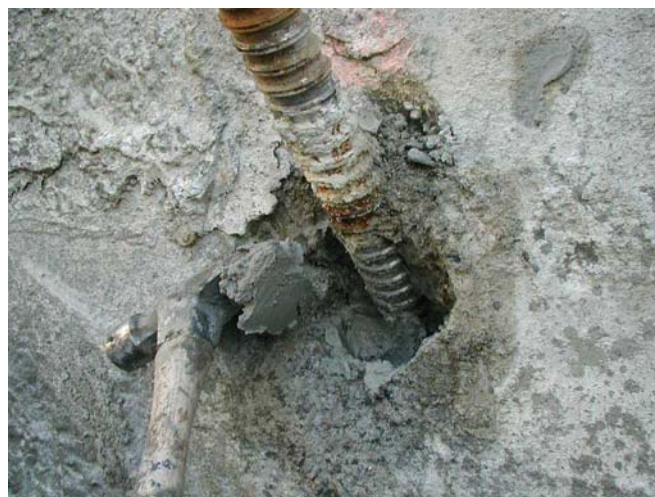
It is the opinion of the authors that the vertical wall movements were the result of failure of the strut nails installed along the bottom of the existing east concrete basement wall to perform as intended. The strut nails were designed to support the full weight of the existing wall. However, when the wall footing was initially undermined, the wall dropped vertically 1.2 inches over a short period of time (3 days). Vertical wall movements continued throughout construction, even after micropiles were installed to resupport the wall. The vertical wall movement at the end of construction was 2.64 inches.

It appears the strut nails failed to support the existing basement wall because of a poor connection with the existing wall. The design theory of strut nails is similar to a truss system. With a rigid connection at the wall face, the strut nails (which were installed at 45 degrees from vertical) are a compression element. A rigid connection would require a continuous column of grout in the annulus between the nail bar and the hole drilled through the existing wall and around the nail bar directly behind the wall. A continuous grout column was probably not achieved because the strut nails were grouted with a neat cement grout, which likely flowed into the gravel drain rock directly behind the wall before setting up around the nail bar. As discussed above, we also observed a considerable amount of soil within the grout of the strut nail connection. A photograph of one of the connections observed is shown in Fig. 10. When the existing wall was undermined, the poor connection did not allow full compression of the strut nail and the strut nails, along with the regular soil nails, were loaded in bending.

Fig. 10. Observed strut nail connection at existing wall.

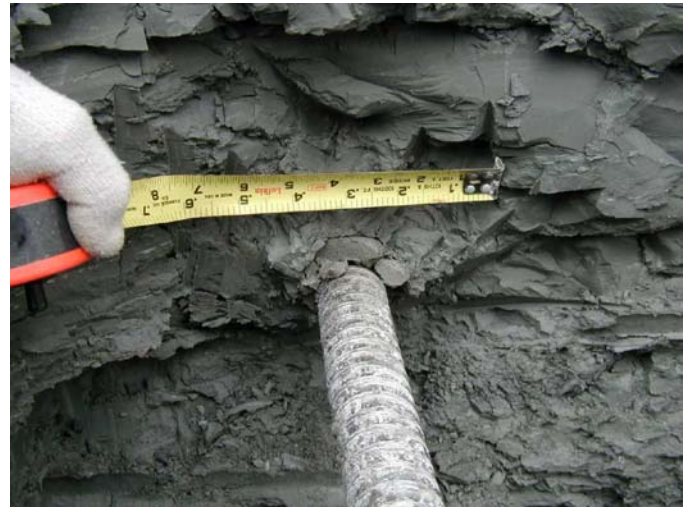
- Fractures and planes of weakness in the soil unit as stress relief and lateral translation movement occurred. This resulted in softening and loss of soil strength near the planes of weakness. It also resulted in loading of the nails at the plane of weakness. If the plane of weakness was located outside (beyond) the failure plane assumed in design, the nails would be attracting more load than assumed for design. This would also result in a reduced pullout capacity of the nails because the Lawton Clay is a strain-softening soil material.
- Inability to completely clean out the silt and clay cuttings during the grout-injected nail installation. This may have resulted in plugs of remolded, disturbed soil left in the hole and thus incomplete grouting of the nails. Drilling spoils were observed in the nail hole annulus of several

nails upon cutting the soil face in preparation of shotcrete, as shown in Fig. 11 and 12.

Fig 11. Nail hole annulus. Majority of 6-inch-diameter hole is soil cuttings, with some grout around nail bar

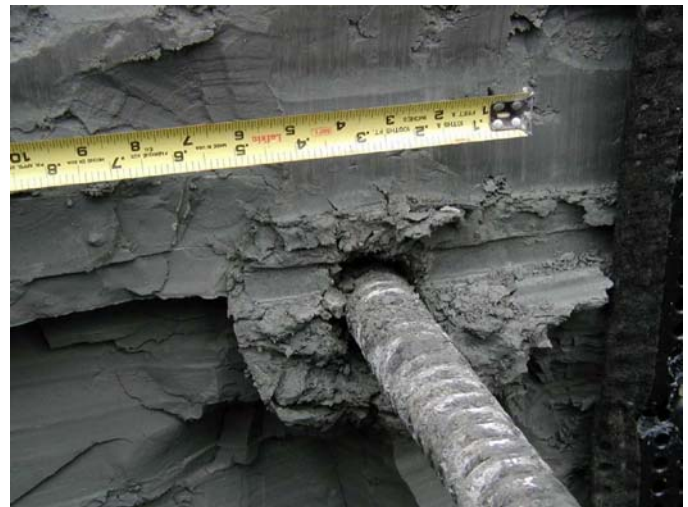
Fig 12. Nail hole annulus with no grout in drill hole or around nail bar
