Observations and Performance of a Soil Nail Shoring Wall in Seattle Silts and Clays

OBSERVATIONS AND PERFORMANCE OF A SOIL NAIL SHORING WALL IN SEATTLE SILTS AND CLAYS

The Seattle Central Library project, which replaced the existing downtown library, consists of a twelve-story building with several below-grade levels. The excavation encompassed an entire city block and had plan dimensions of approximately 250 feet by 240 feet. The original excavation depth was up to 53 feet in height. The excavation was made in highly overconsolidated Seattle silts and clays (Lawton Clay). The Lawton Clay has been documented to exhibit expansive behavior along planes of weakness associated with stress relief upon excavation.

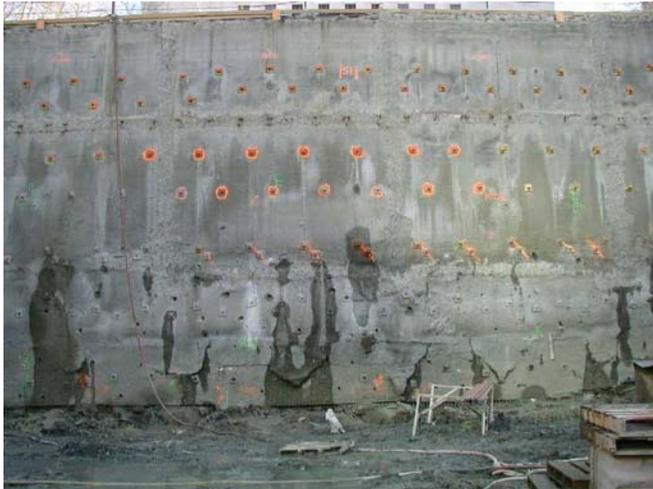
Fig. 1. Photograph of east wall during construction.

Numerous issues occurred during Phase III construction of the east shoring wall, particularly when the existing wall was undermined to extend the excavation deeper. The existing wall dropped vertically over 1 inch when the footing was initially undermined. Additional vertical support was provided by installing micropiles. By the end of construction, the east wall had dropped vertically over 2.6 inches, with over 0.5 inches occurring after the micropiles were installed. Additionally, significant lateral movement of the wall began to occur as excavation below the wall footing occurred. The total horizontal movement of the east wall that occurred during construction was 4 inches. A significant amount of this movement occurred along planes below the bottom of the excavation, generally within 4 to 12 feet of the current excavation bottom. This type of movement is consistent with stress relief within the Lawton Clay, resulting in the opening of fractures and movement along planes of weakness (Peck, 1963; Palladino, 1971). Water, which tended to collect in the fill behind the existing wall, may have exacerbated the lateral wall movements on the weak planes.

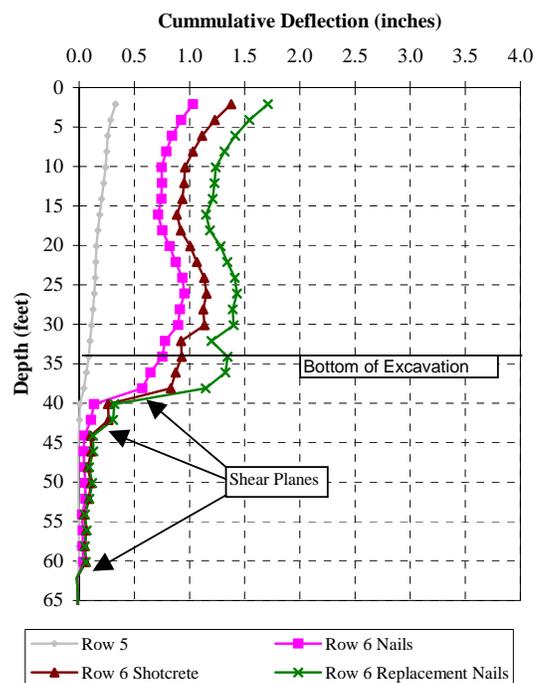
Significant horizontal and vertical wall movements were measured on both the optical survey points and the inclinometer when the north half of the existing wall was undermined (row 6 nails). The vertical and horizontal movements of the east wall were about 1.2 and 0.6 inches, respectively, as shown in Table 1. The inclinometer data, as shown in Fig. 4 and Table 2, showed that almost all of the incremental horizontal wall movement occurred 6 feet below the bottom of the excavation.

Fig. 4. East wall inclinometer data after completion of row 6.

When the shotcrete for row 6 had been completed, the total wall movement was 1.2 inches horizontal and 1.6 inches vertical (see Table 1 and Fig. 4). The proof tests were then completed on the row 6 soil nails. All four of the proof test nails failed in pullout (between 65 and 130 percent of the design pullout of 3.5 kips/foot). Because the design required a factor of safety of 2 on the pullout, replacement soil nails were installed. The replacement nails were installed in between the original nails. With the additional of the replacement soil nails, the effective nail spacing was reduced from 5 feet to 2.5 feet. The replacement nails were installed through the existing shotcrete facing. A rock hammer was used to break through the existing shotcrete. The vibrations of the rock hammer resulted in an additional 0.4 inches of horizontal wall movement and 0.4 inches of vertical wall movement. Proof testing of the replacement nails indicated that 4 out of 5 nails failed in pullout (again between 65 and 130 percent of the design pullout of 3.5 kips/foot), but the sum pullout capacity of the initial nails plus the replacement nails met the required row 6 pullout capacity.

At the completion of row 6, the total vertical and horizontal wall movements were 1.9 inches and 1.6 inches, respectively. At the inclinometer, the total horizontal movement was 1.7 inches, of which 1.1 inches occurred on three shear planes located at depths of 6, 10 and 28 feet below the bottom of the excavation (depths of 40, 44 and 62 feet below the top of the wall)(see Table 2 and Fig. 4).

As a result of the rapid movement of the wall, the southern half of the wall was shotcreted using a staggered excavation approach. Each excavation, or slot, was approximately 20 feet in length. The slots were spaced such that the adjacent slots were either protected by a soil drill berm or completed shotcrete wall.

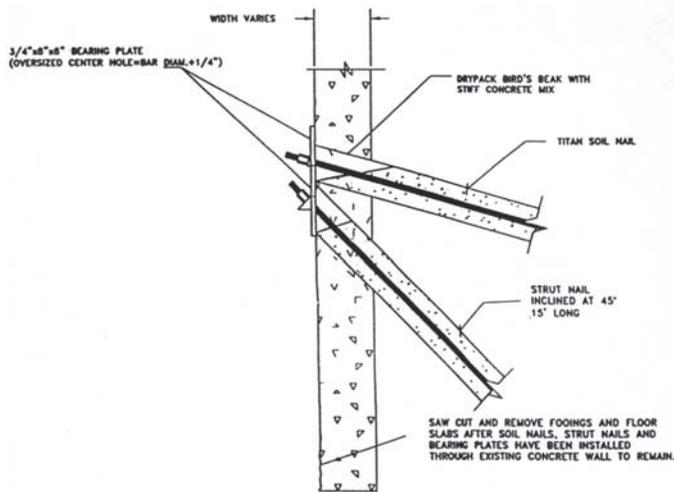
During the shotcreting of the southern half of the wall, a visual survey of the wall and 5th Avenue was completed. The survey revealed that the several of the row 1 through 5 soil nail nuts were loose. In addition, the accessible strut nail locations were observed to determine if the strut nails had been damaged as a result of the vertical movement. A detail of the strut nail connection is shown in Fig. 5 (strut nail is shown inclined at 45 degrees from horizontal). Half of the strut nails evaluated showed either relative slipping/movement between the grout and wall or very weak grout connection (soil/grout mixture) that could easily be removed with hand tools. The relative movement was small and did not account for the 1.2 inches of vertical wall movement measured, but did call into question the integrity of the connection of the strut nails to the existing wall.

Fig. 5. Strut nail connection to the existing concrete wall

During the installation of core holes in the existing wall, it was observed that the gravel drain at the base of the wall was partially filled with grout. It appeared that the neat cement grout from the strut nail installation had contaminated the gravel drain, contributing to the buildup of groundwater behind the existing wall (the continuity of the drain pipe had already been compromised as discussed above). This also may have contributed to a poor structural connection between the strut nail and the existing wall. Without a continuous grout column around the strut nail, the nail would not be able to support the weight of the existing wall by functioning as a compression member as intended by the design. It is the author's opinion that this poor structural connection led to the

failure of the strut nail system and the resulting vertical wall movement. In essence, the soil nails (both regular and strut nails) were supporting the existing wall in a bending mode (similar to nails supporting a picture frame on a wall).

Row 7 Observations. Because of the continued vertical movement of the wall, the contractor proposed installing a series of micropiles to replace the strut nails. The micropiles were installed at the bottom of the row 6 shotcrete. The micropiles consisted of near vertical, 6-inch diameter, 32-foot long, post-grouted nails. After installation of the micropiles, the vertical wall movements slowed significantly, but did not stop.

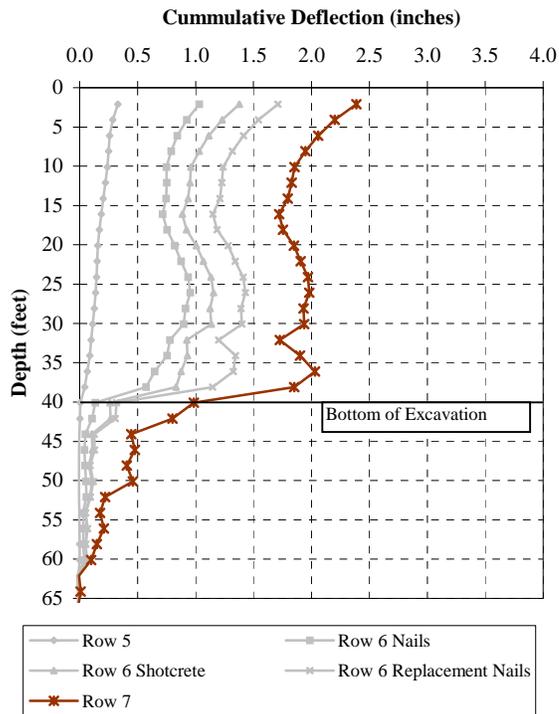
During construction of row 7, the movement of the wall continued. The wall moved vertically approximately 0.3 inches, for a total cumulative movement of 2.2 inches. The horizontal wall movement increased from 1.6 inches to 2.1 inches. As with row 6, a significant amount of the additional movement occurred below the bottom of the excavation. A fourth shear plane also developed 12 feet below the excavation (52 feet below the top of the wall) and accounted for about one-half of the horizontal movement observed during row 7 installation, as shown in Fig. 6.

Fig. 6. East wall inclinometer data after completion of row 7.

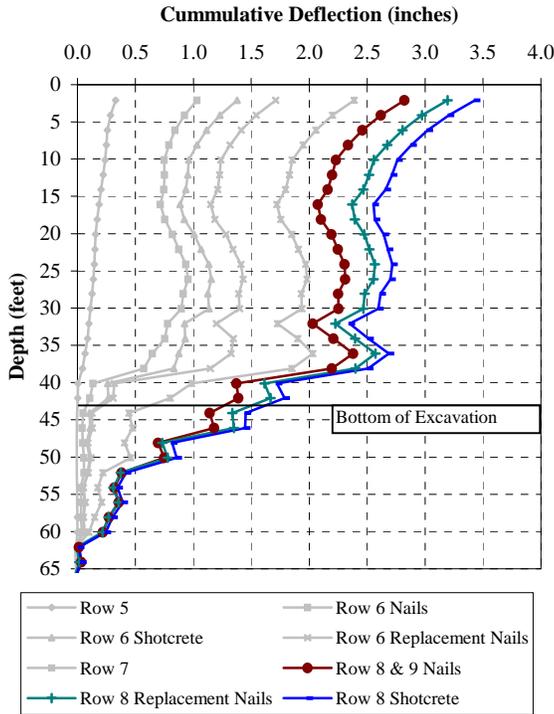
the grout return. It appeared that the grout would then pressurize and begin flowing through the cracks and fractures within the Lawton Clay. Grout was observed flowing from the wall face through fractures in the silt as far away as 25 feet from the drilling location. Based on the survey and inclinometer data (Tables 1 and 2 and Fig. 7), approximately 0.4 inches of horizontal wall movement occurred during installation and grouting of the replacement nails. Approximately one-half of this movement occurred below the bottom of the excavation.

Fig. 7. East wall inclinometer data after completion of row 8.

At the completion of rows 8 and 9 shotcrete, the total vertical wall movement was 2.34 inches and the total horizontal movement was 3.18 inches. As with previous rows, the majority of the movement occurred on shear planes below the bottom of the excavation. During this stage, a fifth shear plane occurred at a depth of 5 feet below the base of the excavation (depth of 48 feet below the top of the wall).

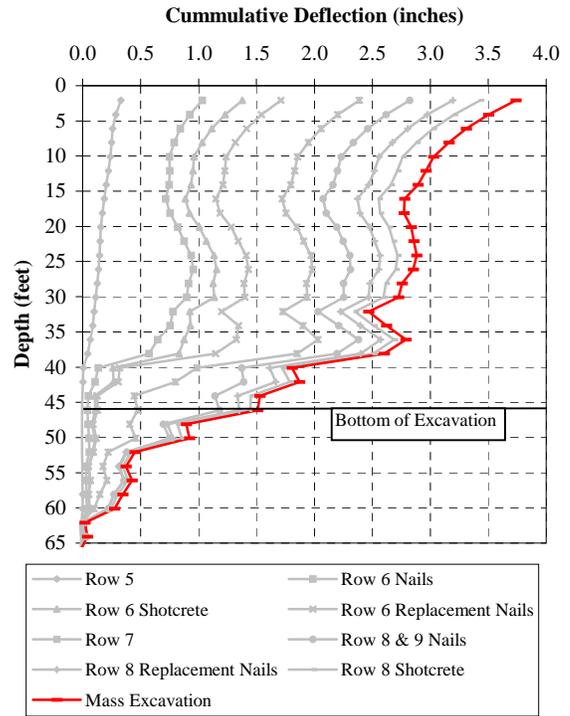
Once the shotcrete was installed in the trench slots, mass excavation of 6 feet of soil in front of the wall occurred to bring the site grade down to the bottom of wall elevation. This mass excavation occurred between 0 and 50 feet in front of the wall and resulted in an additional 0.25 inches of horizontal movement and 0.1 inches of vertical movement, as presented in Tables 1 and 2 and Fig. 8.

Fig. 8. East wall inclinometer data after completion of mass excavation to bottom of wall elevation.

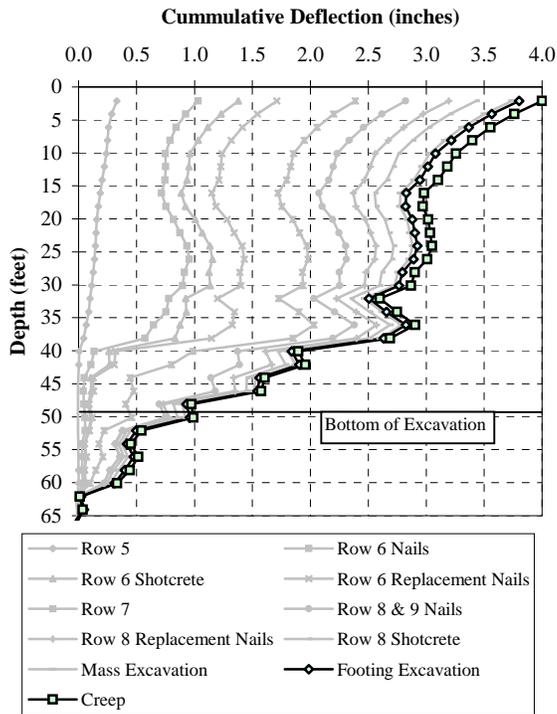
Following Construction. Movement of the east wall, both horizontal and vertical, continued to occur after all earthwork construction activities were completed in front of the wall. Movement was measured over a period of several months. The movement essentially stopped when enough building structure (i.e. permanent walls and floor slabs) had been constructed in front of the shoring wall. The horizontal and vertical wall movements that occurred during this period were 0.36 inches and 0.12 inches, respectively (see Tables 1 and 2 and Fig. 9). Very little of the horizontal movement (0.03 inches) occurred below the bottom of the excavation. The majority of movement was outward rotation of the wall.

These movements were occurring with little or no additional load being applied to the wall, which is the definition of creep movement.

Fig. 9. Final east wall inclinometer data.

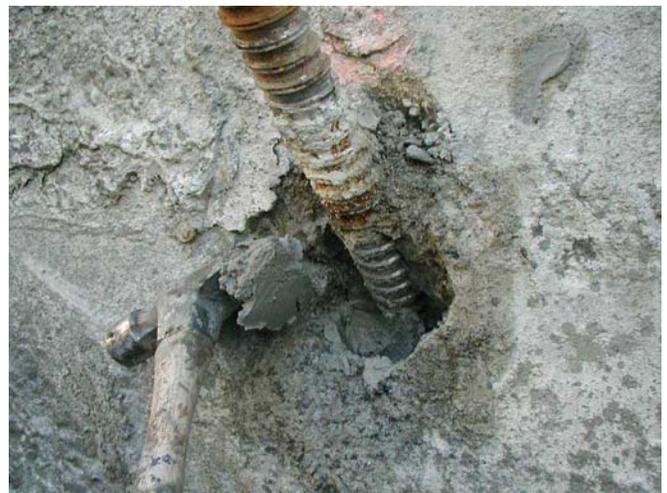
It is the opinion of the authors that the vertical wall movements were the result of failure of the strut nails installed along the bottom of the existing east concrete basement wall to perform as intended. The strut nails were designed to support the full weight of the existing wall. However, when the wall footing was initially undermined, the wall dropped vertically 1.2 inches over a short period of time (3 days). Vertical wall movements continued throughout construction, even after micropiles were installed to resupport the wall. The vertical wall movement at the end of construction was 2.64 inches.

It appears the strut nails failed to support the existing basement wall because of a poor connection with the existing wall. The design theory of strut nails is similar to a truss system. With a rigid connection at the wall face, the strut nails (which were installed at 45 degrees from vertical) are a compression element. A rigid connection would require a continuous column of grout in the annulus between the nail bar and the hole drilled through the existing wall and around the nail bar directly behind the wall. A continuous grout column was probably not achieved because the strut nails were grouted with a neat cement grout, which likely flowed into the gravel drain rock directly behind the wall before setting up around the nail bar. As discussed above, we also observed a considerable amount of soil within the grout of the strut nail connection. A photograph of one of the connections observed is shown in Fig. 10. When the existing wall was undermined, the poor connection did not allow full compression of the strut nail and the strut nails, along with the regular soil nails, were loaded in bending.

Fig. 10. Observed strut nail connection at existing wall.

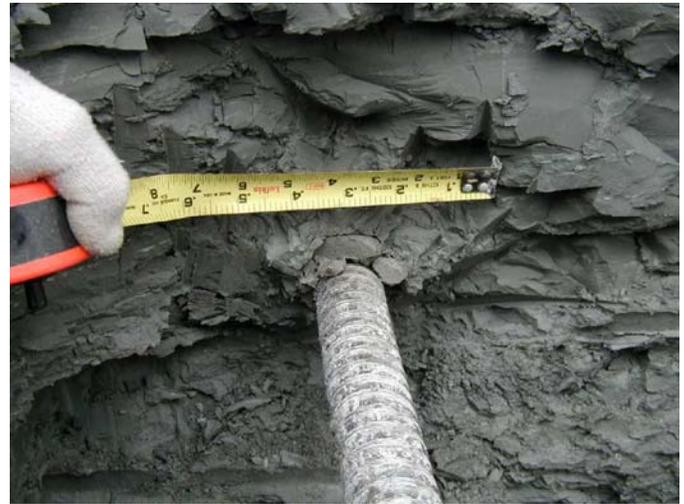
- Fractures and planes of weakness in the soil unit as stress relief and lateral translation movement occurred. This resulted in softening and loss of soil strength near the planes of weakness. It also resulted in loading of the nails at the plane of weakness. If the plane of weakness was located outside (beyond) the failure plane assumed in design, the nails would be attracting more load than assumed for design. This would also result in a reduced pullout capacity of the nails because the Lawton Clay is a strain-softening soil material.
- Inability to completely clean out the silt and clay cuttings during the grout-injected nail installation. This may have resulted in plugs of remolded, disturbed soil left in the hole and thus incomplete grouting of the nails. Drilling spoils were observed in the nail hole annulus of several

Fig 11. Nail hole annulus. Majority of 6-inch-diameter hole is soil cuttings, with some grout around nail bar

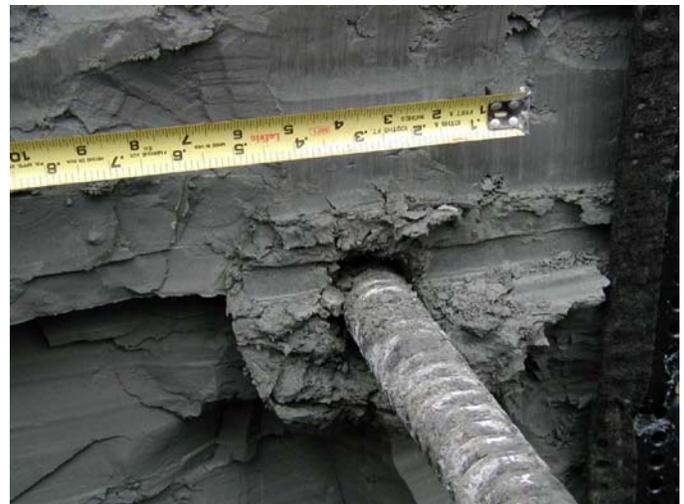
Fig 12. Nail hole annulus with no grout in drill hole or around nail bar
