# Stabilization of the Dividing Wall at a Drinking Water Reservoir

Ingo Fox  
*Malcolm Pirnie, New York*

Burjor Kharivala  
*New York City Department of Environmental Protection, New York*

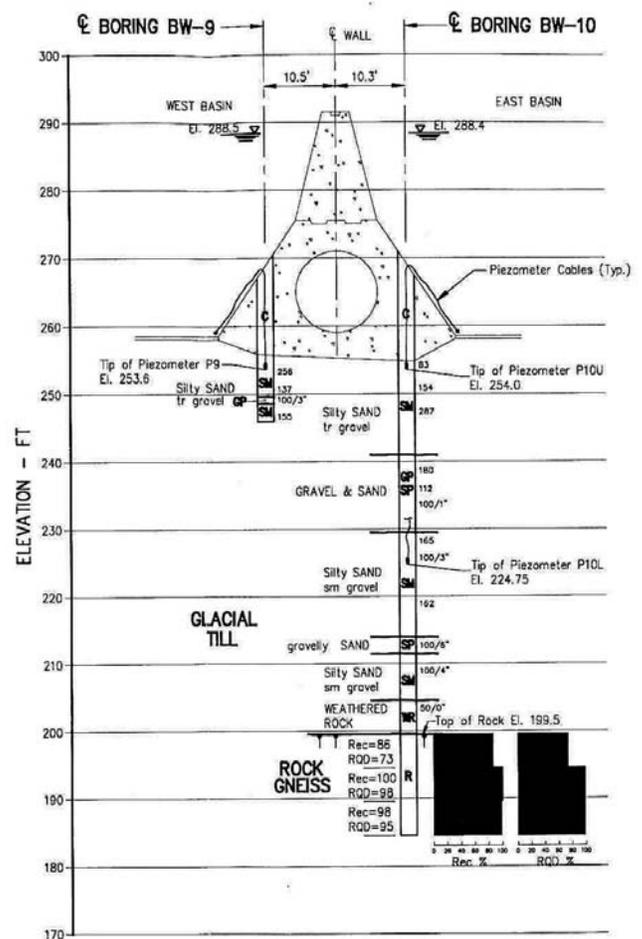
Fig. 2. Exploratory Drillholes through Dividing Wall

Three of the drillholes, one at the north side, one at the center and one at the south side of the wall, were taken down to bedrock, see Fig. 2. The need to know the bedrock depth and its quality stemmed from the initial thought of using post-tensioned anchors to increase the wall stability. Because of the gravel and cobbles present in the Glacial Till, only disturbed samples were recovered for index properties and grain size distribution analyses. The sieve analyses showed,

typically, that the Glacial Till under the wall base had fines content, soil particles smaller than 0.074 mm (No. 200 mesh) between 20 and 40%, and of low plastic index. The Glacial Till encountered directly under the wall was very dense comprised of boulders, gravel, sand and silt with some clay and was similar to materials encountered in prior

explorations and representative of the Glacial Till confirming that the wall was founded directly on it.

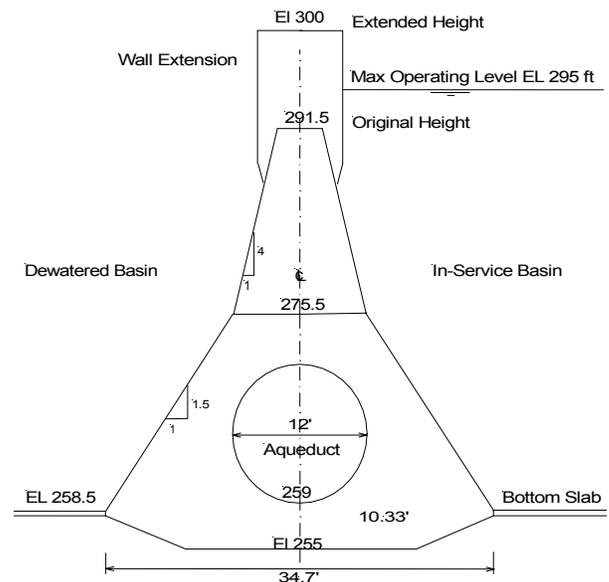
Fig. 3. Dividing Wall and New Extension

Under unequal basin water levels, the dividing wall is subject to unbalanced lateral water thrusts that need to be resisted by frictional resistance along the wall base. The net excess horizontal water thrust increases as the unbalanced water levels between the two basins gets larger. Because the frictional resistance derived from effective contact stresses due to gravitational forces acting at the wall base were not sufficient to meet the necessary factors of safety against sliding, and also to maintain the resultant of all forces close to or within the middle-third of the wall's base, it became

necessary to investigate methods that would increase the normal effective stress at the base of the wall. Based on the index properties of soil laboratory tests of samples recovered from under the wall base it was decided to treat the foundation formation as a purely frictional material with no cohesion. The adopted friction angle for base-shear failure was 35 degrees.

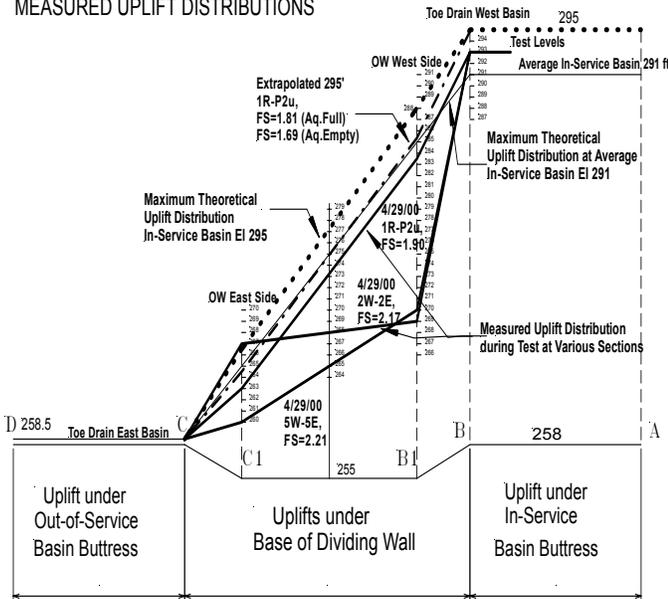
Fig. 8. Stability Test of East Side Buttressed Wall

The test results show that for an operating level of the in-service basin equal to 293 ft, the average factor of safety of the wall against sliding is 2.07, with the lowest value of 1.90 at an instrumented section at the south side of the wall. The calculated factors of safety were for the empty aqueduct condition, which was the case during the test. The uplift response at the section with highest readings (section 1R/P2u, at the south side of the wall) was extrapolated for an in-service basin at its maximum operating level of El. 295 ft.

For that condition, the anticipated factor of safety was calculated to be 1.81 for the aqueduct full of water condition, 1.69 for the empty aqueduct. Both values are above the minimum design values.

The graphical presentation below shows the measured distribution of uplift under the wall during the test period compared to the maximum theoretical distributions. Factors of safety are shown for three typical sections. Piezometric head readings at other sections fall generally between the limits shown.

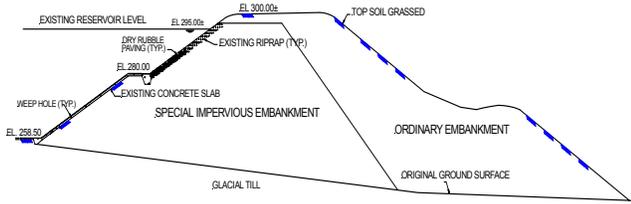
Fig. 9. Typical Embankment Section with Fill Materials

The embankment was constructed with two fill zones. The inner portion of the embankment was built of special impervious fill, which consists of screened Glacial Till obtained directly from the excavation of the reservoir. It was placed in 4-inch lifts and compacted with 10-ton sheepfoot rollers. The outer slope or stabilizing shoulder, the ordinary embankment zone, was built of unsorted Glacial Till and less compacted than the impervious zone; see Fig. 9.

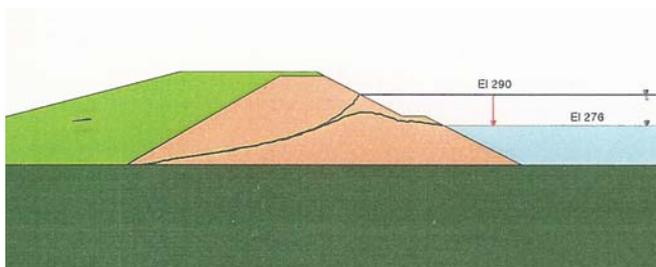
Fig. 10. Embankment Phreatic Change under Drawdown

The stability of the inner embankment slope during drawdown of the basins was also a concern. During drawdown of the reservoir, the water contained within the select fill will slowly drain from the embankment into the Glacial Till beneath and reservoir. The rate of drainage and pore-pressure dissipation in the select fill of the inner slope is a function of the reservoir drawdown rate, properties of the materials and efficiency of the weepholes in the concrete lined lower slope. The rate of drawdown was studied theoretically by means of flow nets and integrated stability analyses.

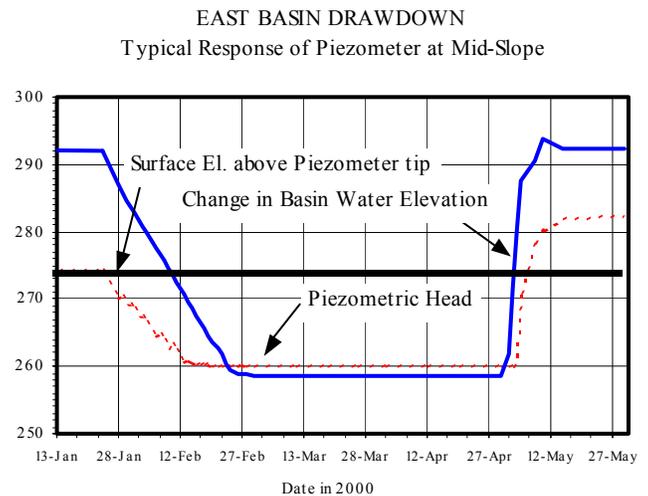
Fig. 11. Second East Basin Drawdown & Piezometric Response

Figure 11 shows the adopted drawdown rate at the east basin during second emptying for the construction of the east wall buttress. The figure also shows the response of the piezometer installed at mid height of the lower slope. The drawdown rate adopted this time around was 12 inches in 24 hours. The behavior and calculated factors of safety were satisfactory and no distress was observed on the slope or at the 10-foot bench. From the experience gained during emptying each basin twice it was concluded that a maximum safe drawdown rate for both basins should not exceed 12 inches in a 24-hour period.

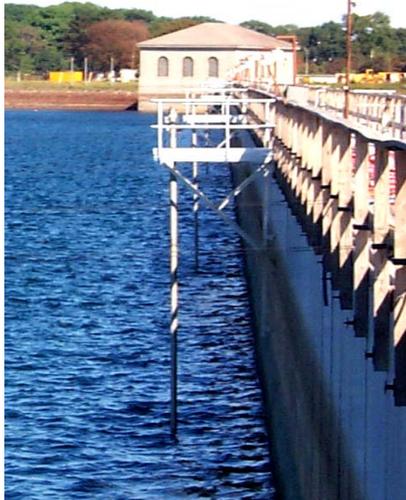
*Fig. 12. Dividing Wall Monitoring Station for Wall Uplift*

on each wall monolith and daily readings of crackmeters to an accuracy of 1 mm installed across the monolith expansion joints formed part of the monitoring effort. Twice-daily manual readings of the observation wells installed along the wall at 12 sections were performed to cross-check the automated readings stored in a data acquisition system. However, as mentioned above, pressure transducers installed near the bottom of the wells read pressures continuously and the automatic readout unit was hooked up to an alarm system with speakers at both intake and dwtake chambers. The trigger levels were set based on water levels measured in the observation wells that could pose risks to the wall stability.
