REPAIR OF THE CHURCH OF LA PURISIMA CONCEPCION OF HUELVA (SPAIN) WITH JET-GROUTING, FOR DAMAGES CAUSED BY THE CONSTRUCTION OF DIAPHRAGM WALLS IN ITS PROXIMITY

The Church of La Purísima Concepción, raised in 1515 as the second parish of Huelva (Spain) has been affected by diverse natural disasters along its history.

The foundation of the church has been repaired using the technology of jet-grouting, with columns of 15 and of 30 meters of depth and 0.75-0.80 m of diameter. Later, it was realized concrete slab to join all the heads of the columns of jet-grouting. Measurements of levelling have been realized to observe the movements of the church structure during the accomplishment of the jet-grouting.

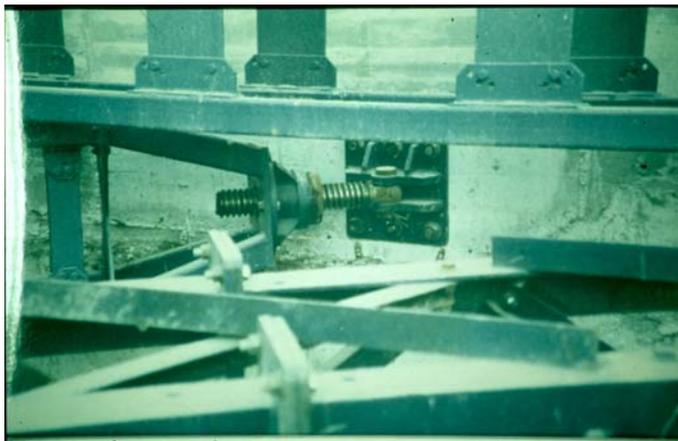
Fig. 3. Pinned fix detail.

The struts that were placed to avoid the movements of the walls suffered very important elastic shortage, because of fundamentally of the inflexibility of their nodes. The diagonals of the struts were fixed to the main cords by a screw, which does not permit to guarantee the fixing among these two elements, should calculate like an pinned fix.

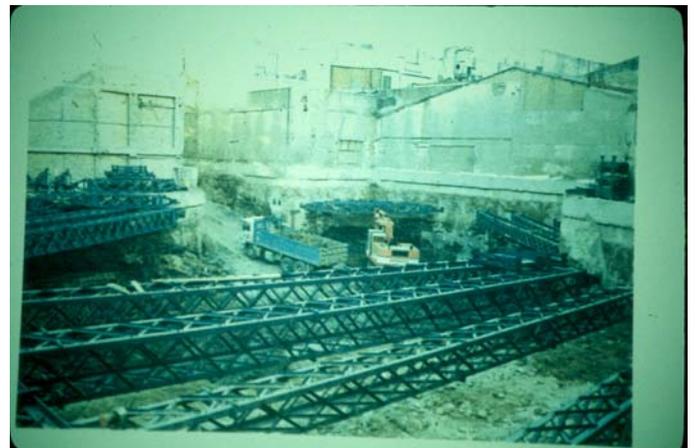
Fig 5. Bracing support.

Because of the irregular geometry of solar, the bracing supports were not arranged perpendicular to the walls, but are placed in angles even in 41°, what complicates clearly the

transmission of efforts and the efficacy of the pre-stressed. Besides the lengths of many of the support are next to the 30m. The wall was built in very long parts in many cases, longer than the 5 meters.

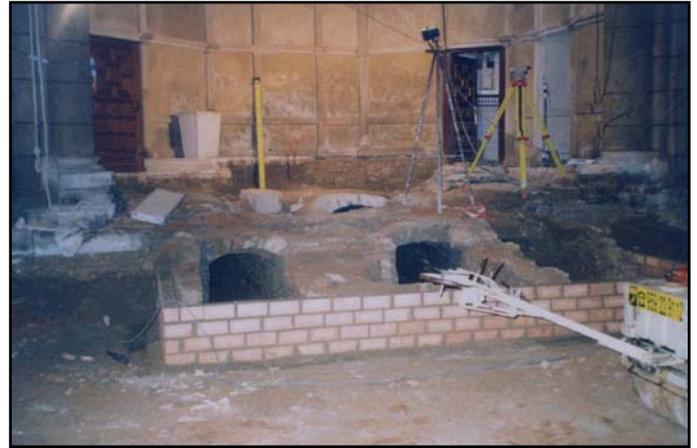
Fig 9. Crypts

In some zones the excavation was made by hand because they found three crypts in the presbytery and an under the chapel of the Vera Cruz, in which human remainders were found. Their vaults are straight tube with circular guideline, built with a solid thread of a foot brick received with lime mortar.

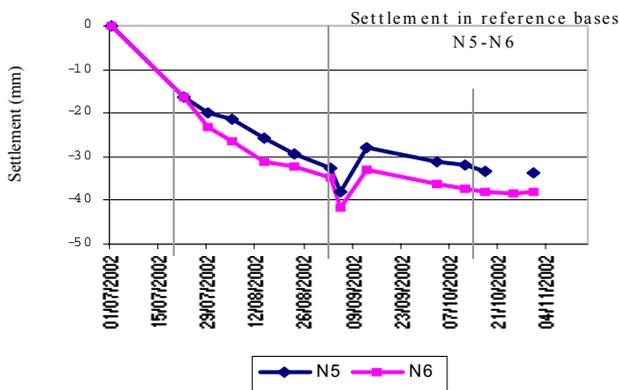
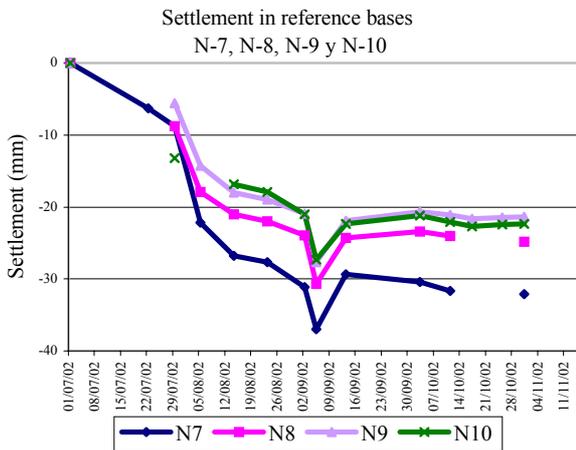
Fig 8. Settlements in reference bases.

The measured heaves went of 9 mm maximum in some points, oscillating most of them, around 1-2 mm, as we can see in the graphics (fig. 8).
