ESTIMATE THE MAGNITUDE AND NATURE OF DISTRESS THE VARIOUS STRUCTURES HAVE UNDERGONE DUE TO RECENT BHUJ EARTHQUAKE

Dr. A. R. Katti

On January 26, 2001 one of the most destructive earthquakes ever to strike India occurred in Gujarat. More than 13,000 lives were lost in this earthquake. Several civil engineering sections have undergone moderate to severe distress. In this paper two cases of one port at Adani and a salt factory which has undergone severe distress has been covered.

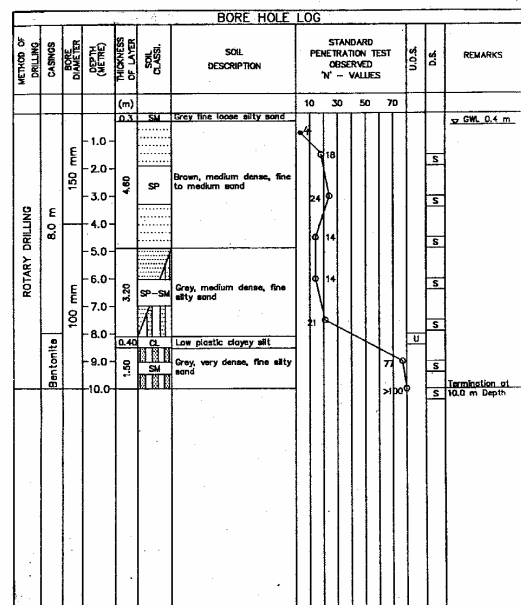
Fig. 1 Typical borehole in Adani Port area

The sub-surface comprises of layer of blackish grey silty clay having thickness of around 5 m. The N value of this zone is less than 3. Stiffer strata up to large depths follow this. There appears presence of large longitudinal cracks in several areas such as the rock-fill embankment, open go-downs, and the receiving and dispatch yard of the railways.

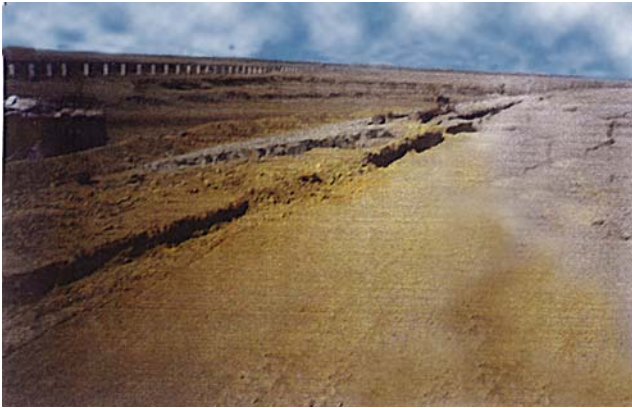
Major distress is observed on the railway embankment when the embankment crosses the road. Here 15 cm wide longitudinal cracks are seen over the entire width of the embankment as seen in Figure 4. The wing has displaced more than 15 cm away from the concrete structure.

Fig. 4. Longitudinal crack over the length of the embankment

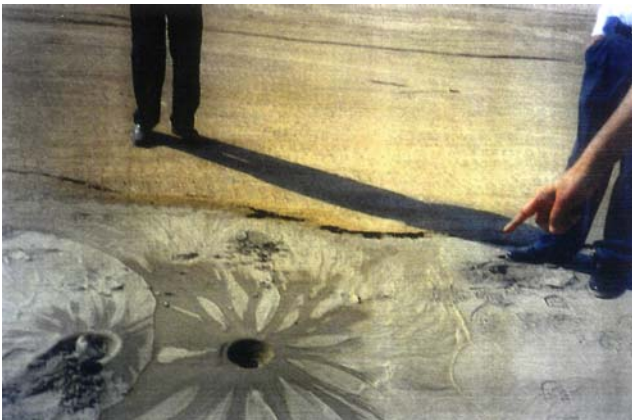
Fig. 5. Wet hole on February 11, 2001 from which water and silt had oozed out

On the top of the embankment at several places silt is oozed out from the embankment and spread over 3 m to 4 m. The diameter of these holes is as high as 10 cm as seen in Figure 5. The height of the water jet, which came out of the embankment, was around a meter or metre and a half. The depth of these cracks was as high as 2 m to 2.5 m.

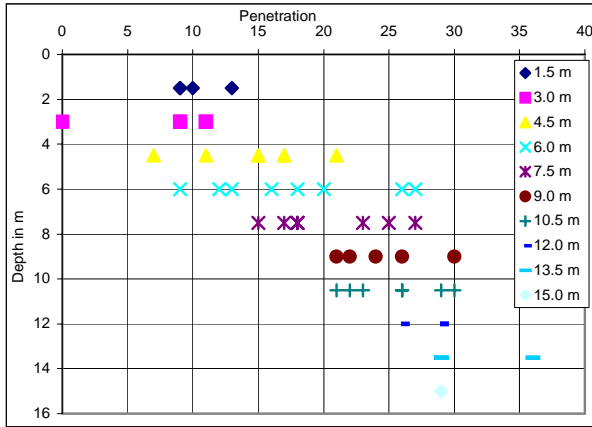
Variation of penetration value with depth is presented in Figure 6. From the penetration values observed in the field it is seen that the N value lies between 7 and 20 between depths 1.5 m and 6 m hence we can infer that the soil is loose to medium dense kind of material. It is observed on the site that liquefaction of the soil has taken place. This is confirmed from the fact that sand boils are observed on various locations on the factory site. Hence it is observed that due to liquefaction the soil has become loose. Hence we may go in for higher factor of safety.

Fig. 6. Variation of penetration value with depth

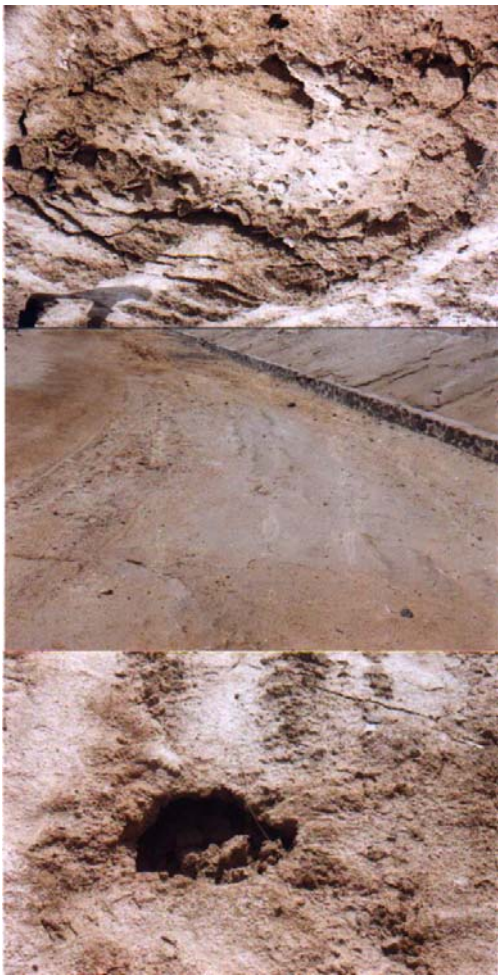
Fig. 7 Location from where the salt and water oozed out at salt factory at Bachau

Based on the field and the laboratory data, liquefaction analysis is carried out. The detailed calculations for evaluation of liquefaction potential are presented in Table 5 and 6. From the calculations it is evident that liquefaction has taken place. It is observed that the depth of liquefaction is up to 5 m from the ground surface.

The photographs, in Figure 7 which were taken just after the earthquake on the January 26th, 2001, also clearly indicate that the liquefaction has occurred at the site.

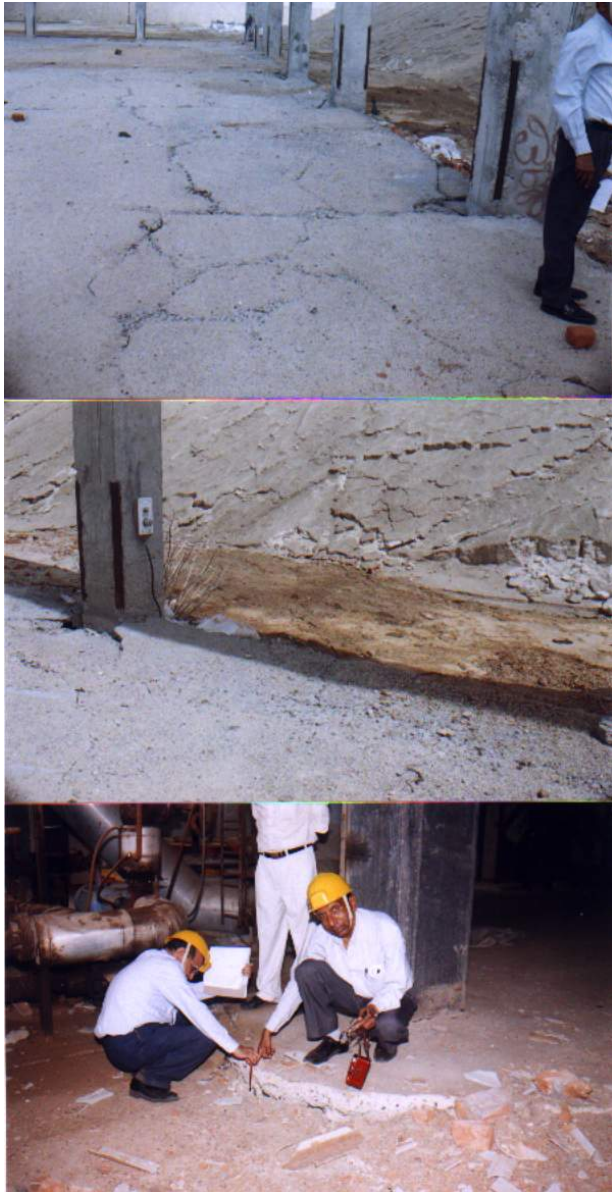
Fig. 9. Settlement of the surrounding flooring and the entire flooring of the stacking go-down is cracked
