# A Case Study of Characteristics of Damages Caused by Typhoon EWINIAR 2006 in South Korea

## **A CASE STUDY OF CHARACTERISTICS OF DAMAGES CAUSED BY TYPHOON EWINIAR 2006 IN SOUTH KOREA**

### **ABSTRACT**

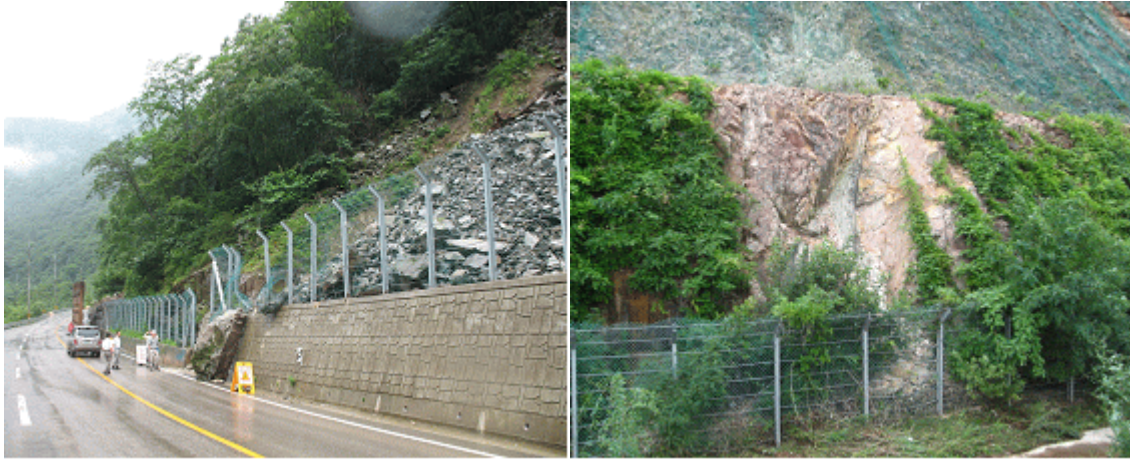
In the damaged area, rocks partially fell down from the cut slope due to weathering of the face of the rock or the

penetration of water into the joint face. However, there was no serious damage to the roads primarily because the slopes were equipped with facilities to block the falling rocks. Figure 4 shows the pictures of stone falling and the blocks to prevent damage or blockage of the roads.

**Fig 4. The Damage Example due to Stone falling**

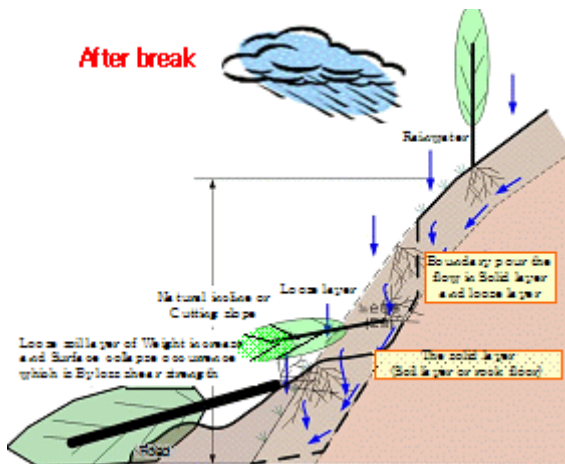
It was estimated that the collapses occurred when the underground water flew along the joint face of the loose and stiff layers after the concentrated rain. As a result the soil lost its shear strength at the interface, which caused the slope to

fail. The common size of the collapse was 50cm ~ 1m in depth and 1m ~ 2m in width. Figure 5 shows the schematic of the slope failure due to surface runoff and Figure 6 shows a picture of the failure caused by surface runoff.

**Fig 5. Schematic of slope failure due to surface runoff**

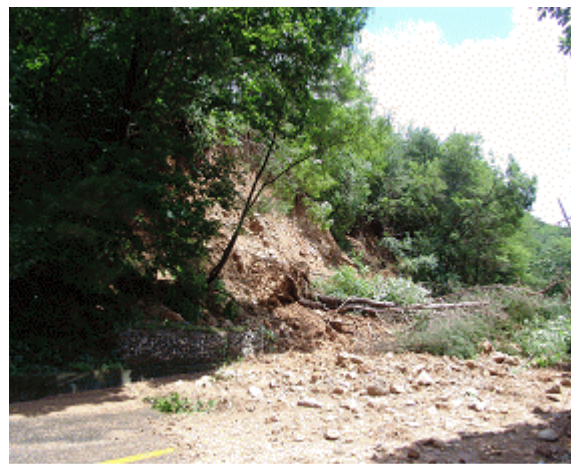
**Fig 6. Picture of slope failure due to surface runoff**

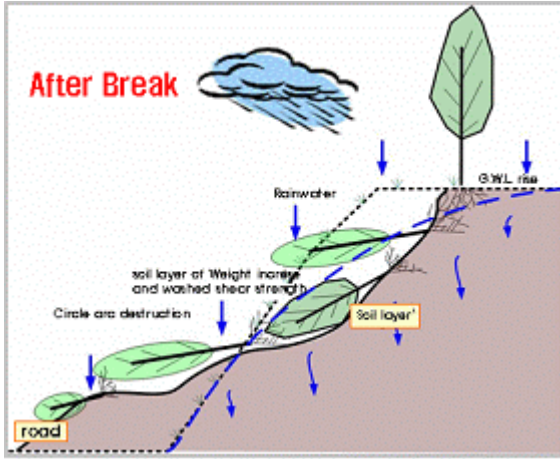
Some cut slopes and natural slopes failed in a more or less arc pattern primarily due to (1) the process of freezing, melting, and weathering, (2) the increase in self weight of the soils, and (3) the reduction in shear strength of soil caused by heavy

rains. In this rainy season, the surface runoff also caused some slopes to fail in the arc pattern. Figure 7 shows the schematic of the arc type failure of the slopes and Figure 8 shows a picture of the arc type failure of a slope.

**Fig 7. Schematic of arc type failure**

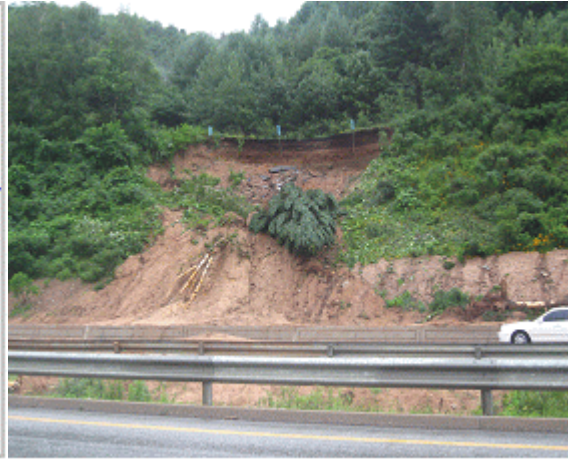
**Fig 8. Picture of arc type failure**

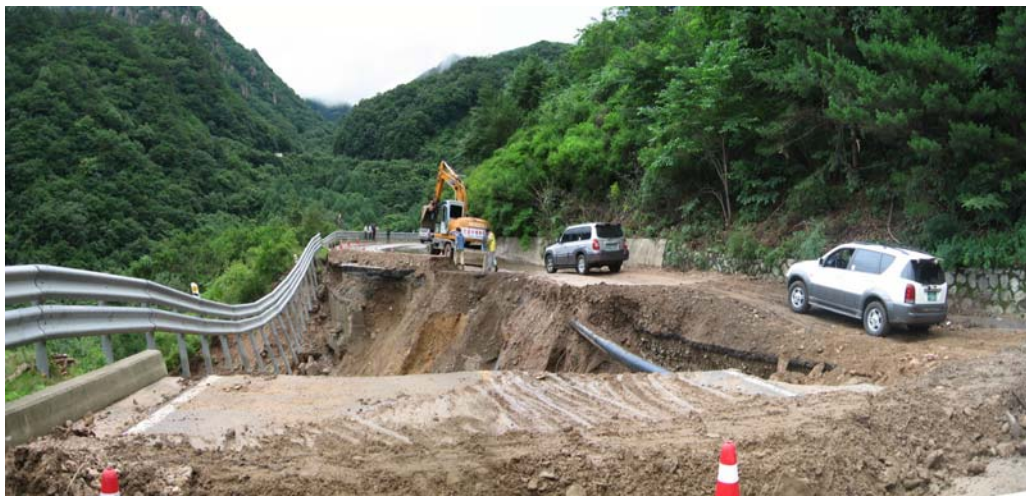
At places where fill slopes were constructed on bedrock, the water from valleys and roads penetrated the fill layer and flew

on the face of the rock and washed off soil which resulted in the collapse due to the loss of the soil from the fill layer. Reinforcing stone walls and retaining walls constructed on these fill slopes collapsed due to the loss of the soil layer. Figure 9 shows the picture of failure of fill slope.

**Fig 9. The damage example by banking section**

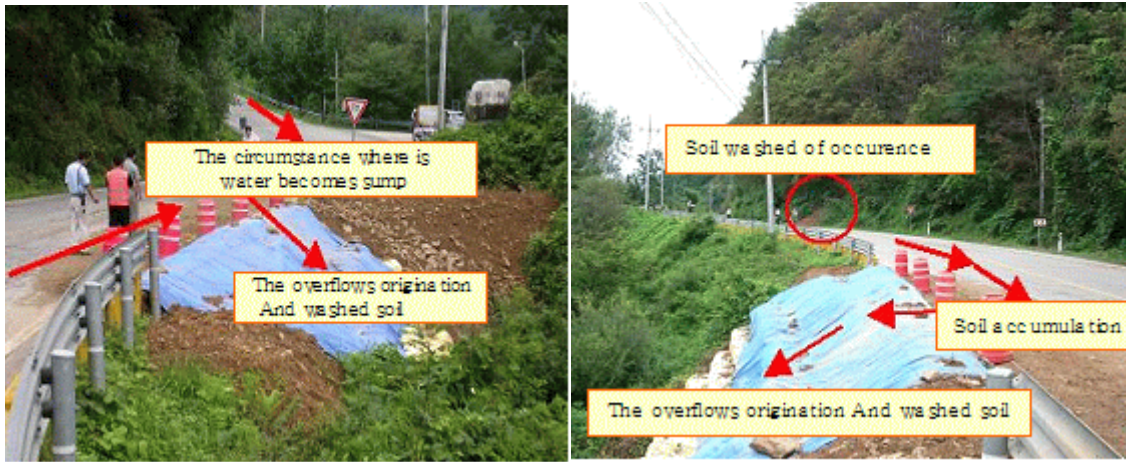
Another type of damage that occurred on the fill slopes was due to washing out of the fill after the fallen soil from the

adjacent cut slope blocked the flow of the water. Figure 10 shows the pictures of fill slope failures due to washing of fill materials.

Fig 10. The damage example due to washing of fill material

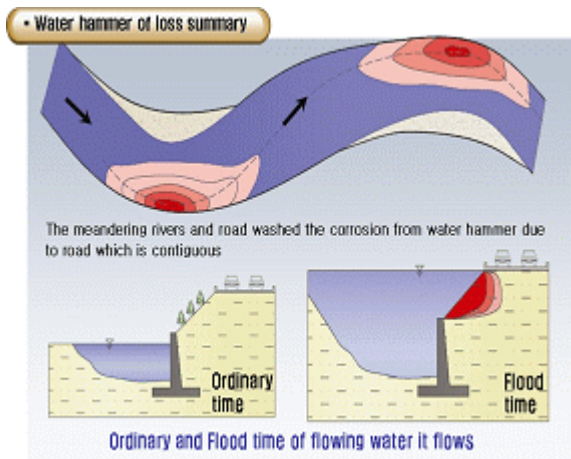
Heavy rains caused significant flow in the streams. The bank protection facilities like retaining walls constructed at

locations where streams meandered, failed because they could not endure the impact of water caused by concentrated heavy rain. Figure 11 shows the schematics of failure to roads at stream banks and Figure 12 shows the picture of such a failure.

Fig 11. Schematic of water-impacting portion

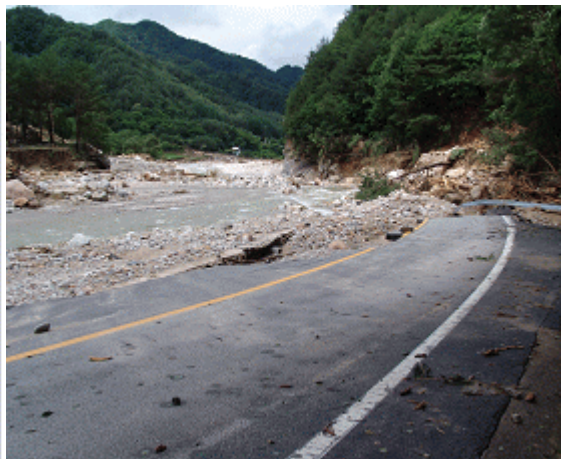
Fig 12. Picture of failure due to water impact

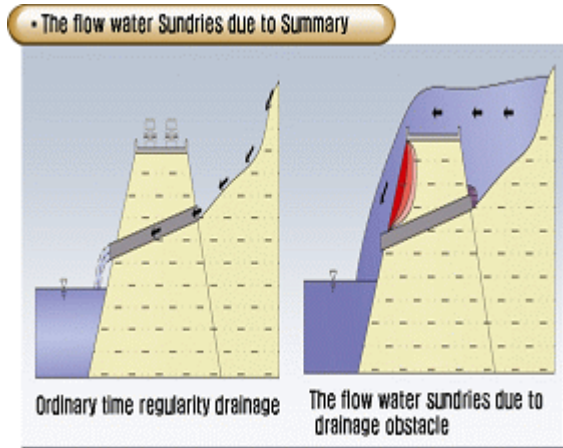
Typical mountainous roads in the region had valleys and slopes on both sides which are connected by crosswise drain pipes to drain water from one side to the other as shown in Figure 13. Damage to these roads was observed after the July 2006 heavy rains. Based on the observations made, it was

concluded that the extraneous materials transported by the water that poured from the valley on the right side blocked the draining function of the crosswise drain pipe and forced the water to flow above the roads. The increased water pressure washed away the roads. Figure 14 shows the damage to the road caused by overflowing water.

**Fig 13. Damage due to flow of extraneous material**

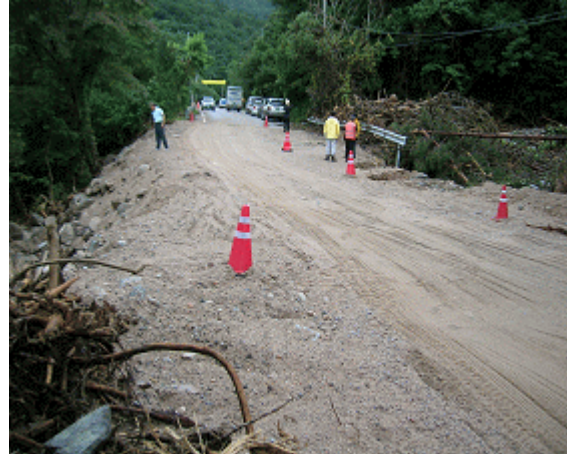
**Fig 14. Damage to a road due to overflowing water**

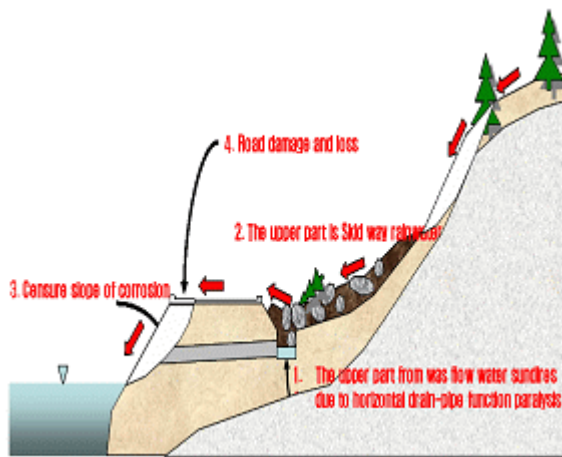
The collapse of the slopes in Gangwon-do region, due to the concentrated heavy rain, occurred mainly in natural slopes, especially the rocks and soil in the valleys. The damaged areas were valley with colluvium that had big rock mass on the rock face, and there were thick forests in the valley. Due to the rainfall, the extraneous materials transported from the upper

part paralyzed the function of the crosswise drain pipe at the lower part of the road, and the concentrated rainfall overflow and eroded the filling part of the road. Figures 15 and 16 show the schematics of damages to roads due to falling of rocks and soil. Figures 17 and 18 show pictures of road failures due to falling of boulders.

**Fig 15. Road breakage by the boulder flow**

- (1) Most of the collapses of the slopes were minor washout of soil. So there were no serious casualties, but the massive loss of rocks and soil that occurred in the valley parts caused the washout of many roads.
- (2) To prevent the repetition of similar damages, it is recommended to develop and improve the breeds of plants that fit the characteristics of domestic atmosphere and apply them to the actual sites.
- (3) It is recommended to set up structures like control dam that can decrease the movement energy of rocks and soil in the places where valleys are formed.

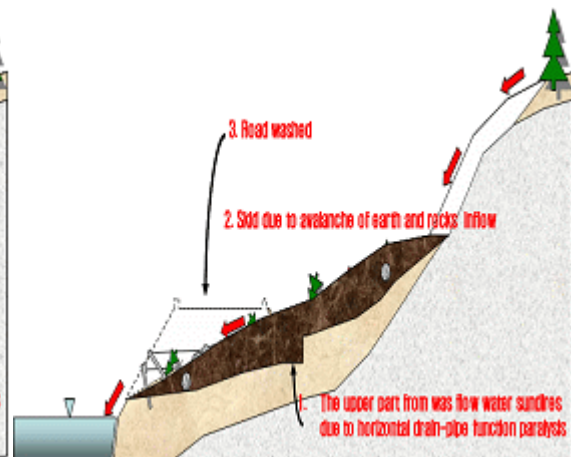
**Fig 16. Road breakage example**

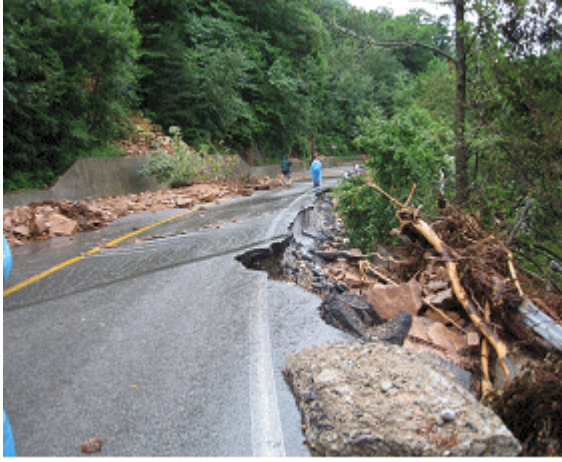
**Fig 17. Loss of road by the boulder flow**

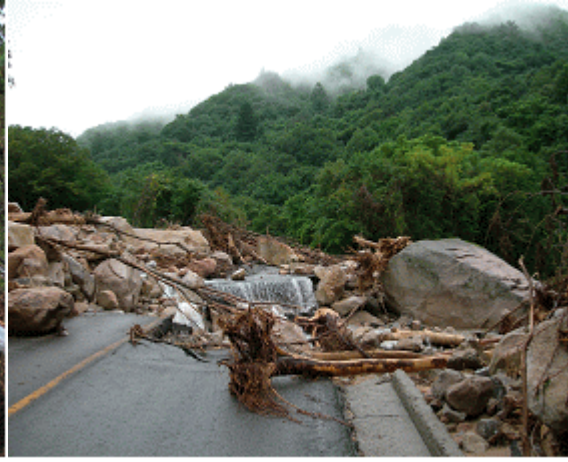
**Fig 18. Loss of road example**
