# An Investigation on Failure of Embankments in Bangladesh

## AN INVESTIGATION ON FAILURE OF EMBANKMENTS IN BANGLADESH

### ABSTRACT

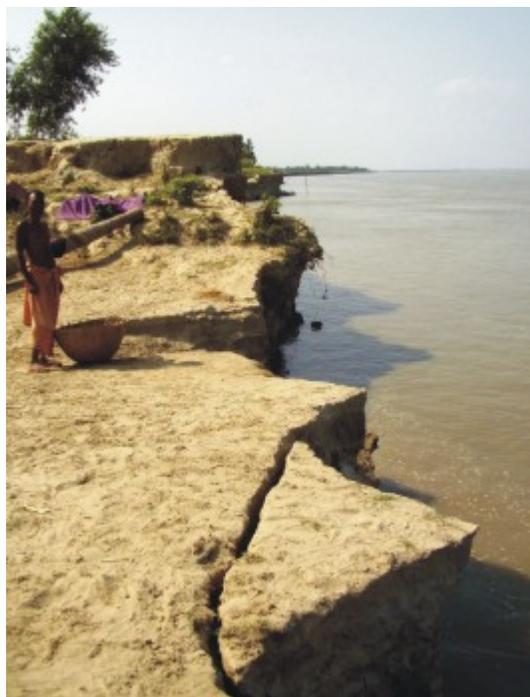
The failure of Jamuna flood control embankment is shown in Fig.3. Over 150000 families have been affected due to the threat of Jamuna right bank flood control embankment at Talukderpara in Shariakandi upazila in May 2007 in Bogura. The daily star on May 2, 2007 reported that the local Union Parishad (UP) member Mr. Shahadat Hossain

Dulal said his house is likely to be devoured within a few days if erosion continues unabated. He said a major portion of the flood control embankment at Talukderpara point would be eroded within a short period if the erosion is not checked immediately.

*Fig.3. Jamuna flood control embankment in Bogura, The Daily Star 2007/05/02*

Local people have apprehended damage of scores of houses. A large number of houses along the embankment eroded last year. The BWDB Sub-Divisional Engineer (SDE) Engr. Zahural Haque said more than 150000 families might be affected in Dhunat and Sharikandi upazila if erosion could not be checked without further delay. If the erosion continues in such a speed the flood control embankment may be washed away within a week. Engr. Zahural Haque said the department already invited a tender to protect the embankment at Talukderpara point. But fund was not allotted timely. A portion of Chandanbaisa hard point eroded last year which had been built to protect Chandanbisa and adjacent areas including part of Talukderpara. But the eroded point was not being repaired due to fund constraint. An amount of Tk 80 lakh is required to repair the hard point while Tk 99 lakh is required to protect the embankment at Talukderpara point.

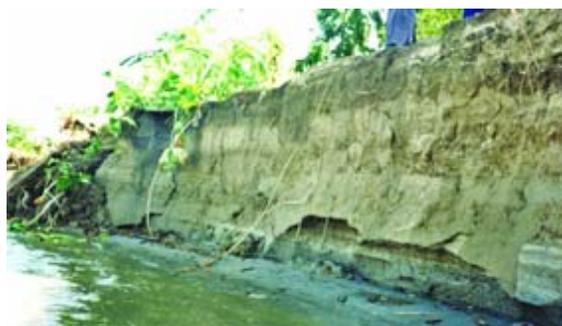
The damage of Padma river embankment at Rajbari is shown in Fig.4. Nearly 50 km Padma river embankment at Rajbari from goalando to pangsar sengram has been damaged in June 2007 due to heavy current of padma river water that flooded and come from upstream part. This beribad at Rajbari was breached in 2004 causing numerous damages of lives and agricultures. Then, huge amount of money was being spent to repair the beribad in 2005 and 2006. It required about Tk.650 lakh for filling, repairing and reconstruction of the embankment. However, because there were lot of fault and complaints in the repair and reconstruction works, this beribad is now in great threat especially in the rainy season. Approximately 60 unions and 14 lakhs peoples within the beribad in Rajbari are passing their days with great fear and danger of flash flood owing to the sudden breach of the embankment. The villages of daulotdia, debgram, ujanchor, ratandia, kalikapur, bbahadurpur, habampur, sawrail, and kasaba as well as thousand of houses and families already destroyed near the Padma bank in just one week due to the thrust of water current.

*Fig.4. Padma river embankment damages at Rajbari., Naya Digonta 2007/06/16*
