Analysis of Problems in Cut Slope Survey and Design Based on Case Studies

ANALYSIS OF PROBLEMS IN CUT SLOPE SURVEY AND DESIGN BASED ON CASE STUDIES

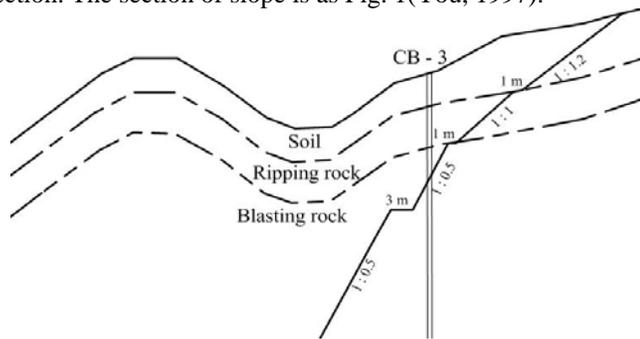
Fig. 1. Slope cross section

Therefore, in application of standard inclination, it has been designed that earth and sand are 1:1.2~1.5, ripping rock is 1:1 and blasting rock is 1:0.5. Installation of berm has been performed installing berm of 3m width at 20 m point from the bottom of slope and berm of 1m width for every 5m of the rest section. The section of slope is as Fig. 1(You, 1997).

In construction by the design, the toppling failure and wedge failure is generated on 4 places due to the development of a fracture zone paralleled with slope on lower part of the slope and by the fracture zone or combination of fragmental zone of fault and joint.

For the cause of slope failure, it is investigated that the slope failure has been generated from development of fracture zone, unexpected at design, on lower part of the slope.

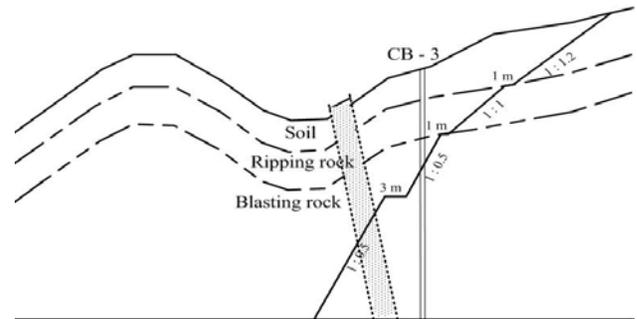
Fig. 2. Relationship between survey location and depth
CASE STUDY 2

First, at planning soil investigation, it could not consider the topographical characteristic (fault topography) indicating that strike-slip fault growing parallel with route has been developed. Second, while the investigation has been executed down to 1.0m of design height of slope to cut, the depth of boring investigation could not meet the requirements of investigating position and toppling failure.

Finally, since topographical characteristic could not be considered, the position of boring investigation and horizontal direction of elastic wave exploration are inappropriate.

Therefore, the way of resolving these problems is to set the position of boring investigation and the horizontal direction of geophysical exploration at planning soil investigation fully reflecting the result of preliminary investigation and to increase the depth of drilling investigation properly to satisfy the geological condition of toppling failure (Fig. 2). The inclined boring is also a recommendable method.

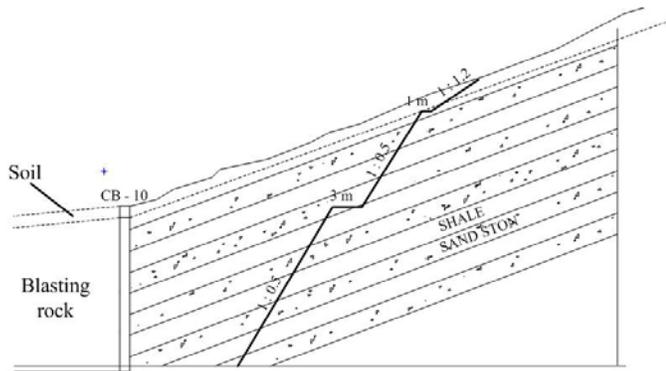
Fig. 3. Slope cross section

Therefore, in application of standard inclination, it has been designed that earth and sand is 1:1.2, ripping rock is 1:1 and blasting rock is 1:0.5. Installation of berm has been performed installing berm of 3m width at 20 m point from the bottom of slope and berm of 1m width for every 5m of the rest section. The representative section of slope is as Fig. 3.

As a bedding plane with narrow uncemented clay layer between sand stone layer and shale layer in the lower part of the slope has been developed during the construction, a large scale plane failure has been generated along with vertical joint performing a role of tension cracking.

For the cause of this slope failure, it is shown that the slope failure has been generated from development of uncemented clay layer, unpredicted at design, in narrow existed bedding plane, and from increase of sliding force and decline of shear strength of ground by rainfall.

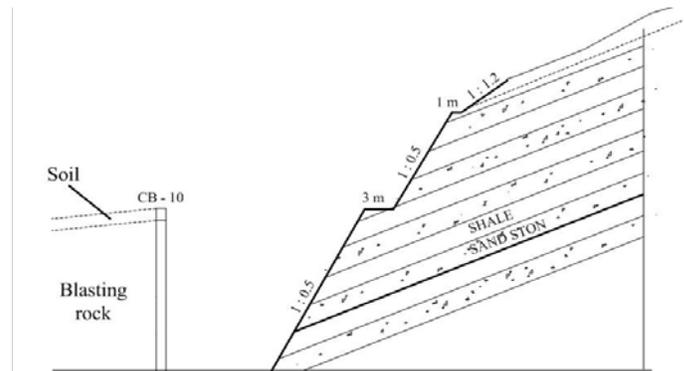
Fig. 4. Relationship between survey location and depth

First, at planning soil investigation, it could not consider the characteristic of bedding (stratification) that is a feature of sedimentary rock developing paralleled with route.

Second, the depth of boring investigation has been performed to 1.0m down of design height of slope to cut, regardless of satisfying the position of investigation and geological condition of plane failure.

Therefore, the way of improving these problems is to select the position of boring investigation with fully reflecting the result of preliminary investigation at planning soil investigation and increase the depth of drilling investigation properly to satisfy the geological condition of plane failure (Fig. 4).

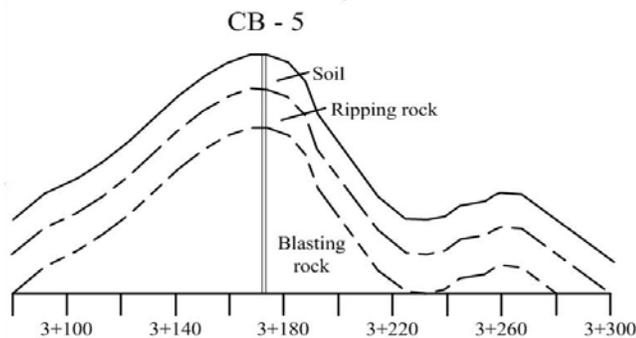
Fig. 5. Layers conditions (design)

Constituent rocks are black mica and granite; the earth and sand (weathered- residual soil) are distributed in a layer of 5.5m from the ground, 4.0m of the ripping rock distributed in its below and 9.5m of blasting rock in the lower part (Fig. 5). N value of earth and sand is 18 times/30 cm ~ 50 times/13 cm that indicates a relative density from middle to high dense, and unified classification is resulted to classify as SM. It has been estimated that the unconfined compressive strength of rock is 765~1210 kg/cm², TCR is 73~95%, RQD is about 35~90%, and it comes under III-IV class in the result of Rock mass classification system by RMR.

From the result of face mapping, the safety of slope could not be evaluated by stereographic projection method, as the discontinuity could not be investigated due to absence of outcrop development and fine growth of vegetation.

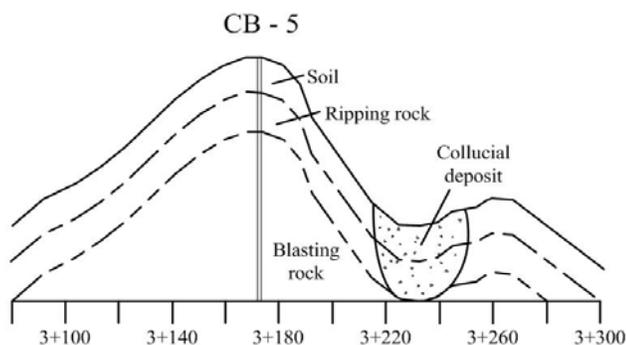
Fig. 6. Layers conditions (construction)

As the following Fig. 6, the collucial deposit is distributed with 8.5m thickness in valley part, a circular failure has been generated during construction (slope inclination 1:1.5).

For the cause of slope failure, it is reviewed that the slope failure has been generated from development of collucial deposit, unpredicted at design, on valley part, and pore water pressure and increase of sliding force by rainfall.

First, the face mapping has not been performed properly as, at planning soil investigation, it could not consider the geological characteristic (gentle slope) showing that collucial deposit was growing.

Second, the item and position of soil investigation have not been appropriate. In other words, the test pit investigation has been performed only at maximum cutting section and a hand auger boring has not been performed at valley part of cutting block.

but the constituent factor of the layer (residual soil and collucial soil), i.e. a significant influence factor, has not been considered. Therefore, the way of resolving these problems is that directional set, terms and position of soil investigation should be determined by fully reflecting the result of preliminary investigation at planning soil investigation. In other words, the investigation of face mapping should be executed as; examining the distribution of collucial deposit; in accordance with the result of the examination, performing test pit investigation, hand auger boring, or etc. even in valley part; and seizing the distribution characteristic of collucial deposit.

The design standard of cut-slope should set an adequate standard inclination (over 1:2.0) by adding constituent items of the layer that is a primary factor affecting the safety of slope.
