# Rapid Recovery of Demolished Young-Dong Highway 205.4km Due to Heavy Rain

## RAPID RECOVERY OF DEMOLISHED YOUNG-DONG HIGHWAY 205.4KM DUE TO HEAVY RAIN

### ABSTRACT

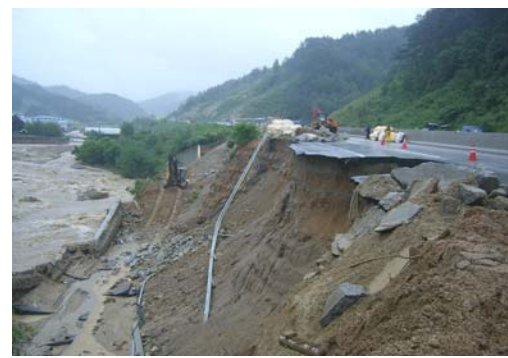
Walljeong stream has a small water volume except the rainy season, but heavy rainfall in the rainy season scoured the ground below concrete retaining walls, and retaining walls were overturned. A lot of water smeared into the embankment, and the two westbound lanes at 205.4km from west end of Yong-Dong highway contact on the stream were demolished. A sharpened S-shape flow line was detrimental to stability of the embankment. Length and maximum height of overturned concrete retaining walls were 114m long and 8m high, respectively. The lost soil amount of the embankment was about 19,000m<sup>3</sup>, and length of broken asphalt concrete pavement was 72m. Pic.1 shows the overturned concrete retaining walls, the broken asphalt concrete pavement, and guardrails. Pic.2 shows S-shape line of water, which flows turbulently and some equipment try to recover the destroyed highway just after the accident.

Pic.1 Destroyed embankment

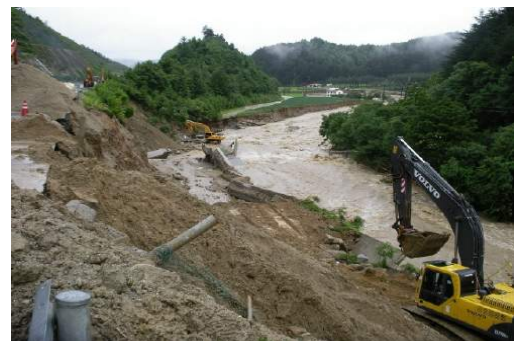
Pic.2 S-shape flow line

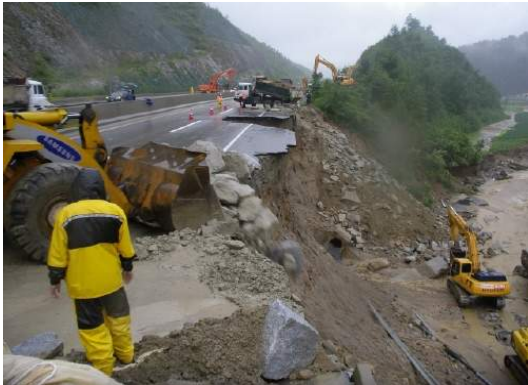
Pic.3. Dropping rocks

In Korea about a half of rainfall a year comes for the rainy season. KEC has an obligation to recover the highway rapidly to provide a convenient travel to South Korean people. To get rid of possibility for fast flowing water to scour the embankment, we changed the flow line by removing the deposit area of the other side, and dropped big rocks whose diameters are over 1m to compensate the lost

embankment without compaction. Pic.3 shows the scene dropping rock.

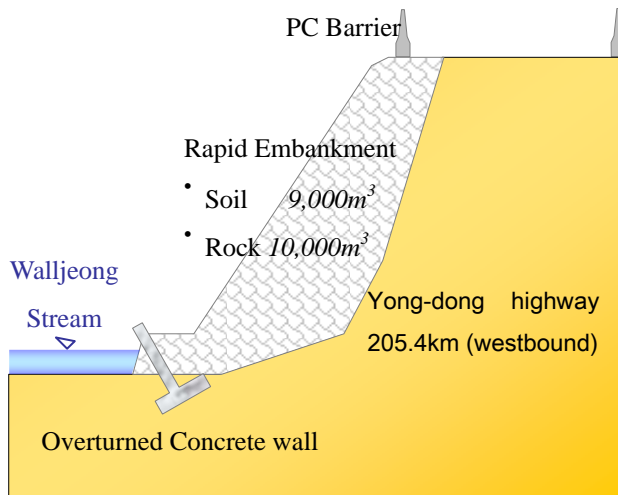
Fig.5 Schematic drawing of rapidly constructed embankment

To prevent the further overturning of the concrete retaining walls a lot of rocks were deposited in front of them. Fig.5 shows a schematic drawing of the rapid recovery. Some soil was put below a subbase of an asphalt concrete pavement.

We checked stability of the rapidly constructed embankment with Modified Bishop Method by SLOP/W 3.0. Table 1 shows values of unit weight, friction angle and cohesion to check stability of the embankment. A minimum safety factor was 1.4, and it satisfies a minimum value, 1.3, of South Korea slope design specification (KISTEC, 2006)

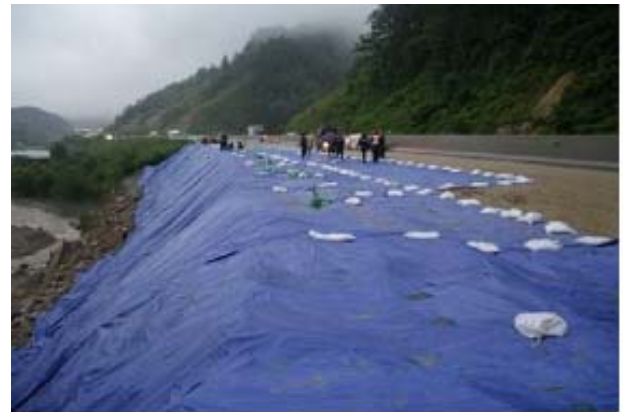
Pic.4 Vinyl mat was covered on the embankment

We also could check the stability of the rapidly constructed embankment by driving heavy vehicles on it. After making the embankment, a big vinyl mat was covered on it to prevent the embankment from washing out as Pic.4. Asphalt concrete pavement was made on the recovered area just after rain stopped. It took only two days to recover the demolished embankment and additional two days to pave the damaged highway with asphalt concrete.

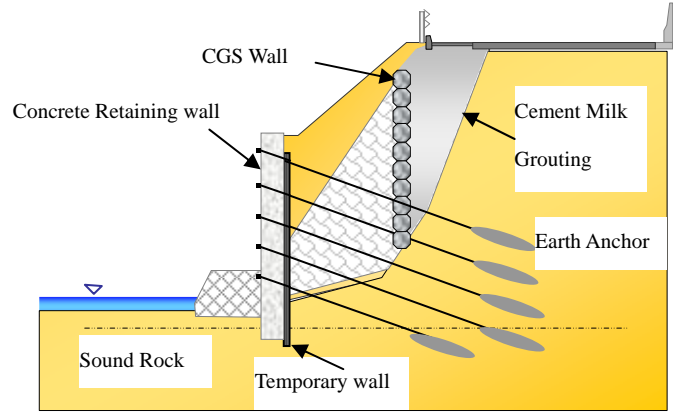
*Pic.6 Concrete retaining wall and earth anchor*

The rapidly constructed embankment that was consisted of big rocks had a lot of voids, and it could make upper soil fall down through them. The subbase below asphalt concrete pavement had resistance because of arching effects in a short period, but in the long run it could not resist the pavement and traffic load. To prevent pavement from losing subbase material through a lot of voids, we decided to make a wall with compaction grouting system (CGS), which has a role to prevent cement grout milk from leaking out though the voids and is grouting method with cement paste, and then grout the whole area recovered by rocks. The grouting was done at many points with low pressure to escape the disturbance from the high pressure. The foundation of the concrete wall was installed from 1m below sound rock to get rid of any possibility to be scoured considering 100-year flood. In South Korea L-type concrete retaining wall is common, but concrete wall and earth anchor were chosen in this case. The reason is that if the base of L-type retaining wall is constructed, a large excavation will be made and it will hurt the embankment. To escape the disturbance of the highway and deformation of the pavement, temporary retaining wall and earth anchors were installed before constructing the concrete retaining wall. A size of H-pile for the temporary wall is 250x250x9x14 mm, and it was driven at every two

meters. Every earth anchor is installed at 20 degrees from horizontal line in one to six layers and length of anchors is from 12m to 24m including 6m bonded length. Design tensile forces of anchors are 5.1 ~ 24.0 ton. They are calculated in every cross section by EXCAV/W, which is for a temporary retaining wall design and back analysis program. During constructing the temporary wall some tilting gages were installed on H-piles, and the deformation of H-piles was monitored. We could check stability of the temporary retaining wall during construction through reviewing the measured data from them. Pic.5 shows the temporary retaining wall under construction. Pic.6 shows the concrete wall whose thickness is 1m was made in the front of the temporary wall and the anchor was extended. Fig.6 shows a schematic drawing of permanent recovery works. It took about four months, from August 14<sup>th</sup>, 2006 through December 16<sup>th</sup>, 2006, to complete permanent recovery works. Several cracks were found in the pavement of westbound and eastbound lanes due to deformation of the rapidly repaired embankment before grouting it with cement milk. Cracks of the eastbound lanes mean that deformation of rapidly recovered embankment was transmitted. The depths of cracks were very deep, and it indicated the cause of cracks was deformation of the embankment. Pic.7 shows cracks in the westbound pavement, and Pic.8 Shows cracks in the eastbound pavement. Table 2 shows the recovery work schedule.

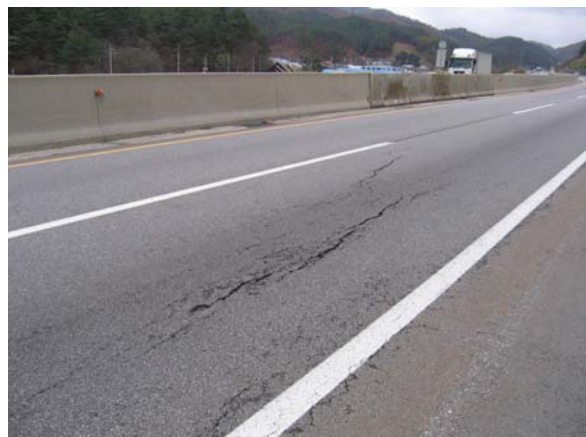
*Pic.7 Cracks of the westbound lane pavement*
