Rehabilitation of Sliding Motorway Slopes on Deep Failure in Bulgaria

Chavdar Vassilev Kolev

"Perikal 2003" Ltd., Sofia, Bulgaria

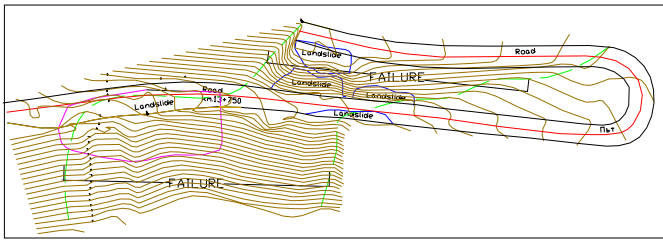
Fig.1: Situation at km.13+750

The sliding is part of an ancient landslide circus, which reaches the erosion base of the river at the foot of the slope (*Fig.1*). The uncovered layers along the steep inner slope consist of uneven alternations of decayed marls and cracked sandpits. The layers are tilted towards the slope. Once the

maps were prepared, and drainages and geophysics profiles were made, we found out that the broken culvert is located within a zone of tectonic movement with amplitude up to 0.5-1.0 m. An erosion gully was formed along it, which was filled with rubble and talus cover. The zone is wide 18 m. On the side of the fault the road is on the natural steep profile of the slope. The thickness of the talus layer starts at zero at the inner slope and reaches 5.5 m at the outer road lay-by. Under the diluvia is located the decaying zone of the rock padding, which has a variable thickness. In the drainage we have made along the axis of the gully, the zone is represented by cracked and decayed rock and marl materials with maximum thickness of 2.0-2.5 m. To the left and right of the axis of sliding the decaying zone gradually becomes shallower.

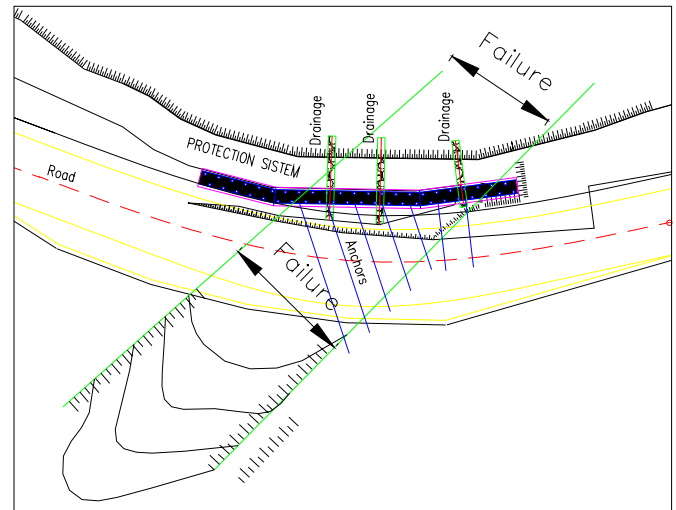
Fig.3. Situation of the protection at km.89+383

The geological cross-section of the slope is represented by dust clay with fragments of marl, decayed marl with layers of clay, and a base of alternating at each 20-30 cm sandstones, marls and alevrolits. The sliding has developed in the clays. The main sliding surface is along the contact with the rock padding. A considerable part of the road embankment has slid. The road lane has sunk about 2.50 m and has moved horizontally nearly the same distance. The depth of the main sliding surface in the zone of the road is from 6 m to 9 m (Fig.3).

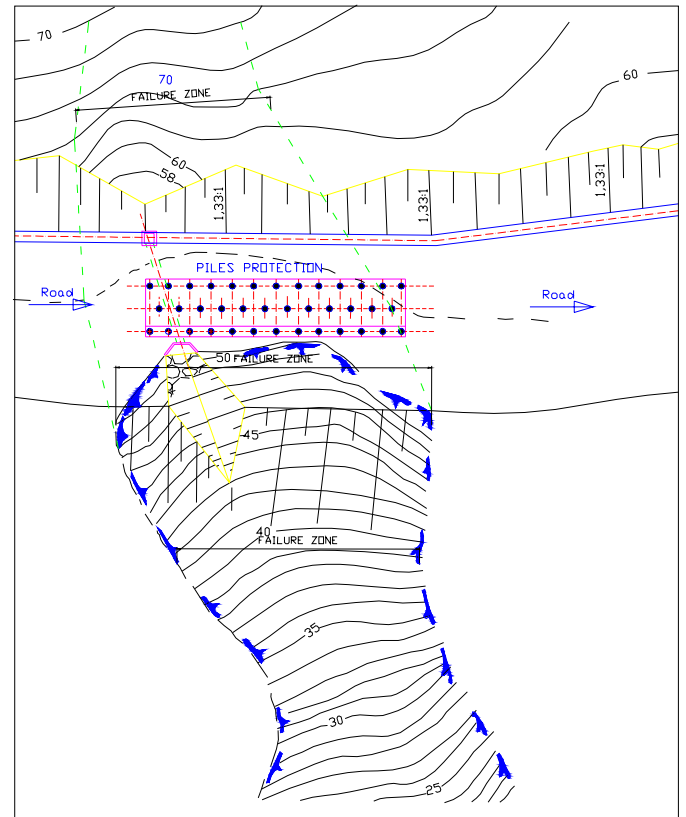
Fig.6. Situation of the protection near Bosna village

The road is situated in a steep Northern slope (Fig.6). It is parallel to a small river, which is located at the heel of the slope, more than 30 m below the elevation of the road. At this

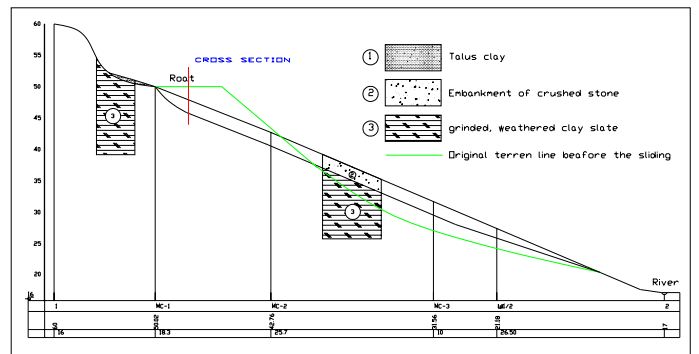
Fig.7. Cross section of the failure near Bosna village

Therefore, the rock base in the fault section is hidden along its whole vertical profile. Water is constantly concentrated there and forms a steep depression curve, joining the river at the heel of the slope (Fig.7). The disconnected fractioned rubble, used to construct the road embankment, slid under the influence of the hydrodynamic pressure, caused by the infiltrated waters from heavy rainfalls during the period of the spring snow melting. When uncovering the rock base in the fault section at a depth of 6 m and more, it turned out that its density is not higher than that of the surface (Fig.8). This fact is an additional proof of the existence of a fault. At the two ends of the damaged section one could clearly notice the transition to monolithic rock along the sides of the fault.
