Analysis of a Group of Failing Retaining Walls and Remediation Measures

Sami Arsoy
Kocaeli University, Kocaeli, Turkey

ANALYSIS OF A GROUP OF FAILING RETAINING WALLS AND REMEDIATION MEASURES

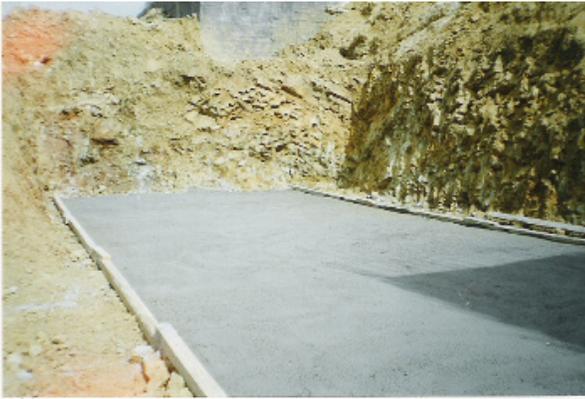
a) Foundation excavation

Foundation soil was graywacke throughout the site as can be seen in Fig. 1.a. No laboratory testing was conducted for the site soils. However, Graywacke is an unweathered rock and it can be described as cemented with usual strength of medium (8000 psi or 50 MPa) to very high (over 32000 psi or 200 MPa) according to Peck et al. (1974).

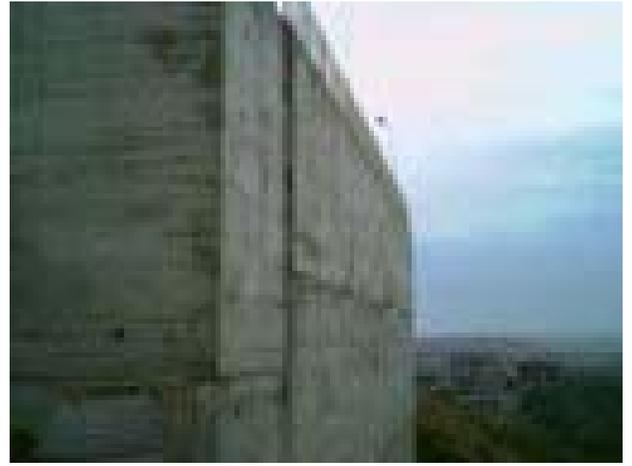
Wall type 23 was 8,3 meters high, wall type 30 was 16 meters high, and wall type 41 was 9,4 meters high as shown in Figs. 2 through 4. The primary displacement mode of the wall type 30 was translation. Wall type 23 and 41 had combination of rotation and translation. The maximum wall displacements observed was about 10 cm.

Fig. 2. Picture of failing wall type 30.

Instead of micro piles, a shear key out of reinforced concrete could be constructed just in front of the walls and it could be anchored to the foundation of the existing walls in order to increase the sliding resistance. This alternative was perfectly suited to wall type 30 because the sliding safety was of primary concern. Hence, it was successfully implemented.

After the causes were identified the factor of safety of the failing walls were significantly improved by using the combination treatment of backfill replacement and base enlargement for wall types 23, 41 and alike and by using post-construction shear key for wall type 30 and alike. Measures for drainage improvement were also taken. The remedial measures were successful and cost effective. This case will serve as a good example of frequently observed poor geotechnical practice but superior structural practice.

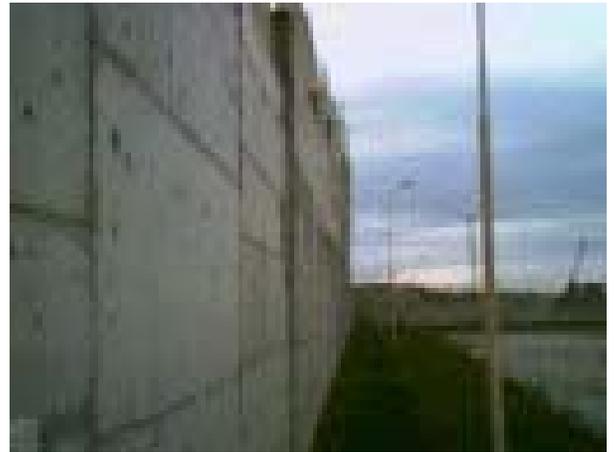
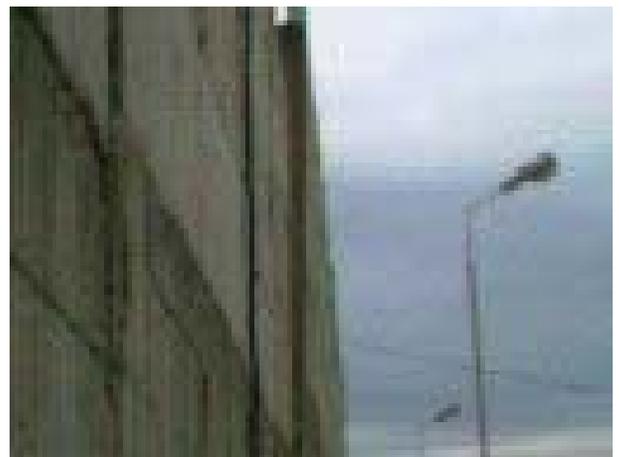
Fig. 3. Pictures of failing wall type 23.

As Table 1 shows, wall type 23, 41 and likes suffer from low factor of safety values for both sliding and rotating. Enlarging the base would improve both values and could be done on either side of the base. It has been decided to enlarge the base on the backfilled side for wall types 23 and 41 and since the existing backfill has to be removed, backfill replacement with clean sand had also been used.

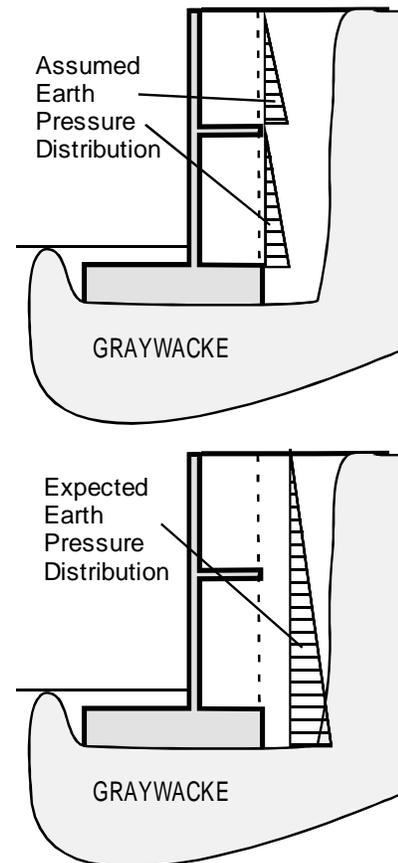
The documents reviewed showed that lateral earth pressures for the walls with a middle console had been calculated erroneously. Design engineer had assumed that the lateral earth pressure just beneath the middle console starts from zero as shown in Fig. 6. This method of calculation may be acceptable for the material design of the walls. The existence of middle console cannot reduce the total lateral load because the backfill extends significantly away from the inner side of the wall.

Fig. 6. Assumed and expected earth pressure distributions

6. Engineering errors were made on calculation of earth pressures. For walls with a console in the middle, the designer had assumed that earth pressures for the lower portion of the wall starts from zero at the console independent of the soil above it.

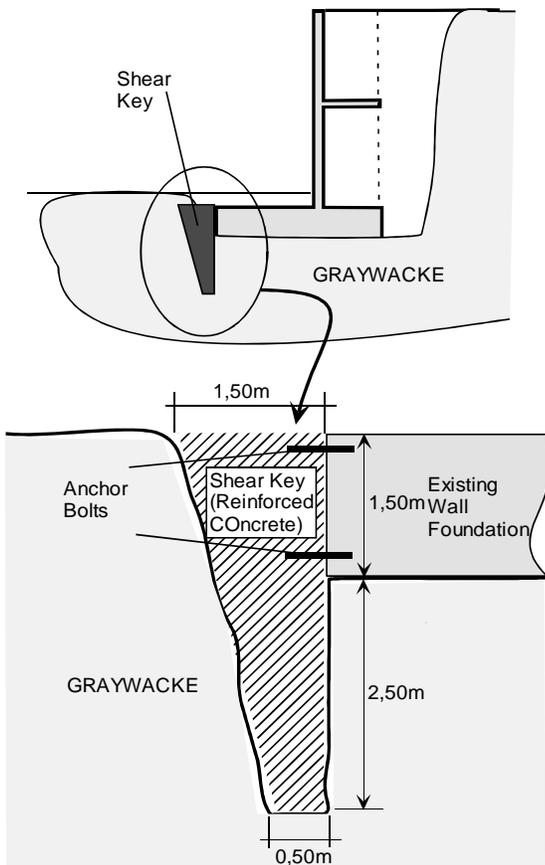
Fig. 7. Adding Shear Key in front of Wall
Drainage Improvement
