Analysis of a Group of Failing Retaining Walls and Remediation Measures

Sami Arsoy

Kocaeli University, Kocaeli, Turkey

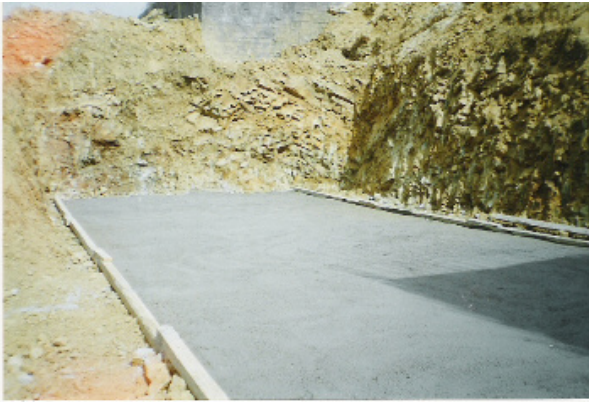
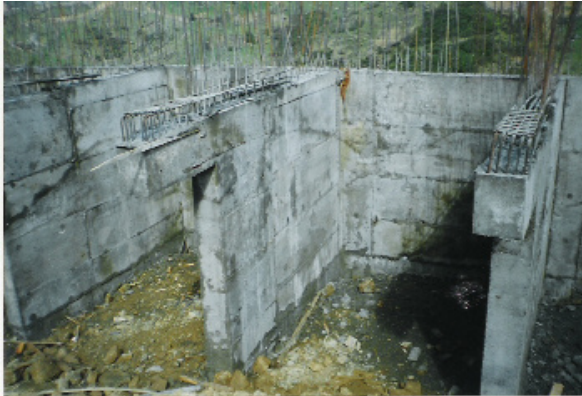
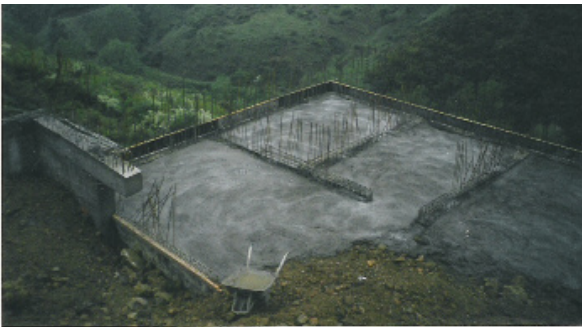
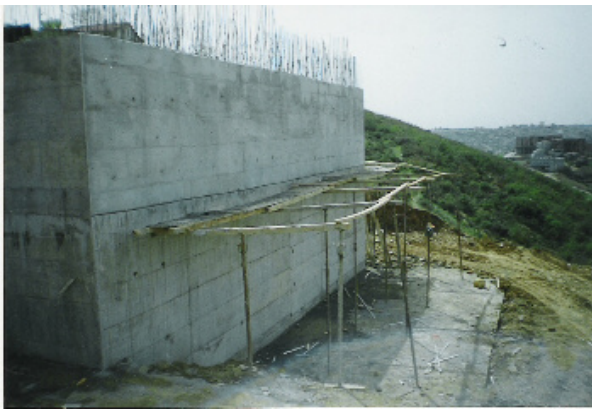
Fig. 1. Construction of wall type 30.

The contractor had documented construction stages well. Wall types fall into two categories: standard cantilever made out of reinforced concrete such as Walls 23 and 41 and cantilever with a console in the middle such as Wall 30. Pictures taken during construction stage of Wall Type 30 are shown in Fig. 1.

Foundation soil was graywacke throughout the site as can be seen in Fig. 1.a. No laboratory testing was conducted for the site soils. However, Graywacke is an unweathered rock and it can be described as cemented with usual strength of medium (8000 psi or 50 MPa) to very high (over 32000 psi or 200 MPa) according to Peck et al. (1974).

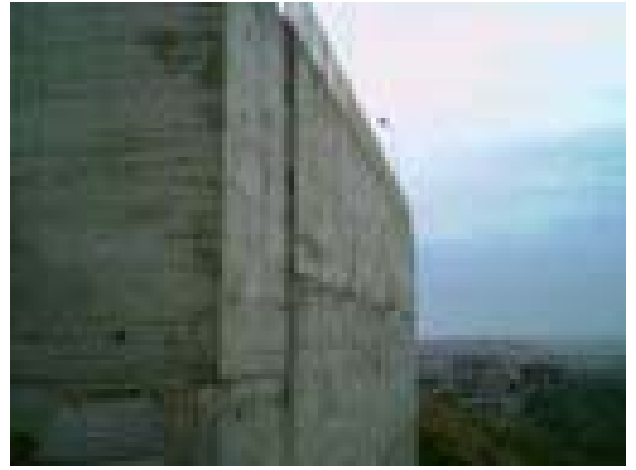
Fig. 2. Picture of failing wall type 30.

Wall type 23 was 8,3 meters high, wall type 30 was 16 meters high, and wall type 41 was 9,4 meters high as shown in Figs. 2 through 4. The primary displacement mode of the wall type 30 was translation. Wall type 23 and 41 had combination of rotation and translation. The maximum wall displacements observed was about 10 cm.

The results of the analysis supports the field observations that displacements for wall type 23, 41 and like were mostly rotational and sliding and for wall type 30 and like were mostly translational. It was concluded that the reason of the excessive movements was because the walls were near failure. In other words, the walls were actually failing slowly and eventually a total failure was inevitable unless remedial measures were taken.

Instead of micro piles, a shear key out of reinforced concrete could be constructed just in front of the walls and it could be anchored to the foundation of the existing walls in order to increase the sliding resistance. This alternative was perfectly suited to wall type 30 because the sliding safety was of primary concern. Hence, it was successfully implemented.

After the causes were identified the factor of safety of the failing walls were significantly improved by using the combination treatment of backfill replacement and base enlargement for wall types 23, 41 and alike and by using post-construction shear key for wall type 30 and alike. Measures for drainage improvement were also taken. The remedial measures were successful and cost effective. This case will serve as a good example of frequently observed poor geotechnical practice but superior structural practice.

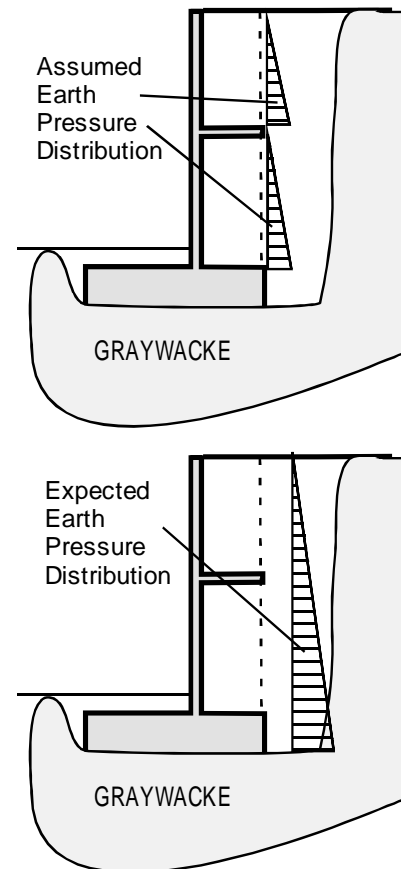
Fig. 6. Assumed and expected earth pressure distributions

The documents reviewed showed that lateral earth pressures for the walls with a middle console had been calculated erroneously. Design engineer had assumed that the lateral earth pressure just beneath the middle console starts from zero as shown in Fig. 6. This method of calculation may be acceptable for the material design of the walls. The existence of middle console cannot reduce the total lateral load because the backfill extends significantly away from the inner side of the wall.

6. Engineering errors were made on calculation of earth pressures. For walls with a console in the middle, the designer had assumed that earth pressures for the lower portion of the wall starts from zero at the console independent of the soil above it.
