Failure of Retaining Structures in Town Lezha and their Consequence in Neighbouring Building

FAILURE OF RETAINING STRUCTURES IN TOWN LEZHA AND THEIR CONSEQUENCE IN NEIGHBOURING BUILDING

Luljeta Bozo

Civil Engineering Faculty
Tirana Polytechnics University, Albania

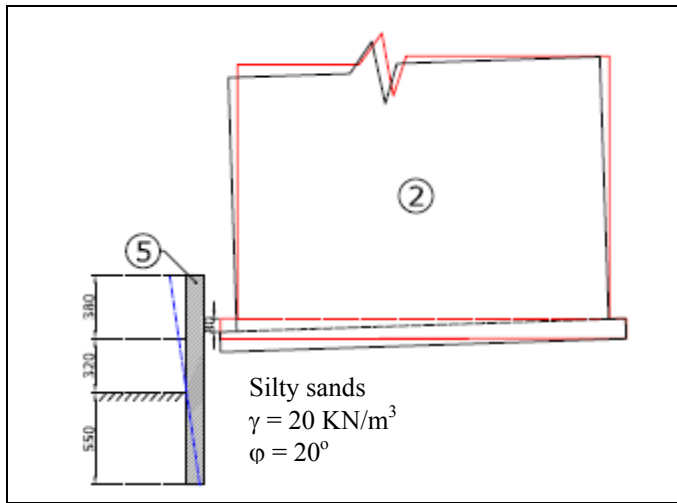
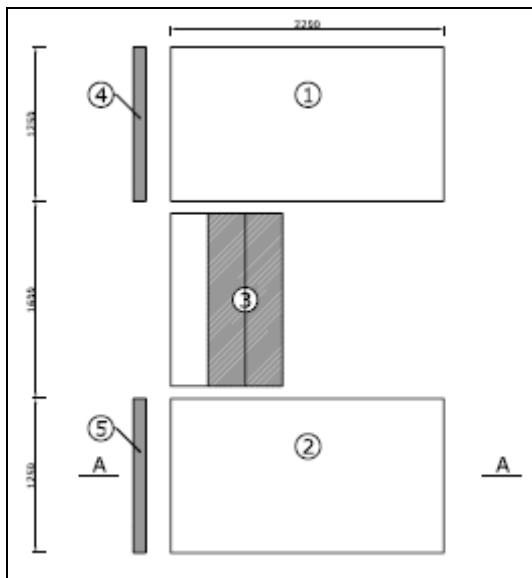
Fig. 2. a. Cross section A-A

Closed to eight floors buildings with mat foundation, which are situated on 3.8m deep from natural surface, was realized the retaining structures (concrete wall) with dimension lengths 12m and depth 12.5m (each of them). The concrete walls were constructed for new buildings for two underground floors (Fig.2). During the processes of excavation (when was arrived 3m down a mat foundation of existing building) the concrete wall was revolved and it had damage to caused in the existing mat foundation dangerous settlement. The settlements are not stabilized during the time; therefore they arrived up to 8 cm near to excavation and 1cm at other side of building. During all the time of excavation it was pumped water from the hole. After 5-7 days by settlements, the inclination of existing mat foundation arrived tag $\theta = 0.0035$ very dangerous value because of the allowable limit is $\text{tag}\theta_{\text{limit}} = 0.0040$.

- 1, 2 - eight stories buildings
- 3- Two stories buildings
- 4, 5 – concrete walls H=12.5m

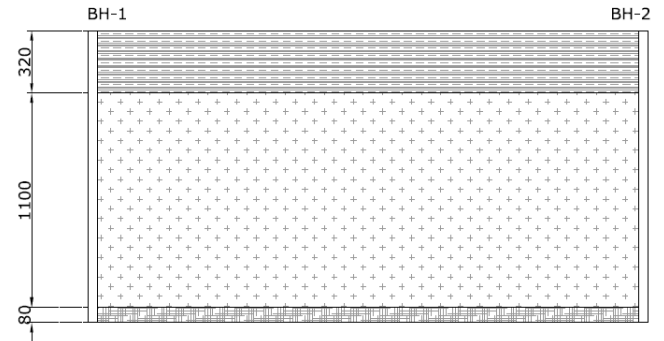
Fig. 3. Lithological profile of investigated site

Initially we have realized some new bore holes to clarified the geological situation and to determinate the exactly the geotechnical properties of soils. From bore holes results the geological profiles consist from three layers (Fig. 3) and underground water table is 1-1.3m deep of natural surface.

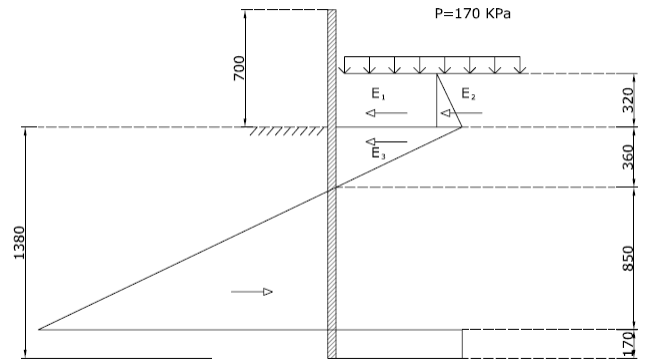
Fig. 5. Sheet pile walls and earth pressure diagrams ($E_1=308$; $E_2 = 55$; $E_3 = 205$).

After our calculation to consider the concrete wall as sheet pile wall (cantilever pile) and to report (refer) a new geological profile and new soils properties (Fig. 5) results that: The necessary depth fixation concrete wall was 5.5m.

In consequence the concrete wall is unstable.

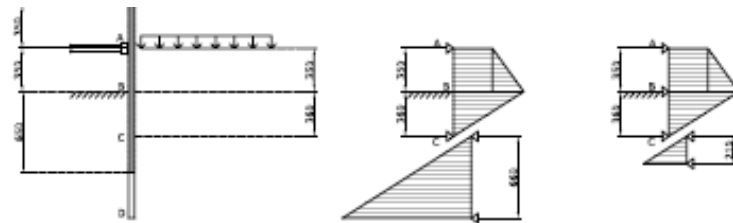
Fig. 8. The scheme of second sheet pile wall with one and two support.

For the second concrete wall (4), where it is not coming the excavation we have executed (accomplished) a reconstruction. We have conceived this retaining structure as anchored sheet pile wall or with support. On the first phase we can to excavate until 3.5m depth from natural surface and we can to put the first support. Then we can continue excavation until 7.0m depth. The real fixed depth of concrete wall was 6.5m . From our calculations this depth is insufficient for the stability

of retaining structure. The necessary length of concrete wall will be 13.7m (Fig. 8).

So, it is necessary to put the second support (Fig. 8b) to insured a resistible retaining structure. The second support shall to put in the bottom of the hole. On second phase, when we can realized the mat foundation of new building, which transmits in the basements 130 kPa pressure we can to take off the supports and in conditions the necessary fixed depth of retaining structure will be 3.5m (Fig. 9).
