A Case Study on Rectification of Damaged Structures on Expansive Soil Deposits

A CASE STUDY ON RECTIFICATION OF DAMAGED STRUCTURES ON EXPANSIVE SOIL DEPOSITS

This article presents the details of case study regarding rectification of damaged structures on expansive soil deposit at Anta (Rajasthan State, India). The problem faced at the gas power project township at Anta during 1995 was that, a large number of structures, which were constructed just about 4 to 6 years earlier, started exhibiting damages of varying degree. The concerned authority referred this problem to author for suggestions and recommendations to salvage/rectify these distressed structures. It was noticed during inspection that the nature and pattern of damages clearly represented typical of distress due to presence of expansive soil deposits underneath. The methodology of approach to investigation, tests conducted remedial measures and their implementation and other relevant aspects are presented and discussed in the subsequent sections.

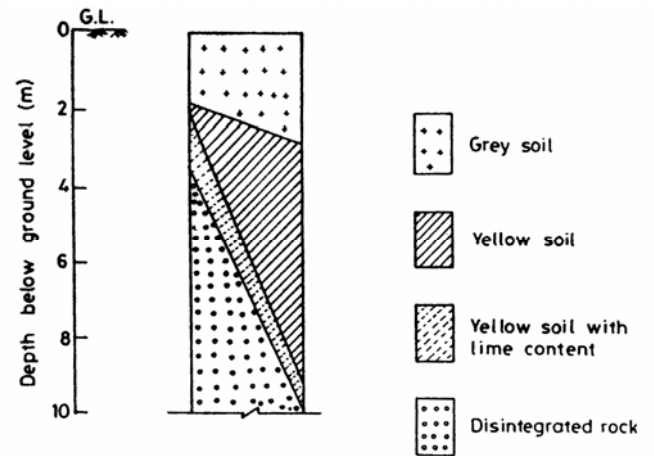
Fig. 2. Generalised subsurface profile representing the area.

(shale) as shown in Fig. 2. The report also points out that both the grey soil forming the top layer and the yellow soil beneath are of swelling type. Based on this, for the present investigation boreholes were drilled to such a depth so as to penetrate into both these soil layers at each location.

Generalised subsurface profile of the area was prepared by synthesis and compilation of available data from the site investigation report and other reliable sources. Figure 2 illustrates such a generalised subsurface profile, which represents almost all the zones/areas where these (distressed) structures were constructed. The top soil stratum comprises of grey coloured silty clay varying in thickness from 1.75 m to 2.8 m. It is underlain by yellow coloured silty clay extending down to a depth from 1.75 m to around 9 m below ground level. Below this yellow silty clay, there is a layer of yellow soil, which exhibits presence of small size lime nodules. This yellow soil is underlain by disintegrated rock
