A Case Study on Rectification of Damaged Structures on Expansive Soil Deposits

J. M. Kate

Indian Institute of Technology, Delhi, New Delhi, India

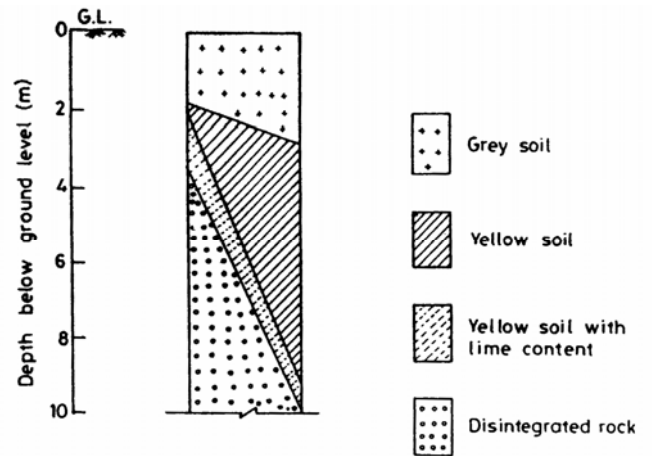
Fig. 2. Generalised subsurface profile representing the area.

(shale) as shown in Fig. 2. The report also points out that both the grey soil forming the top layer and the yellow soil beneath are of swelling type. Based on this, for the present investigation boreholes were drilled to such a depth so as to penetrate into both these soil layers at each location.

Generalised subsurface profile of the area was prepared by synthesis and compilation of available data from the site investigation report and other reliable sources. Figure 2 illustrates such a generalised subsurface profile, which represents almost all the zones/areas where these (distressed) structures were constructed. The top soil stratum comprises of grey coloured silty clay varying in thickness from 1.75 m to 2.8 m. It is underlain by yellow coloured silty clay extending down to a depth from 1.75 m to around 9 m below ground level. Below this yellow silty clay, there is a layer of yellow soil, which exhibits presence of small size lime nodules. This yellow soil is underlain by disintegrated rock

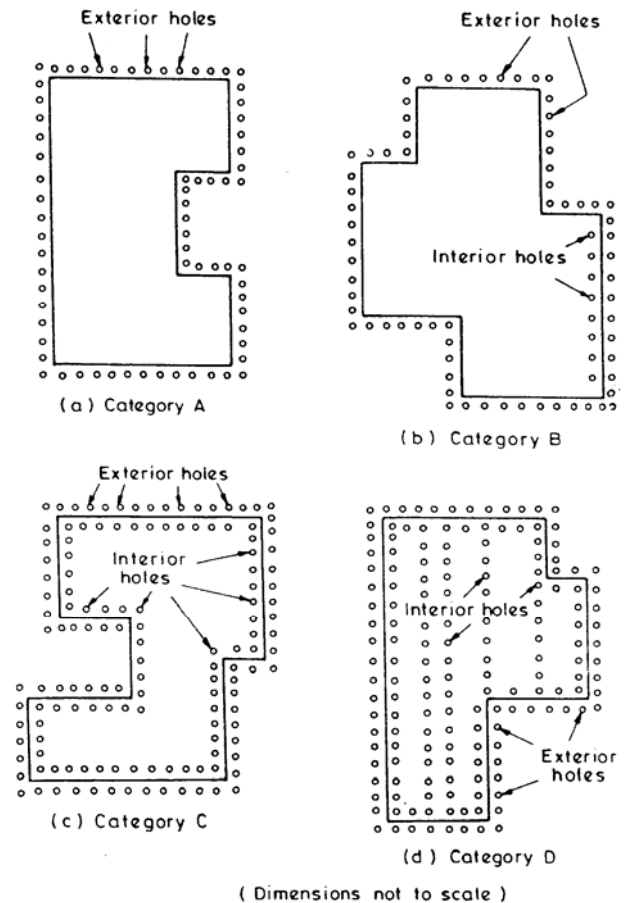
Fig. 3. Schematic arrangement of injection holes for various category of damages.

In order to adopt suitable pattern of injection holes for LSPI application, the damaged buildings depending upon the seriousness of their distress have been broadly categorized as A,B,C and D with the following descriptions.

Category A – Lightly damaged: Minor cracks on the walls extending to short lengths with no visible damage to the floors.

Category B – Moderately damaged: Fairly wide cracks on the walls extending to considerable lengths, with or without visible/minor damage to the floors. One side of the building exhibiting light damage whereas, other side showing moderate to heavy damage.

Category C – Heavily damaged: Very wide cracks in the walls everywhere extending to considerable lengths and heights with visible damages and distortions in the floors.

Category D – Extensively damaged: The distress is widespread throughout the building as evidenced through severe horizontal, vertical and diagonal cracks in the walls extending from floor to ceiling level, heavy crackings in joints of structural members, sinking and considerable distortions in the floors.

Auger holes of 50 mm dia. spaced between 0.5 m to 1.0 m were drilled all around the damaged structures following a pattern based on their shape, size and extent of damages. These holes were drilled to substantial depth ensuring penetration down into constant volume zone or at least to a depth of 1 m below the base of existing footing/under-ream bulb. The preliminary estimate indicated the depth of constant volume zone to be around 1.7 m within yellow soil below its surface. The line of such holes was kept as close to the outer edge of footing/under-ream bulb as practicable. This arrangement of drilling exterior injection holes all around the

structure was common for all the four categories of damages. The schematic arrangement of such injection holes are illustrated in Fig. 3 (a to d) for structures with different degree of distress.

The side(s) of building which exhibit(s) more damage in case of Category B, additional holes were drilled inside the building on damaged side by removing floor slab and the line of such holes kept as close as possible to the inner edge of the footing/under-ream bulb (Fig. 3,b). Similar lines of interior holes were drilled inside the entire building for both the category C and D buildings (Fig. 3, c and d). In addition, for category D, such injection holes were drilled in the central portion encompassing the damaged floor area (Fig. 3,d).
