Investigating Failure of a Geosynthetic-Reinforced Soil Wall in Black Hawk, Colorado

INVESTIGATING FAILURE OF A GEOSYNTHETIC-REINFORCED SOIL WALL IN BLACK HAWK, COLORADO

Approximately 18 months after construction, an 11-m high rock faced Geosynthetic-Reinforced Soil (GRS) wall was found to suffer from subsidence of about 100 mm on the crest, along with rocks being dislodged from the wall face from time to time. In the ensuing three months after these signs of problems were first detected, the subsidence on the crest of the wall increased to about 250 mm with significant lateral bulging on the wall face. The wall comprised two sides. The problems occurred primarily on one side of the wall; while the other side showed little distress. The entire wall eventually had to be demolished and reconstructed. Prior to reconstruction, a forensic program was undertaken and analyses were performed to examine the causes of failure. This paper describes the geometry and properties of the wall, the events leading to failure of the wall, and the post-failure analysis. It was concluded that the failure likely stemmed from two causes: (1) poor compaction of the fill in harsh winter weather during wh

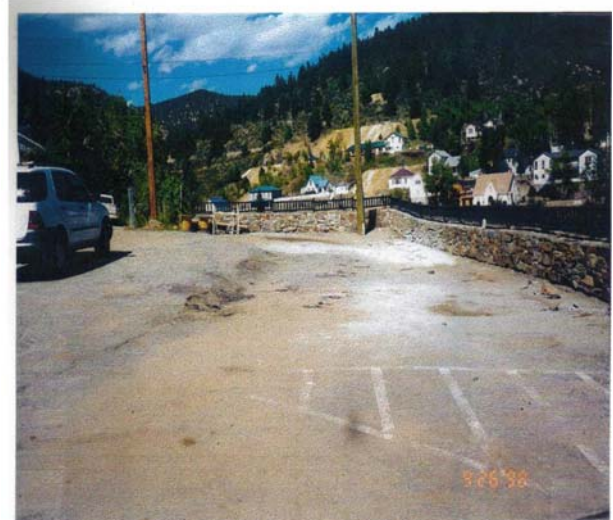
Fig. 1. Settlement at the Wall Crest before Demolition

In May 1998, about 100 mm of vertical settlement was observed in the paved area of the North wall. Some distinct cracks were also noted on the pavement. The cracks were nearly parallel to the wall face, approximately 6.5 to 7.5 m away from the wall face. However, the wall face condition appeared unchanged from that observed in May 1997.

In August 1998, the settlement increased to about 250 mm. The lateral budging had become rather significant, especially at the mid-height of the wall. The wall was subsequently demolished for reconstruction due to the excessive deformation and failing wall face.

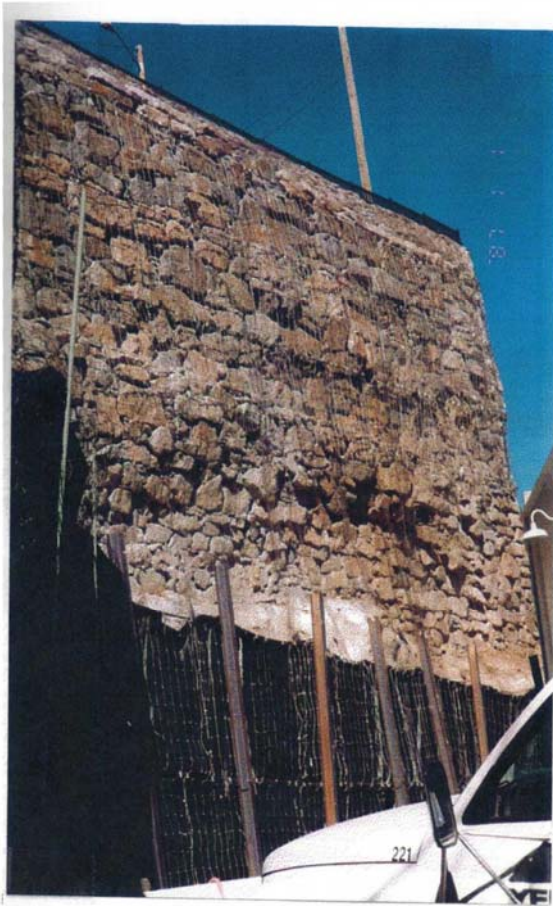
Fig. 2. Lateral Bulging at the Rock Facing before Demolition

The construction of the wall was completed in December 1996 when the weather was bitter cold. In May 1997, the wall face experienced tumbling of rocks, including small rocks and a few larger rocks of approximately 300 to 600 mm in diameter. Outward bulging near the mid-height and one-third from the top of the wall was apparent at some locations. A program of regular “scaling” of the wall was initiated after observing these problems. The “scaling” involved tapping with a hammer, prying each rock in the wall face, and dislodging any loose pieces.

It is to be noted that when the wall was reconstructed in 1998, a slightly different type of backfill was employed and the backfill was compacted to 95% relative compaction. The wall has since performed satisfactorily.

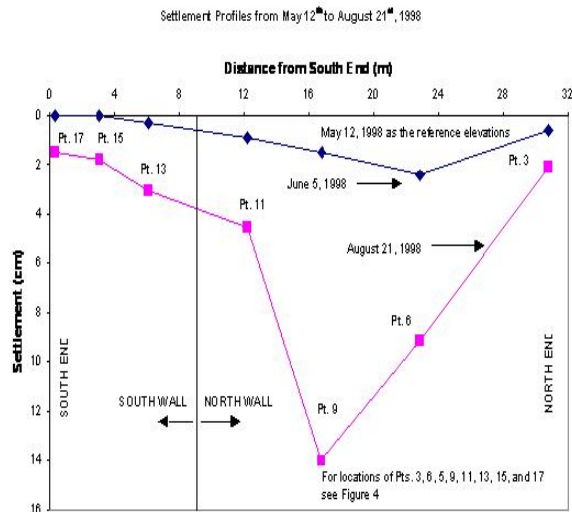
The settlement at different locations of the paved area (Pts. 1 to 17 in Figure 4) on the crest was measured. The survey measurement was taken on May 12, June 5, and August 21, 1998. The elevations recorded on May 12, 1998, approximately one year after initial wall distress was detected, were used as the reference for the subsequent settlement measurements on June 5 and August 21, 1998. The settlements of the pavement area measured between May 12 and June 5, 1998 (over 25-day period) and between June 5 and August 21, 1998 (over 45-day period) are listed in Table 1. From May 12 to June 5, 1998, the largest settlements in the North and South walls were 240 mm (at Pt.6) and 3 mm (at Pt.12), respectively. Between June 5 and August 21, 1998, the largest settlements in the North and South walls were 125 mm (at Pt.11) and 27 mm (at Pt.12), respectively. Note that the largest settlements all occurred adjacent to the wall face.

The settlement profiles relative to the wall geometry on May 12, 1998 are shown in Figure 6. The settlement profiles resemble a bowl shape with the smallest settlements being at the north- and south-ends. The settlement profile of the June 5 measurement was more uniform than that of the August 21 measurement which showed a dramatic increase of settlement near the middle of the North wall. A maximum settlement of 140 mm occurred between May 12 and August 21, 1998.

ig. 6. Settlement Profiles between May 12 and August 21,1998

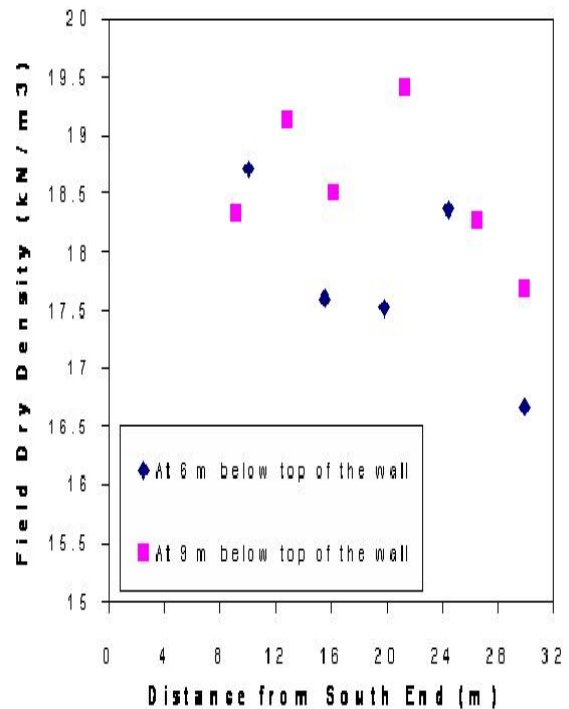
Nuclear density tests were performed at different depths during wall demolition. In addition, a water replacement test in a test pit was conducted to verify the density of the backfill measured by the nuclear density tests. Figures 7 and 8 show the dry unit weights and moisture contents at 6 m and 9 m below the wall crest. The average percentage of oversized material (larger than 19 mm) was 30%. The maximum dry unit weight, per ASTM D1557 method C with rock correction of 30%-oversized material, was 21.9 kN/m³, with the optimum moisture content (OMC) being 6.3%. The average dry unit weight at the depth of 6 m was 17.8 kN/m³ (i.e., 81 % standard Proctor relative compaction). The average dry unit weight at the depth of 9 m was 18.7 kN/m³ (i.e., 86 % standard Proctor relative compaction). Figure 8 shows that the water contents increased from North and South ends toward the middle part of the North wall where the largest settlement occurred. The

Fig. 7. Measured Field Dry Unit Weight

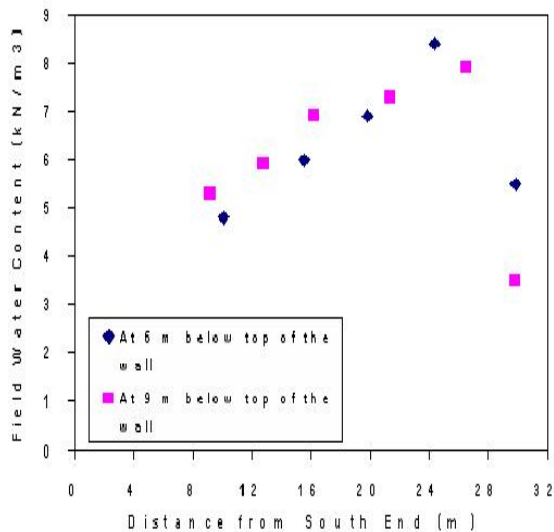
maximum water contents were 8.4% (i.e., 2.1% wet of OMC) at the 6 m depth and 7.9% (i.e., 1.6% wet of OMC) at the 9 m depth.

Fig. 8. Measured Field Moisture Content

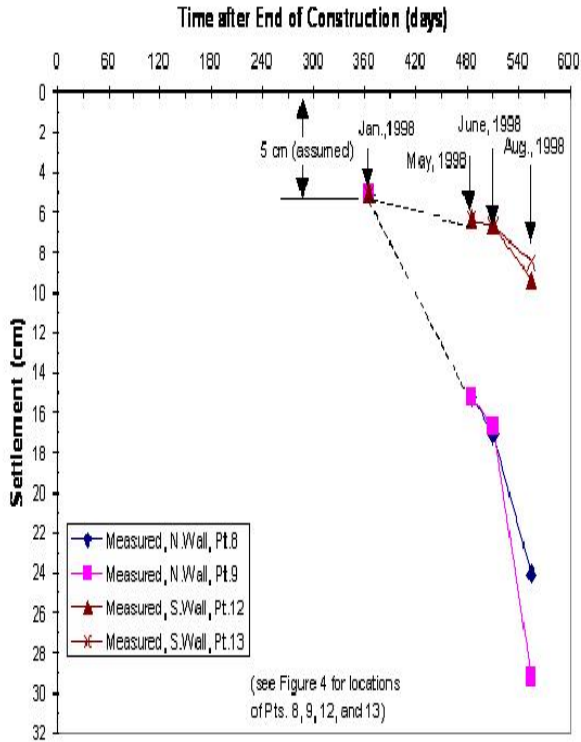
Figure 9 shows a probable scenario of the settlement history at the top of the North wall and the South wall. A total settlement of 50 mm (i.e., 0.45% of the wall height) due to self-weight of the backfill was assumed to have occurred from December 1996 (end-of-construction) to January 1998. It is assumed that the settlement rates between January and May, 1998 were constant, and equal to the settlement rates of the first set of the survey data recorded between May 12 and June 5, 1998. The rates of settlement were 1 mm per day in the North wall and

0.1 mm per day in the South wall. From Figure 9, the maximum total settlements after the end-of-construction were determined to be about 240 to 290 mm in the North wall (at Pts. 8 and 9, Figure 9) and 85 to 95 mm in the South wall (at Pts. 12 and 13, Figure 9).

Upon examining Figure 9, the magnitude and the rate of post-construction settlement in the North wall were considered very unusual. There was a significant increase in the rate of settlement in the North wall after January 1998. The rate of settlement was approximately 5 to 10 times of that in the South wall. This is highly unexpected as the South wall had practically the same conditions as the North wall: they have presumably the same wall configuration, same backfill material, same soil placement procedure, and same construction procedure.

Fig. 9. Settlement versus Time after End-of-Construction

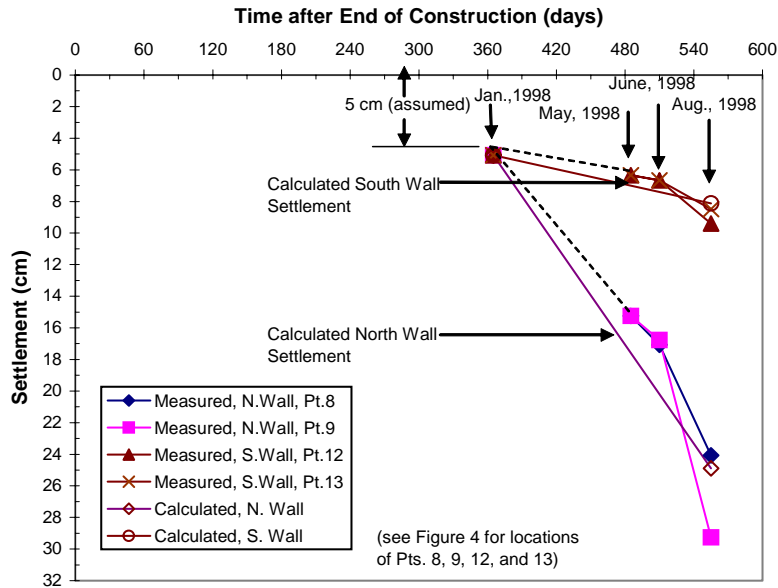
Figure 13 shows the calculated and measured settlement history of the walls from the end-of-construction (December 1996) to August 1998. The calculated settlements induced by wetting were 198 mm in the North wall and 28 mm in the South wall. The measured maximum settlements from January to August 1998 were approximately 190 to 240 mm in the North wall and 35 to 45 mm in the South wall. It is seen that the calculated settlements agree well with the measured values. This implies that the assumed wetting mechanism is probably not far from being true.

Fig. 13. Calculated and Measured Settlements from the End-of-Construction to August 1998
