# Failure of Two High Embankments at Soft Soil Sites

## **FAILURE OF TWO HIGH EMBANKMENTS AT SOFT SOIL SITES**

Two highway bridge approaches, about 10 and 12 m in height, near Calcutta, India constructed with mechanically stabilized earth failed recently. These embankments were founded on soft and compressible, fine-grained soils of the intertidal flats and backswamps of the Ganges delta. One of these embankments, which failed in the final stages of its construction, was constructed after foundation soils were strengthened with preloading and prefabricated vertical drain installation and the other second embankment that failed within a month of its opening for traffic was constructed on unimproved ground. Fortunately, direct collateral damage from these incidents was small. Available geotechnical data indicated that design inadequacy was the main cause of these failures. Using pre- and post- consolidation shear strengths the embankments were redesigned. Reconstruction involved PVD installation at the second site and construction of stabilizing berms at both locations. The facilities are now operational and appear to be performing satisfactorily. Details of the failures, post fail

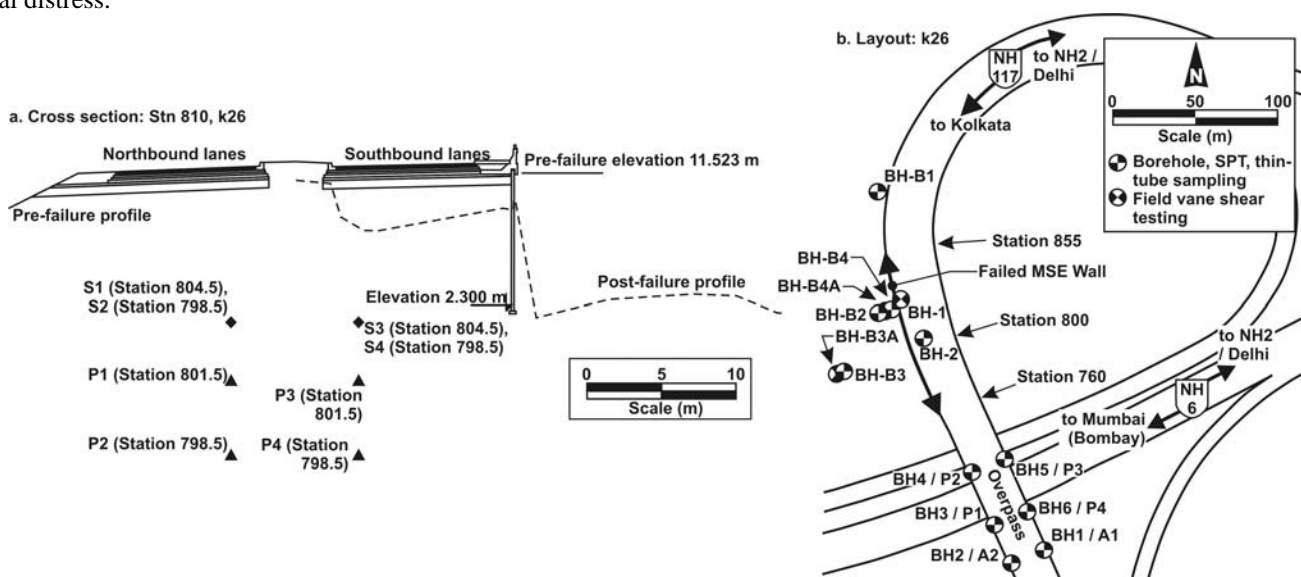
The first event affected a highway interchange structure, under construction since July 15, 2003. The structure is retained by a Mechanically Stabilized Earth wall along the outer shoulder and with the fill slope of 2 (H):1(V) along the inner shoulder. The nearly-complete MSE wall underwent a deep seated failure in the early hours of rains received and an additional 0.4 mm of rainfall on the following day. The height of the affected embankment was between 8.9 and 9.8 m at the time of the incident. The cross section of the failed MSE wall is shown on Fig. 3. Post failure inspection indicated that the MSE wall failed due to external instability without significant internal distress.

Fig. 3. Cross section and layout: KM 26 MSE wall.

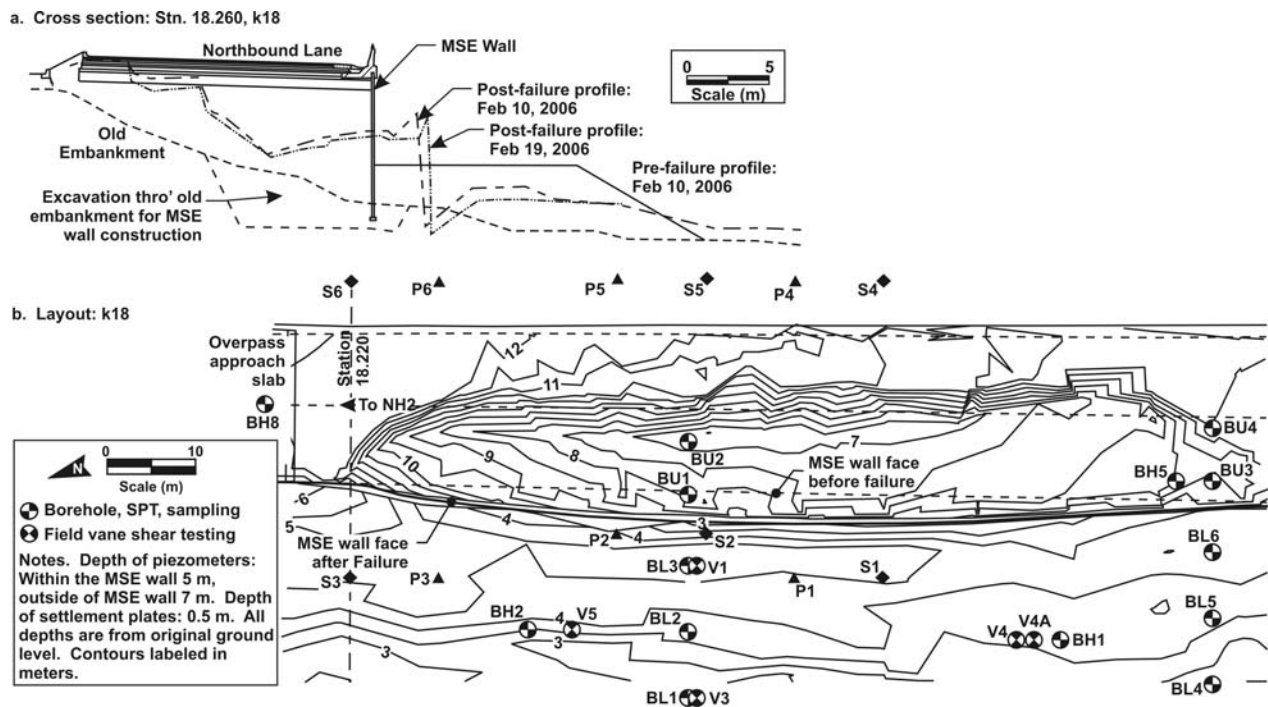
Fig. 4. Cross section of the KM 18 MSE wall.

The failed MSE wall was constructed for four laning of a pre-existing two-lane, undivided highway that runs on the 30-year old embankment with 3(H):1(V) side slopes. The construction of the old embankment also triggered several slope failures. One such failure occurred in 1966, when the embankment reached its full height 10.7 m. The instability was assessed to be due to a deep-seated circular slip that day lighted just beyond the toe. During this failure, the maximum embankment height within the stable stretch was 6.7 m. As remedial measures, the failed embankment was removed, the highway elevation was lowered and the embankment was reconstructed along with a 2.1-m high stabilizing berm along the edges of the embankment. Another slope failure occurred later immediately to the south of the railway tracks. Since poor subsurface conditions did not allow construction of an embankment of required height at the location of this failure, the earth embankment at the location of this failure was replaced by structural spans added to the bridge structure for carrying the overpass. Details on the original geotechnical investigation and design of the highway in this area can be found in Gangopadhyay and Das (1969).

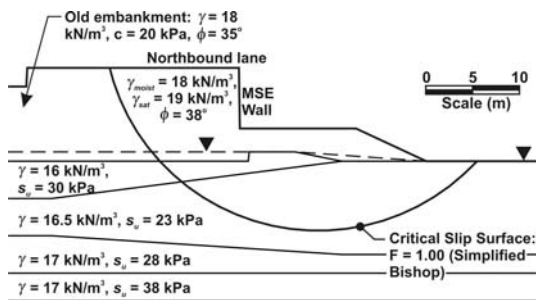
External undrained stability of the configuration of the MSE wall assessed using the simplified Bishop method (Bishop 1955). The input parameters used in the analysis were based on the assumptions that (a) the soil layers underneath the MSE wall were fully consolidated under the vertical stress imposed by the old embankment, (b) that the degree of consolidation due to the MSE wall and the newly constructed embankment was 50 %, and (c) the undrained shear strength profiles can be approximated with the solid and dashed lines of Fig. 5b. The strength parameters for the old embankment were back figured from stability analysis to match the observed instance of deep seated rotational failure during the construction of the embankment in the sixties described earlier. In the stability assessment of the old embankment, strength parameters for foundation soil were assumed in accordance with the dashed line of Fig. 5b. The results of external stability assessment for the MSE wall at failure indicate that the MSE wall and the embankment behind it were indeed marginally stable at the time of failure (Fig. 9).

Fig. 9. Undrained stability of KM 18 embankment at failure.

In comparison, the minimum factor of safety against circular slip in the original design was under static loading was 1.42 in the slope stability assessment. However, in the original design the maximum considered embankment height including pavement structure was 8.4 m against the actual maximum height of 10.5 m and a total unit weight of  $15 \text{ kN/m}^3$  was assumed for the embankment body because of the initial plan of constructing the embankment partly with fly ash. Most importantly, the undrained shear strengths used in the original design, shown on Figure 5b for comparison, were over a large portion of the depth range of interest greater than those inferred from laboratory and in-situ test data. Thus the bases of the original design were, in general, unconservative.

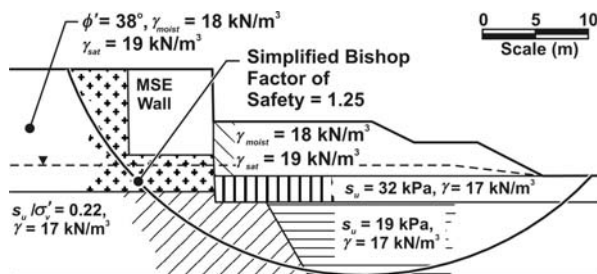
The minimum factor of safety under static loads against overall rotational failure for the MSE wall, embankment and stabilizing berm at the end of construction is estimated at 1.20 (Fig. 10).

Fig. 10. Undrained stability of remodeled KM 26 embankment.

Reconstruction work at the KM 26 failure site included construction of a two-stepped, 5.2-m high stabilizing berm along the outer face of the MSE wall followed by the reconstruction of the MSE wall and the highway embankment. The overall berm width measured outward from the face of the reconstructed MSE wall to the toe of the lower bench was 31.4-m.

Since berm construction was scheduled before MSE wall reconstruction, the shear strengths for the stability assessment were based on the assumption that the foundation soils within the PVD treated zone extending to a distance of 4 m outward from the MSE wall face would consolidate under the weight of the berm by the time the MSE wall reconstruction was complete. As such, the factor of safety meets the recommendation of IRC (1979). Furthermore, as the foundation soils underneath the berm consolidate, the factor of safety is expected to reach a value of 1.35 after about 5 years of berm construction.

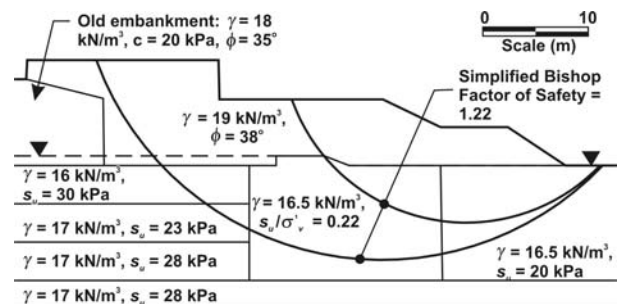
Fig. 11. Undrained stability of remodeled KM 18 embankment.

The remedial measures at the KM 18 site included installation of PVDs to a 13-m depth, construction of a two-stepped stabilizing berm along the outer face of the failed MSE wall, and reconstruction of the MSE wall and the highway embankment. For a configuration shown in Figure 11, the minimum factor of safety against overall rotational failure for the MSE wall, embankment and stabilizing berm at the end of construction was estimated at 1.22. For these assessments it was assumed that the consolidation of soils within the PVD-treated zone would be 75 % complete at end of construction and the effect of consolidation outside the PVD-treated zone was neglected. Although the computed factor of safety at end of construction is slightly smaller than the recommendation of IRC (1979), in longer term the factor of safety is expected to reach 1.38 upon completion of consolidation of soils within the PVD-treated zone.

PVDs (Colbondrain® CX1000) were installed in October 2006 at 1.2 m spacing in square grid pattern using a mandrel of diamond-shaped cross section with diagonals nominally measuring 50 mm and 120 mm was used in PVD installation. The PVD treatment covered an area of width of 19 m (measured outward from the face of the failed MSE wall) north of station 18.300 and 17 m south of station 18.300. The stabilizing berm was constructed between October 2006 and February 2007. The upper bench of the stabilizing berm was 20 m wide and reached an elevation 3 m below the finished road level. The maximum overall berm width measured from the base of the reconstructed MSE wall to the toe of the lower bench was 37 m. Three standpipe piezometers and three settlement gages were installed through the stabilizing berm as discussed earlier. After the removal of the failed embankment to an elevation approximately 5.75 m above the original ground surface, reconstruction work for the MSE wall and the highway embankment was taken up in February 2007. Three standpipe piezometers and three settlement gages were installed within the footprint of mechanically stabilized earth wall after the removal of the failed embankment. These installations were extended with the increasing elevation of the top of the constructed embankment. Drilling, sampling and Standard Penetration Testing were carried out near the end of April 2007 to check whether the gain in undrained shear
