CASE HISTORIES OF FAILURE OF DEEP EXCAVATION EXAMINATION OF WHERE THINGS WENT WRONG: NICOLL HIGHWAY COLLAPSE, SINGAPORE

Professor John Endicott

Fellow, AECOM

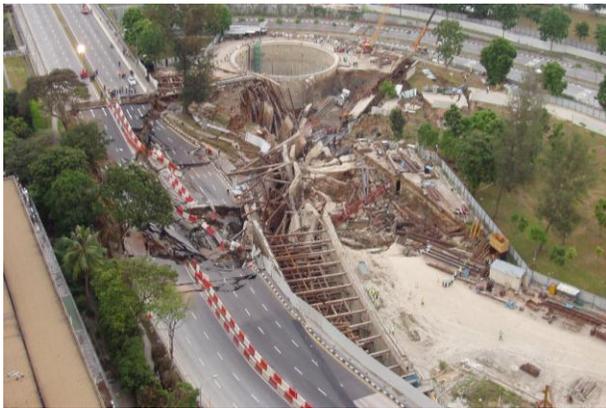
Plate 1. Photograph of the Collapse

About 80 metres length of the diaphragm walls converged to meet each other. The steel struts were destroyed. Adjacent to the walls the subsidence was about 13 m and the visible settlement extended to a radius of about 50 m, see Plate 1.

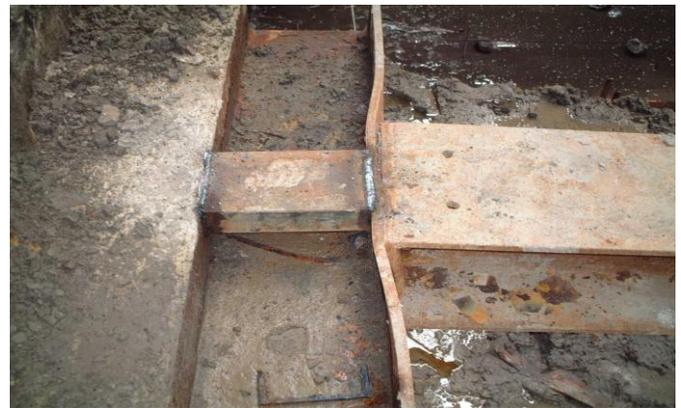
In February 2004, two months before the collapse, walers between struts and wall panels at a nearby location were found to have buckled. As a consequence the design of the connection between the struts and the walers was changed. Pieces of steel channel section were added to strengthen the connection, see Plate 2. Unfortunately the strengthening did not provide adequate capacity. Subsequent laboratory tests on perfectly constructed samples showed about half the capacity, see Figure 1. Moreover whereas steel normally strain hardens and has marginally increased capacity after initial yielding, the connection exhibited brittle failure with massive reduction in capacity after first yielding.

Plate 2. Photograph of Revised Stiffener

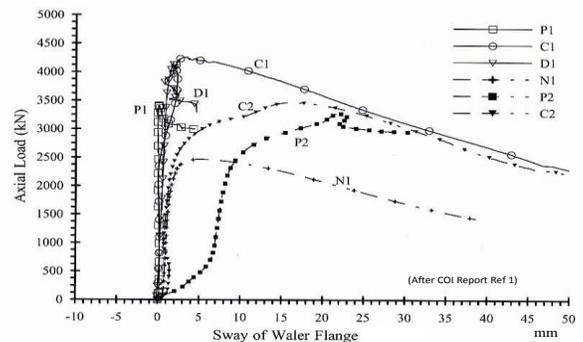
Fig.1. Test results for capacity of connection

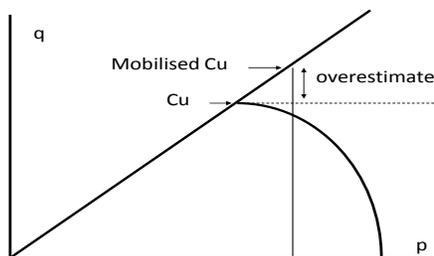
The majority of the soil supported by the diaphragm wall was soft marine clay which would not drain significantly during the works. Therefore it was rightly assumed that the soft clay would be undrained. PLAXIS allows input of undrained shear strengths directly, Method B, or input of effective stress strength parameters c' and ϕ' , whereby the shear strength is calculated using the Mohr Coulomb model with an undrained setting, Method A. The undrained setting, with no change of volume of the soil, results in no change in the isotropic stress, p' , and an over-estimate in the strength of a normally consolidated clay. The manual recommended the use of Method A. The error is about 18% over-estimate of the strength of one-dimensionally consolidated clay Figure 2. The effect is an underestimate by only about 4% underestimate of the force applied to the wall for any one stage but for multi-stages the cumulative effect is greater and, for example, using Method A for this project the computed displacement of the wall is about half of the value obtained by using Method B. The bending moment in the wall is similarly under-estimated.

Fig. 2. Overestimate of strength when using Method A

As a consequence of using Method A, the diaphragm walls were weaker than they should have been. However, during the day of the collapse, inclinometers showed that the walls only developed one plastic hinge and not two hinges that would be required for failure of the wall.

The lesson learned is to understand what the program does and which method to use. One should not follow the manual without making sure that the recommendation applies to the particular application.

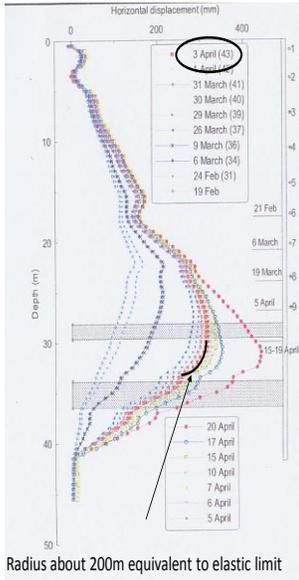
Inclinometers located inside walls or in soil adjacent to wall panels are used to monitor displacements of the walls. From the inclinometer profiles one can determine the radius of curvature at any given time from which it is possible to determine the bending moment in the wall panel. Inclinometer results showed that a plastic hinge developed in the wall panel at the location of the failure some three weeks months before the collapse, see Figure 3. The Alarm Level for the displacement was exceeded and it was relaxed twice, without recognizing the distress of the wall panel at the time. On each occasion a back analysis was carried out which matched the maximum displacement but did not match the deflected radius of curvature. In the back analyses, the soil strengths were reduced to develop more pressure on the walls and induce more displacement. This also resulted in increasing the calculated forces in the struts which did not represent the observed reduced forces in the struts. A correct back analysis would have identified that there was a problem with the struts.

Fig.3. Inclinometer readings

Lesson learned is to understand the monitoring and to set appropriate the AAA limits for the capacity of the structural members as well as for protection of property.

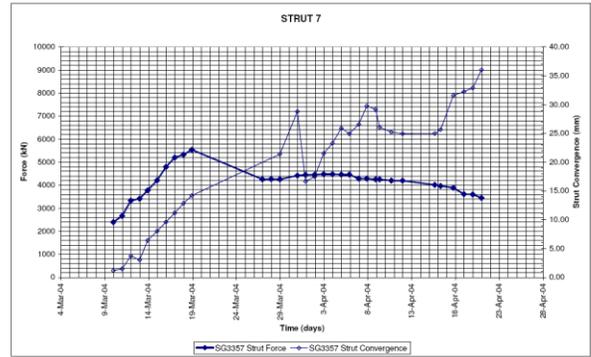
More insight can be obtained from the inclinometer readings. The two inclinometers were located in wall panels on opposite side of the excavation and the sum of displacements for the two inclinometers is the convergence between the two wall panels. Under normal operations strutting should work within the elastic range and therefore the convergence between opposite wall panels and the forces on the intervening struts should be proportional to the stiffness of the strutting system. By comparing the two sets of data, for struts at level 7 as shown in Figure 4, although there is scatter in the convergence data, there is an overall trend of increasing convergence whereas the force in the strut does not change appreciably during late March 2004 and reduces during the three weeks in April 2004. Although the data is not precise, the trend is evident that the forces in the struts were not increasing as they should have done. The assumption in the back analyses that the strutting was behaving elastically was wrong and had the measured forces in struts been used as input data to the back analyses a proper back analysis of the wall could have been achieved.

Fig.4. Force v Convergence for Strut at Level 7

Lesson learned is to conduct back analyses which properly match all of the relevant monitoring results and not just one result.

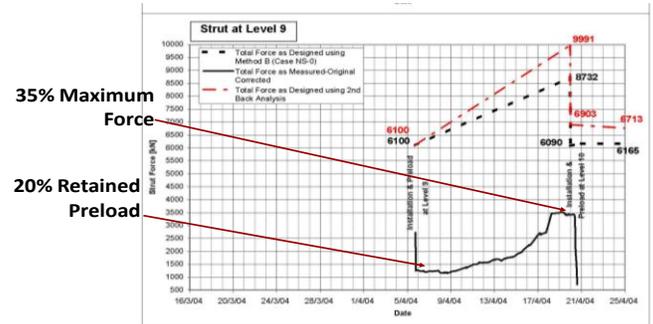
The design required the struts to be pre-loaded to 75% of the design maximum force and locked off. Forces in struts were measured and reported automatically every hour. The record of forces in the strut at level 9 is shown in Figure 5. Within one hour after lock-off the load had dropped to only 20% of the required pre-load. A similar result was recorded for struts at level 7 some two months before the collapse and again at level 8. One month before the collapse.

Fig.5. Force v Time for Strut at Level 9

The AAA limits were based on not over loading the struts. Because the AAA limits were set with a maximum force commencing at 50% of the design load no warning was issued. Just before the collapse the readings had not exceeded 35% of the design value. Moreover, it was not observed at the time that the force in the strut was only 35% of what it should have been and therefore the strut was not providing the support to

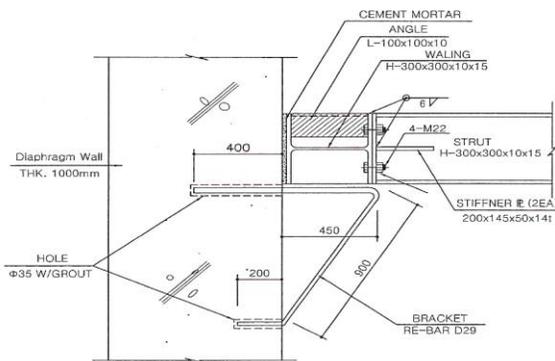
Fig.7. Connection Strut to Waler
