Restoration of the Military Club Building in Sofia, By Micro Pile Injections

Chavdar Vassilev Kolev

RESTORATION OF THE MILITARY CLUB BUILDING IN SOFIA, BY MICRO PILE INJECTIONS

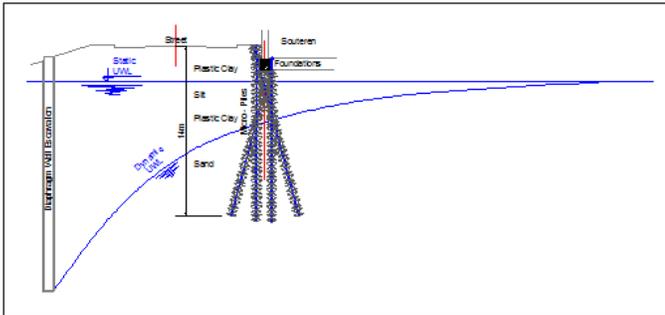
Fig. 4

During the period between the years 2006 and 2008, a tunnel, deep around 20m was built below the diagonal intersection of two streets due to the construction of Sofia subway. Approximately 10 m in front of the building, a deep ventilation shaft, surrounded by a groove wall, was erected between the tunnel and the terrain. During construction of groove walls, the drainage excavation effect quickly formed a very steep depression curve between the building and the shaft. Relatively weak multilayer ground is a precondition for the rapid decrease of the ground water (Fig.4), accompanied

by uneven subsidences. This rapid decline and the large amplitude of the groundwater level resulted in unfavorable settlement of foundation under the front facade of the building at "Tsar Liberator" Blvd. Arches on the facade of the building are cracking, other cracks are opened and dissolved; and a real threat for the stability of the construction is occurring. Most probably, the imbalance of the ground when the excavator was digging for groove walls of about 20 m deep, the same has created conditions for formation of the active earth pressure wedge, and so it has resulted in subsidence of the land and building. After the construction of the subway, a vent was done, where the subsidence of the ground next to the building was measured and it accounted to about 5 mm. And although the subsidence is relatively little, the damages to the building rose quickly.

The injected micro piles are at basic distances of 120 cm and 100 cm from each other. The average length of the piles is 10 m, 12 m and 13 m. Injection occurred at intervals of 50 cm. Consumption of dry cement is 75 kg per interval, or 150 kg per meter (Fig.4).

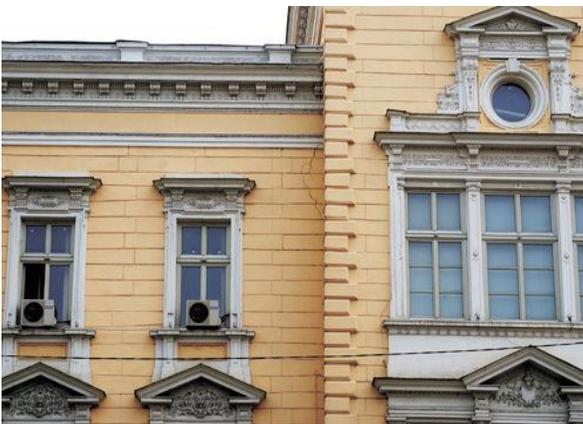
Fig.5

The biggest are the cracks in the southwest and the northeast tower (Fig.5), which are the most haviest parts of the building and are the closest to the shaft and the tunnel. The cracks have different widths - from barely visible to 20-21 mm each. Expanding cracks occur mainly at the sites of the two towers – the southern one and northern one. After analyses of the direction and how to open the cracks of the towers, it was found that the largest active subsidence of the soil is not positioned immediately next under the foundations of the building, but at some distance from it - close to the subway shaft. There are no cracks at the Northwest Tower, although the line of the fault goes beneath.

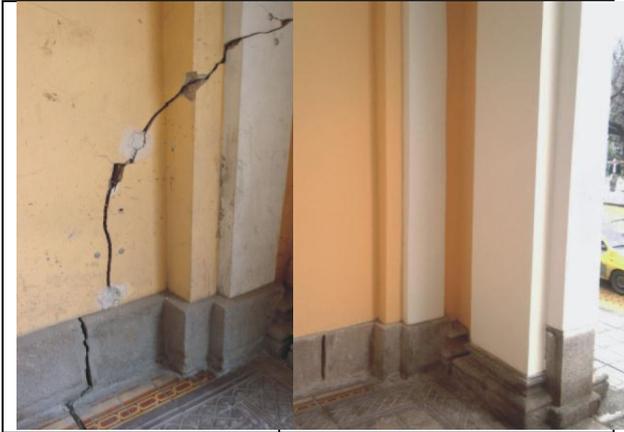
Fig. 7

completing the injections (Fig 7). Suspension was the downfall of the ground and foundations.
