Ground Deformations Observed After 23.10.2011 M_w 7.2 VAN Earthquake (Turkey)

GROUND DEFORMATIONS OBSERVED AFTER 23.10.2011 M_w 7.2 VAN EARTHQUAKE (TURKEY)

A destructive earthquake with a moment magnitude of 7.2 occurred in the north of the Van province (Turkey) on 23rd October 2011 at 13:41 local time and caused approximately 600 deaths and more than 4000 injuries. Many damaging aftershocks were recorded for more than a month after the main shock including a triggered earthquake (M_w 5.6) located in the southern district of Van, namely Edremit, on November 9th, 2011 which caused additional damage and casualties. After the M_w 7.2 Van earthquake, earthquake-induced ground deformations such as liquefaction and lateral spreading were extensively observed around the shores of Lake Van and in the floodplains of rivers. The Karasu River floodplain, which is one of the major streams in the region, severely suffered from liquefaction and lateral spreading. In this study, a brief overview of the M_w 7.2 Van earthquake as well as earthquake-induced ground deformations is presented. Then, the results of field reconnaissance on liquefaction and lateral spreading features observed in the Kar

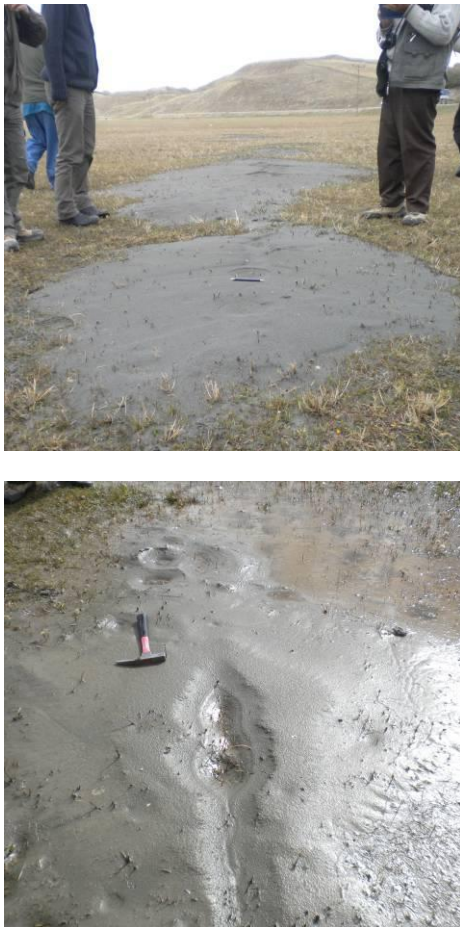
Scattered sand boils with different dimensions were observed after the earthquake in that area. Large scale sand boils with an irregular cone-shaped geometry attained a maximum width and length value of 5 m and 10 m, respectively (Figure 6). Furthermore, longer (>10 m) linear sand boils were also determined by other investigators in different regions of the Karasu River embankment (Ozkaymak et al., 2011).

Fig. 6. Sand boils observed after the M_w 7.2 Van earthquake in the Karasu River floodplain near Topaktas village

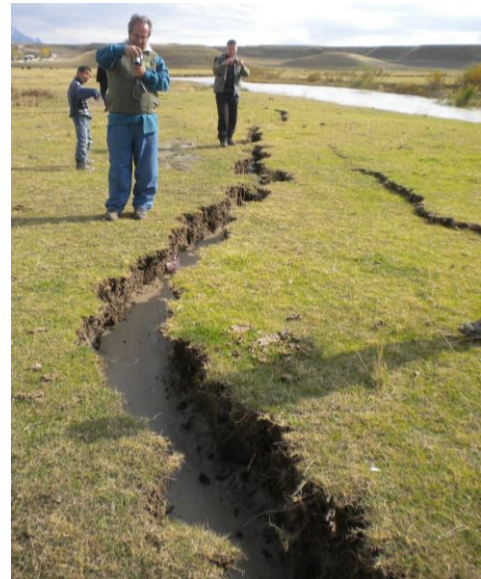
In addition to liquefaction, lateral spreading were also extensive in the same region. In several locations, lateral spreading was accompanied by sand boils. According to the field observations, lateral spreading cracks were parallel to the river bed. The general trend of lateral spreading in the research area was N50W. A maximum of 50 cm separation was measured for one crack whereas a total separation of 70 cm on two parallel ground cracks was noted. The lateral spreading crack reached as deep as 65 cm at several locations (Figure 7). Shallower (<20 cm) ground cracks were also noticed. Lateral spreading was quite persistent (generally >10 m) and a maximum of 30 m persistence was measured in the investigated floodplain.

Fig. 7. Lateral spreading cracks observed after the M_w 7.2 Van earthquake in the Karasu River floodplain
