Ground Deformations Observed After 23.10.2011 M_w 7.2 VAN Earthquake (Turkey)

GROUND DEFORMATIONS OBSERVED AFTER 23.10.2011 M_w 7.2 VAN EARTHQUAKE (TURKEY)

ABSTRACT

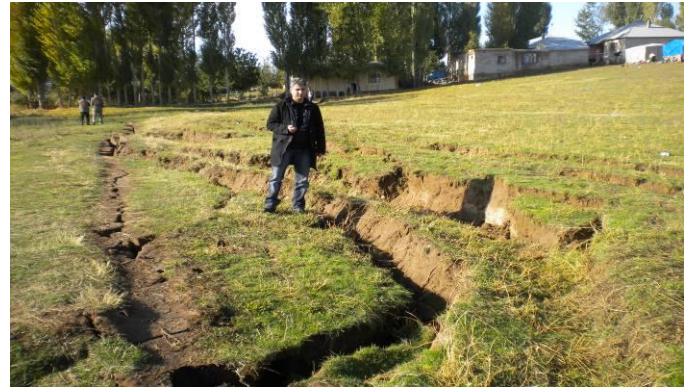
Fig. 4. Lateral spreading cracks in Celebibagi village (Ercis) affecting one-story masonry buildings at the background

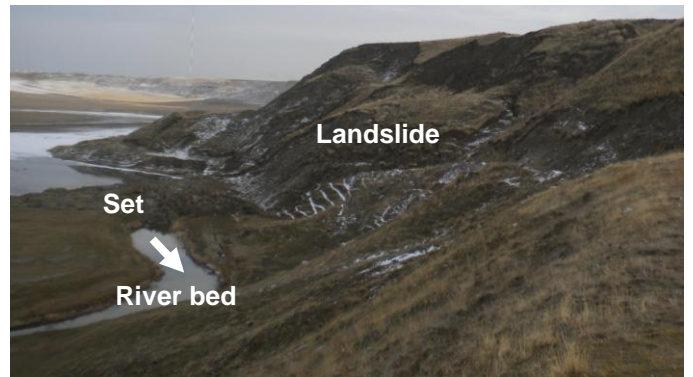
Fig. 5. Seismically-induced landslide near Citoren blocking the Karasu river bed

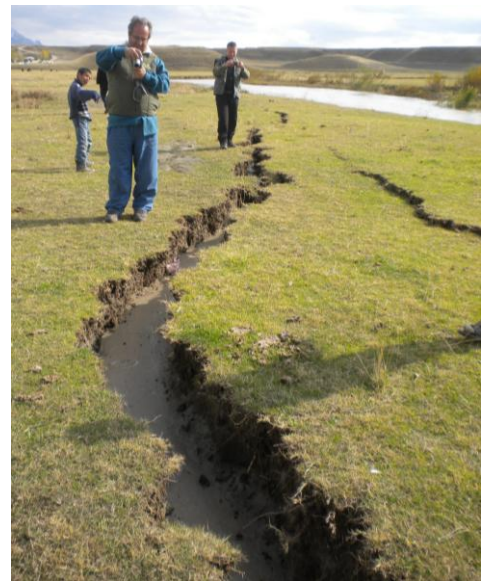
In addition to liquefaction, lateral spreading were also extensive in the same region. In several locations, lateral spreading was accompanied by sand boils. According to the field observations, lateral spreading cracks were parallel to the river bed. The general trend of lateral spreading in the research area was N50W. A maximum of 50 cm separation was measured for one crack whereas a total separation of 70 cm on two parallel ground cracks was noted. The lateral spreading crack reached as deep as 65 cm at several locations (Figure 7). Shallower (<20 cm) ground cracks were also noticed. Lateral spreading was quite persistent (generally >10 m) and a maximum of 30 m persistence was measured in the investigated floodplain.

Fig. 7. Lateral spreading cracks observed after the M_w 7.2 Van earthquake in the Karasu River floodplain
