Ground Deformations Observed After 23.10.2011 M_w 7.2 VAN Earthquake (Turkey)

GROUND DEFORMATIONS OBSERVED AFTER 23.10.2011 M_w 7.2 VAN EARTHQUAKE (TURKEY)

A destructive earthquake with a moment magnitude of 7.2 occurred in the north of the Van province (Turkey) on 23rd October 2011 at 13:41 local time and caused approximately 600 deaths and more than 4000 injuries. Many damaging aftershocks were recorded for more than a month after the main shock including a triggered earthquake (M_w 5.6) located in the southern district of Van, namely Edremit, on November 9th, 2011 which caused additional damage and casualties. After the M_w 7.2 Van earthquake, earthquake-induced ground deformations such as liquefaction and lateral spreading were extensively observed around the shores of Lake Van and in the floodplains of rivers. The Karasu River floodplain, which is one of the major streams in the region, severely suffered from liquefaction and lateral spreading. In this study, a brief overview of the M_w 7.2 Van earthquake as well as earthquake-induced ground deformations is presented. Then, the results of field reconnaissance on liquefaction and lateral spreading features observed in the Kar

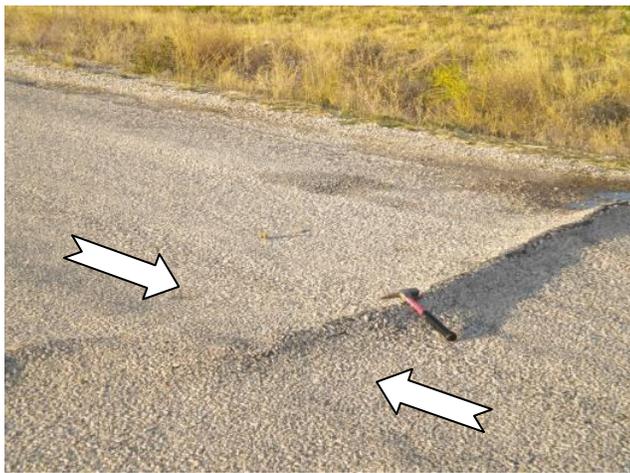
The causative fault that ruptured during the M_w 7.2 Van earthquake is located about 10 km to the north of the city center (Figure 2). No significant surface rupture was observed during the field studies carried out by the authors or other investigators just after the earthquake. However, small scale traces of compressional deformations up to 5-10 cm were measured at several locations along the fault line especially in brittle structures (Figure 3). The signs of compressional deformations point out a thrust fault with the upper plate thrusting southward. The city center of Van is placed on the footwall side of the thrust fault whilst heavily damaged Ercis district is on the hanging wall side. The fault ruptured during the Van earthquake is classified as a blind fault since no obvious sign of surface rupture presents (Alan et al., 2011, Ozkaymak et al., 2011). A fault is identified as a blind fault when the rupture does not reach all the way up to the ground surface and so no clear evidence of fault rupture can be observed (Groshong, 1999; Gates and Ritchie, 2007).

Fig. 3. Trace of compressional deformation on secondary asphalt road

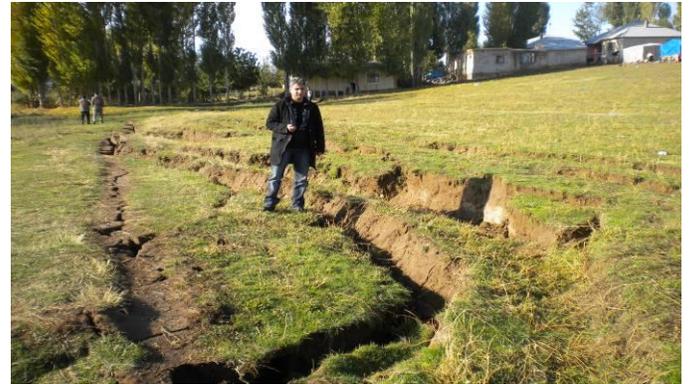
Earthquake-induced ground deformations were extensive in many regions around the eastern and northeastern shores of the Lake Van after the M_w 7.2 Van earthquake. Fortunately, no serious ground deformation-related building damages and collapses were officially reported around the earthquake affected zone except small scale damages in one-story masonry buildings and infrastructural transition lines. Liquefaction and lateral spreading were apparent at many locations, particularly in the floodplains of rivers and streams as well as in the recent deposits nearby the Lake Van. Celebibagi and Kasimbagi villages in Ercis district and the Karasu River floodplain severely suffered from ground deformations associated with liquefaction and lateral spreading. Numerous sand boils and lateral spread cracks with varying dimensions were observed around these settlements and along the embankments of the Karasu River (Figure 4). Furthermore, a large scale seismically-induced landslide near Citoren village was initiated after the earthquake blocking the Karasu river bed (Figure 5). No liquefaction or lateral spread-related features occurred in older deposits than recent alluvium during the Van earthquake.

Fig. 4. Lateral spreading cracks in Celebibagi village (Ercis) affecting one-story masonry buildings at the background

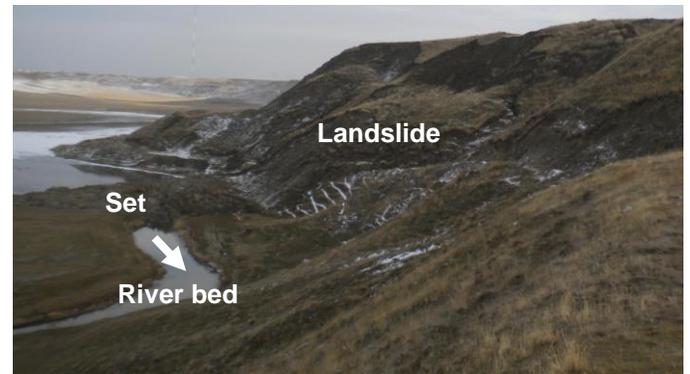
Fig. 5. Seismically-induced landslide near Citoren blocking the Karasu river bed

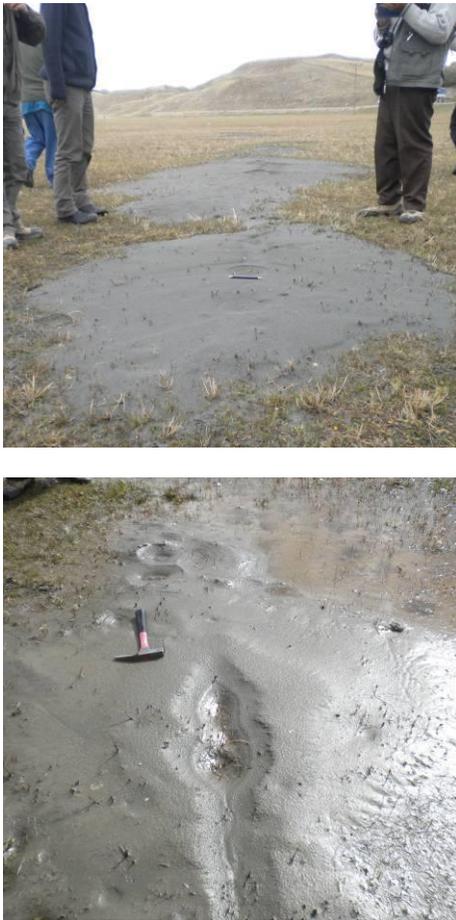
Scattered sand boils with different dimensions were observed after the earthquake in that area. Large scale sand boils with an irregular cone-shaped geometry attained a maximum width and length value of 5 m and 10 m, respectively (Figure 6). Furthermore, longer (>10 m) linear sand boils were also determined by other investigators in different regions of the Karasu River embankment (Ozkaymak et al., 2011).

Fig. 6. Sand boils observed after the M_w 7.2 Van earthquake in the Karasu River floodplain near Topaktas village

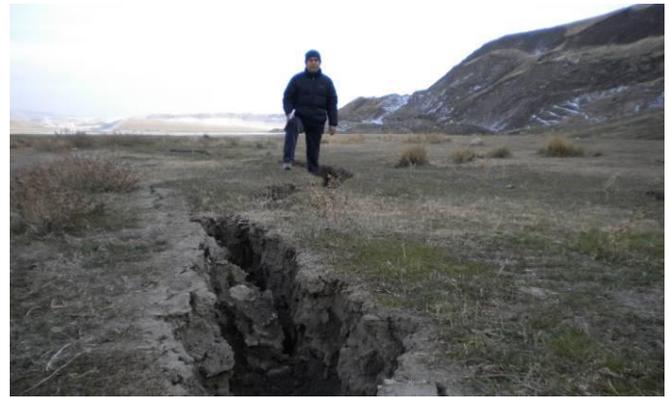
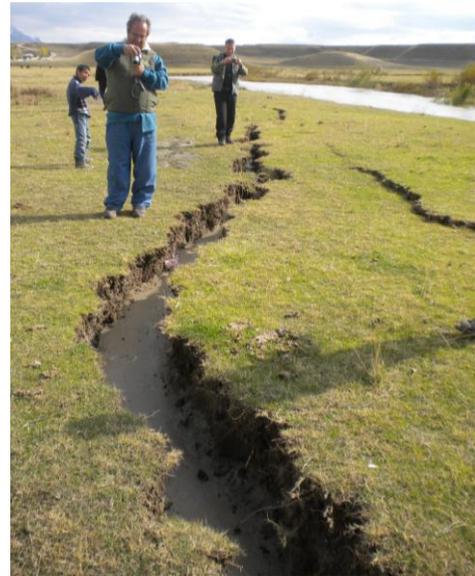
In addition to liquefaction, lateral spreading were also extensive in the same region. In several locations, lateral spreading was accompanied by sand boils. According to the field observations, lateral spreading cracks were parallel to the river bed. The general trend of lateral spreading in the research area was N50W. A maximum of 50 cm separation was measured for one crack whereas a total separation of 70 cm on two parallel ground cracks was noted. The lateral spreading crack reached as deep as 65 cm at several locations (Figure 7). Shallower (<20 cm) ground cracks were also noticed. Lateral spreading was quite persistent (generally >10 m) and a maximum of 30 m persistence was measured in the investigated floodplain.

Fig. 7. Lateral spreading cracks observed after the M_w 7.2 Van earthquake in the Karasu River floodplain

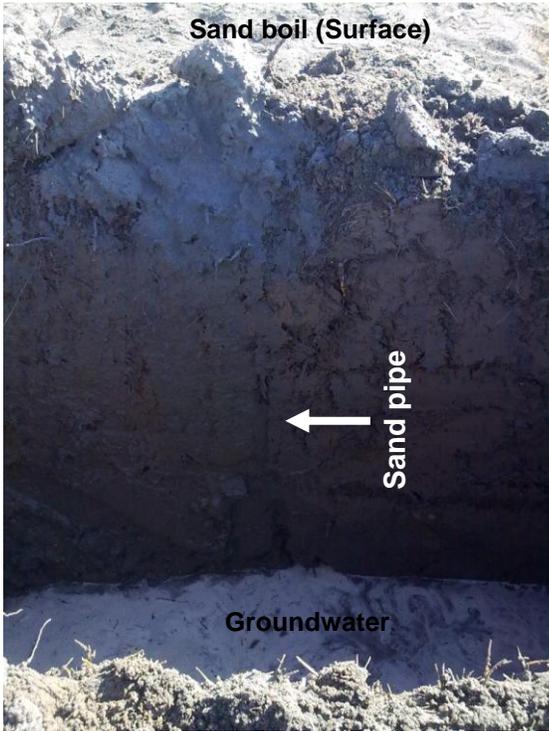
Fig. 8. Cross-sectional view of trial pit excavated on a sand boil

The thickness of clayey cap soil in the investigated area is around 2 meters considering the trial pit data. Although the groundwater level is about 2 m in Figure 8 and was deeper when the pit was first excavated, all pits were filled with water in a short time span and finally the groundwater table (GWT) rose to 40 cm below the surface. Below plastic cap soil, non-plastic, fine-grained loose sandy material which was possibly transported to the surface during liquefaction exists.

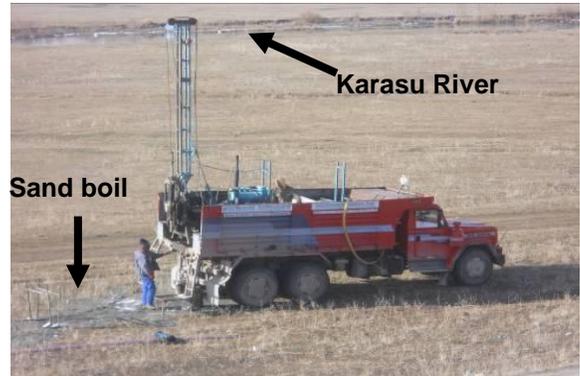
In order to observe the soil profile in the liquefaction zone and to determine the geotechnical properties of the liquefied and non-liquefied layers, a 20 m deep borehole (LBH-1) was drilled next to the boundary of a sand boil after the earthquake (Figure 9). The groundwater depth was 40 cm when drilling was performed in December, 2011. Instead of 1.5 m intervals, standard penetration tests (SPT) were performed at every 1 meter depth in LBH-1 to obtain a continuous soil profile as much as possible. The soil profile of LBH-1 and the SPT blow

Fig. 9. Drilling on sand boil at Karasu River floodplain after the M_w 7.2 Van earthquake

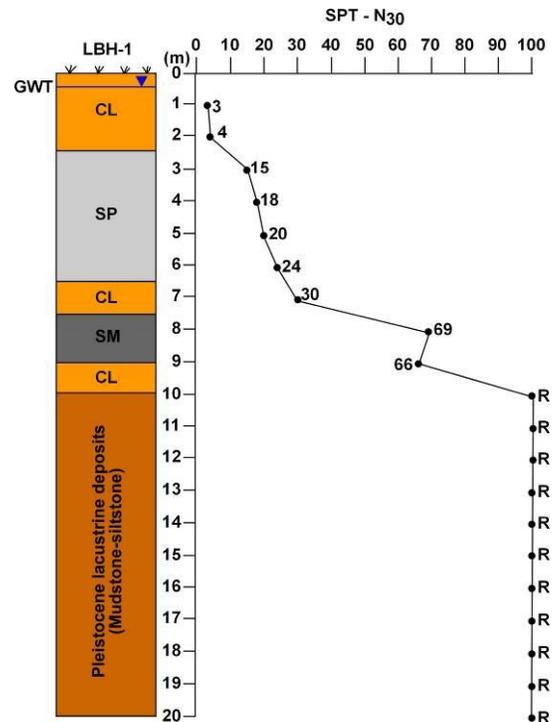
The plastic cap soil (CL) at LBH-1 is around 2.5 m thick as seen in Figure 10. The thickness of poorly graded sand (SP), which is supposed to be the liquefied layer in this location, is almost 4 m. After 6.5 m, thin alternations of low plastic clay (CL) and non-plastic silty sand (SM) exist. Late Pleistocene lacustrine deposits are encountered at 10 m, and are composed of mudstone and siltstone layers. A gradual increase in SPT blow counts is obvious in the LBH-1. SPT N_{30} values vary between 15 and 24 in the liquefiable zone. Refusal (R) values were obtained after 10 m in lacustrine deposits.

Fig. 10. Soil profile and N_{30} values of the LBH-1 drilled on a sand boil (R: Refusal value)

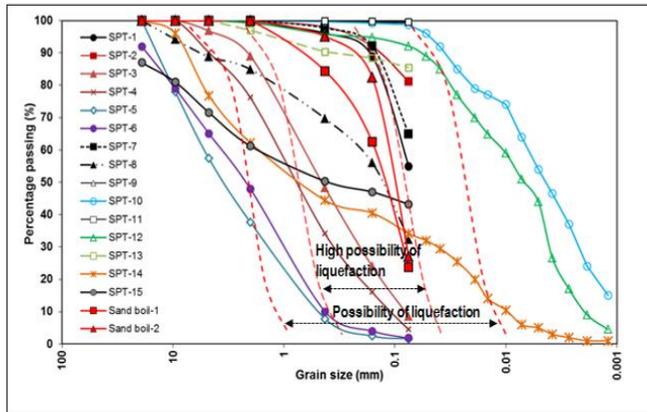
The grain size distributions of the disturbed samples as well as sand boil samples from the surface at the LBH-1 were determined by wet-sieve analyses in the laboratory (Figure 11). The sieve analyses of sand boil samples indicate that the liquefied soil is silty sand (SM). Moreover, the SPT samples of 3 and 4 m (poorly graded sand) exhibit high possibility of liquefaction. The fine content values of the soil layers between 3 and 6 m in the LBH-1 vary between 1.6% and 8.5%. The distribution of the fine content with depth in LBH-1 is depicted in Figure 12. All grain size distributions and SPT blow counts point out that the liquefaction probably occurred in a zone between 2.5 and 6.5 m in the investigated area.

Fig. 11. Grain size distributions of the disturbed (subsurface) at the LBH-1 and the sand boil (surface) samples

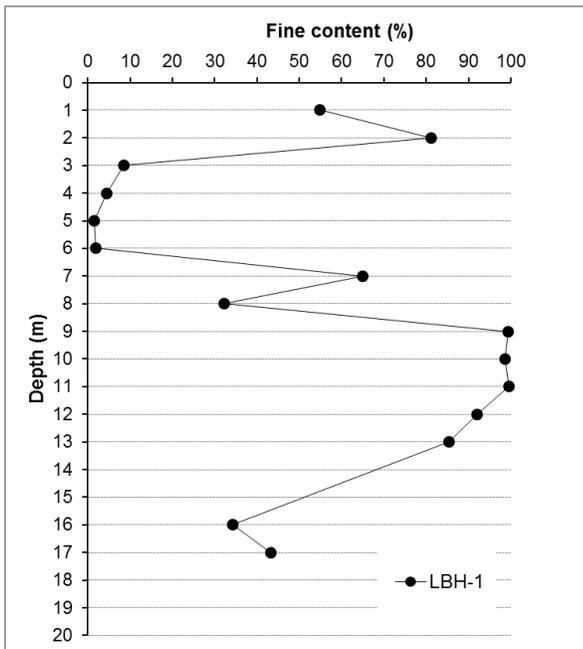
Fig. 12. Distribution of the fine content of the soil samples with depth in LBH-1

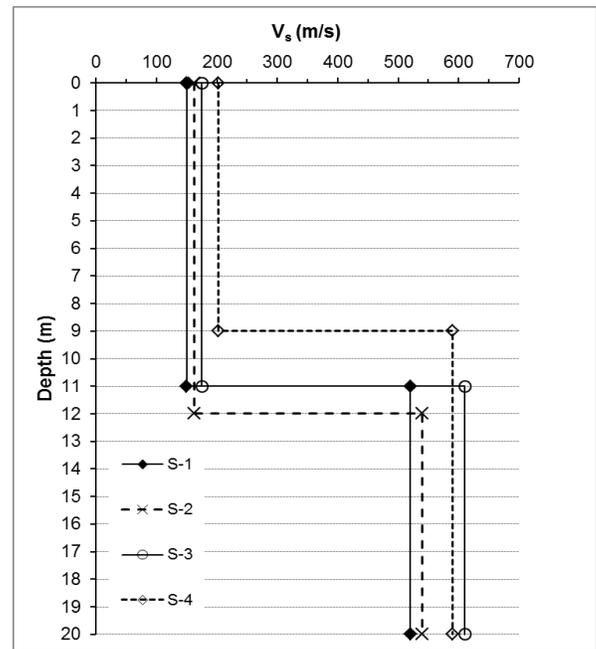
Seismic refraction surveys were carried out at four locations in order to determine the shear wave (V_s) velocity of the subsurface layers in the Karasu River floodplain where the sand boils extensively occurred. WZG-12 type engineering seismograph designed for shallow refraction survey was employed in the seismic studies. Seismic source for testing was gained by a hammer. Two subsurface layers were differentiated in accordance with the seismic investigations. The depth of the unit boundary varies between 9 and 12 m at different seismic survey points (Figure 13).

Fig. 13. Shear wave velocity (V_s) of the subsurface layers in the Karasu River floodplain

As seen in Figure 13, the shear wave velocity of the loose alluvium ranges between 150 and 202 m/s, and the velocity rapidly increases as high as 610 m/s in the lacustrine deposits. As a particular note, the lowest V_p (520 m/s) and V_s (150 m/s) velocities were measured on the sand boil where liquefaction occurred (S-1). In other words, the borehole LBH-1 and the seismic survey point S-1 are on the same sand boil.
