FAILURE INVESTIGATION OF A HELICAL ANCHOR TIE-DOWN SYSTEM SUPPORTING AN OLYMPIC SIZE SWIMMING POOL

Tom Labuda, P.E., P.G.
CTLGroup
Columbia, Maryland-USA 21044

Gene W. Corley, Ph.D., P.E., S.E.
CTLGroup
Skokie, Illinois-USA 60077

Michael Murphy, Ph.D.
CTLGroup
Columbia, Maryland-USA 21044

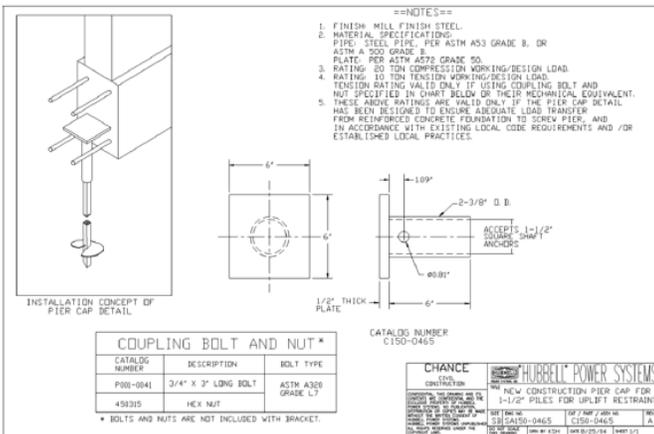
The anchorage system used also depended on the connection between the helical anchor and the pool bottom slab to transfer uplift forces from the slab to the helical anchors. The anchor cap assembly consists of a pipe sleeve and steel cap plate that are fitted loosely over and connected to the square shaft of the helical anchor. After being assembled and attached to the helical anchor, it is embedded (cast) into the pool slab. Pipe sleeves used on this project were originally designed to be connected to the helical anchor shaft using a bolted pin-connection, as shown in Fig. 3. This pile cap connection has been rated in the catalog for a maximum tensile capacity of 20 kips.

Fig. 3. Anchor Cap Detail – Hubbell Power Systems.

In the original anchor cap connection design by Hubbell/Chance, a ¾-inch diameter ASTM A320, Grade L7 bolt was indicated, Fig. 3. The allowable shear strength of the bolt was evaluated following Chapter J, Section J3.6, of the AISC Specifications and found to be inadequate to resist the specified design service load of 27 kips. It should be noted, however, that because ASTM A320, Grade L7 bolts are not covered in the AISC Specification the properties for an ASTM A325 bolt were used for analysis. The ASTM A325 high strength bolt has nearly the same minimum tensile strength as an ASTM A320, Grade L7 bolt (120 ksi vs. 125 ksi) and similar minimum yield strengths (92 ksi vs. 105 ksi).

The lowest allowable strength was found to be associated with a bearing failure at the bolt hole. This failure mode was evaluated using Chapter J, Section J7, of the AISC Specifications and was found to be significantly less than the specified service design load of 27 kips.

The weld strength connecting the steel pipe and ½-inch cap plate was checked consistent with Chapter J, Section J2.4, of the AISC Specifications. Since the exact details for the weld size and type of electrode used were not specified, it was assumed that a ⅛-inch fillet weld with E70 electrode was used. This is in accordance with what would typically be prescribed based on guidance from the AISC Specifications, considering the pipe wall thickness of ⅛ in. Calculation results indicated that the maximum service load permitted based on allowable weld stresses was about half the specified design service load of 27 kips.

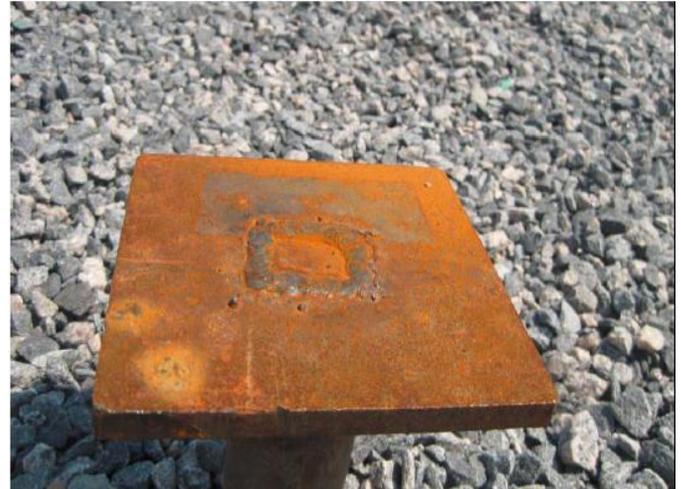
However, this connection was field modified so that the as-built shaft-to-cap connection was welded using inconsistent weld types and procedures, Fig. 4.

Fig. 4. Field Modified Anchor Cap Where Helical Shaft Has Been Inserted Through a Hole in the Cap Plate and Welded.

1. Embedded sleeve anchors did not show any sign of pullout from concrete slab.
2. Slab hold-down failure appeared to have originated with the welded connection between the embedded pipe sleeve cap plate and the helical anchor shaft. The weld connection failure was evident for most helical anchor shafts exposed during demolition. It was apparent that the failures occurred and propagated along the weld lines.

Evidently, due to constructability issues related to variable shaft cutoff elevations, the pre-drilled holes in helical anchor shafts were not at the required theoretical design elevation. This required the original pin-connected anchor cap design to be abandoned for a welded connection. In the modified connection, the square anchor shaft was inserted through a hole cut in the ½ inch thick plate of the anchor cap and then welded directly to it.

A photograph of the actual cap assembly, Fig. 4, shows this weld not to be a true fillet weld, but rather it resembles a partial penetration butt weld. In any case, the photograph shows that the weld quality was not consistent with a quantifiable weld procedure and any strength calculations for this weld are somewhat speculative. Allowable design values calculated using the AISC Specifications are based on quality welds made by certified welders. The welds observed in the field were not consistent with good weld quality and therefore could be expected to have strengths less than that calculated by the AISC Specifications.

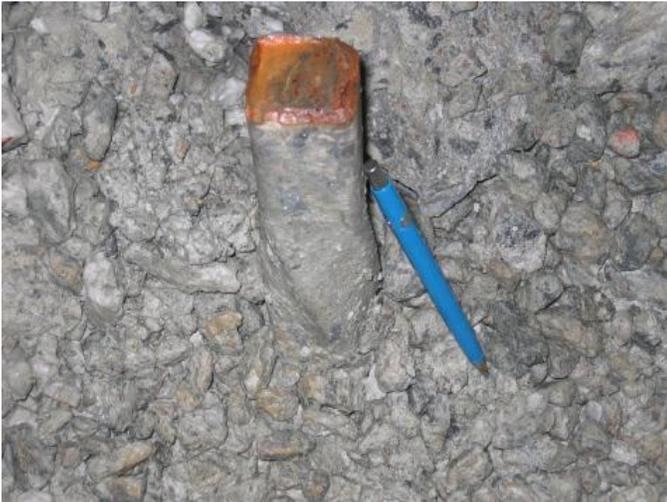
Exposed steel rod tops were generally at their design elevations indicating adequate embedment and sufficient uplift capacity. Most of the helical shaft rods exposed during demolition showed inelastic twist deformation of approximately ¼ turn in the upper eight inches of exposed shaft length. The observed permanent twist deformation very likely occurred during installation at the maximum installation

torque which was sufficient to produce inelastic torsion in the shaft, Fig. 5.

Fig. 3. Twisted Helical Anchor.
