WOLF CREEK DAM INSTRUMENTATION & MONITORING

Georgette Hlepas, PhD, PE

US Army Corps of Engineers – Chicago District
Chicago, IL 60630

ABSTRACT

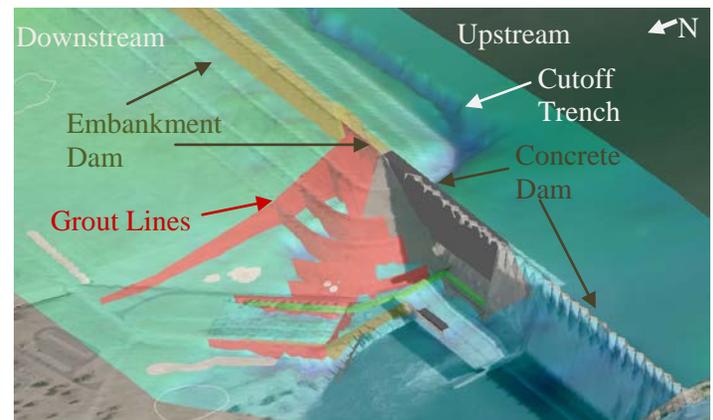
The development of sinkholes led to an emergency investigation and a subsequent emergency grouting program shortly thereafter. The grouting program consisted of a three-line grout curtain that began at the embankment/concrete dam interface on the crest and extended downstream for a distance of approximately 200 ft and extending to a depth of 273 ft, targeted the base of the Leipers formation. In order to protect the downstream embankment wrap around area, additional grouting was installed perpendicular to the downstream grout lines and extending toward the right abutment and following the curve of the wraparound. In addition, single line grouting was performed at select locations near the switchyard. Figure 3 identifies the grouted areas, highlighted in red, in a 3D rendering.

Figure 3: 3D rendering of remedial grout program (grout lines shown in red)

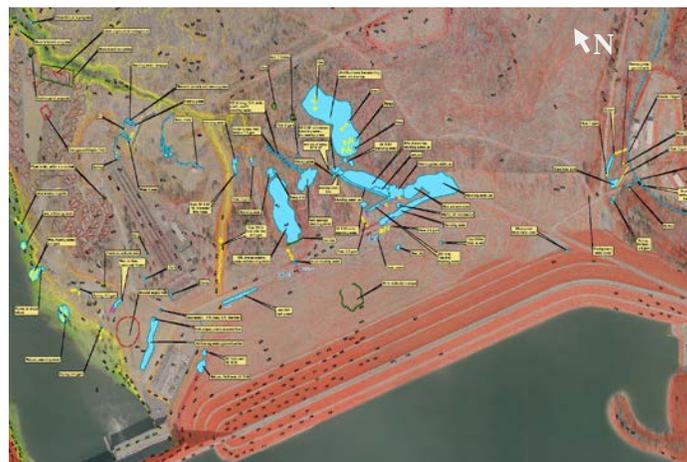
By 2004, wet areas were extensive throughout the downstream toe and switchyard areas. Figure 4 shows a map location of the wet areas that were identified in 2004.

Figure 4: Plan of wet areas (shown in blue) identified in 2004
