Recognition and Delineation of a Landslide, Turkey

Lester M. Tyralla

Stone & Webster Engineering Corporation, Boston, Massachusetts

SYNOPSIS: Geological mapping, geophysical surveys, test pits, and shallow borings were used to identify and evaluate a site containing a landslide complex. An investigation was performed to characterize the extent and nature of the complex, determine the susceptibility to movement, and the potential for impact on a nearby proposed reservoir and dam.

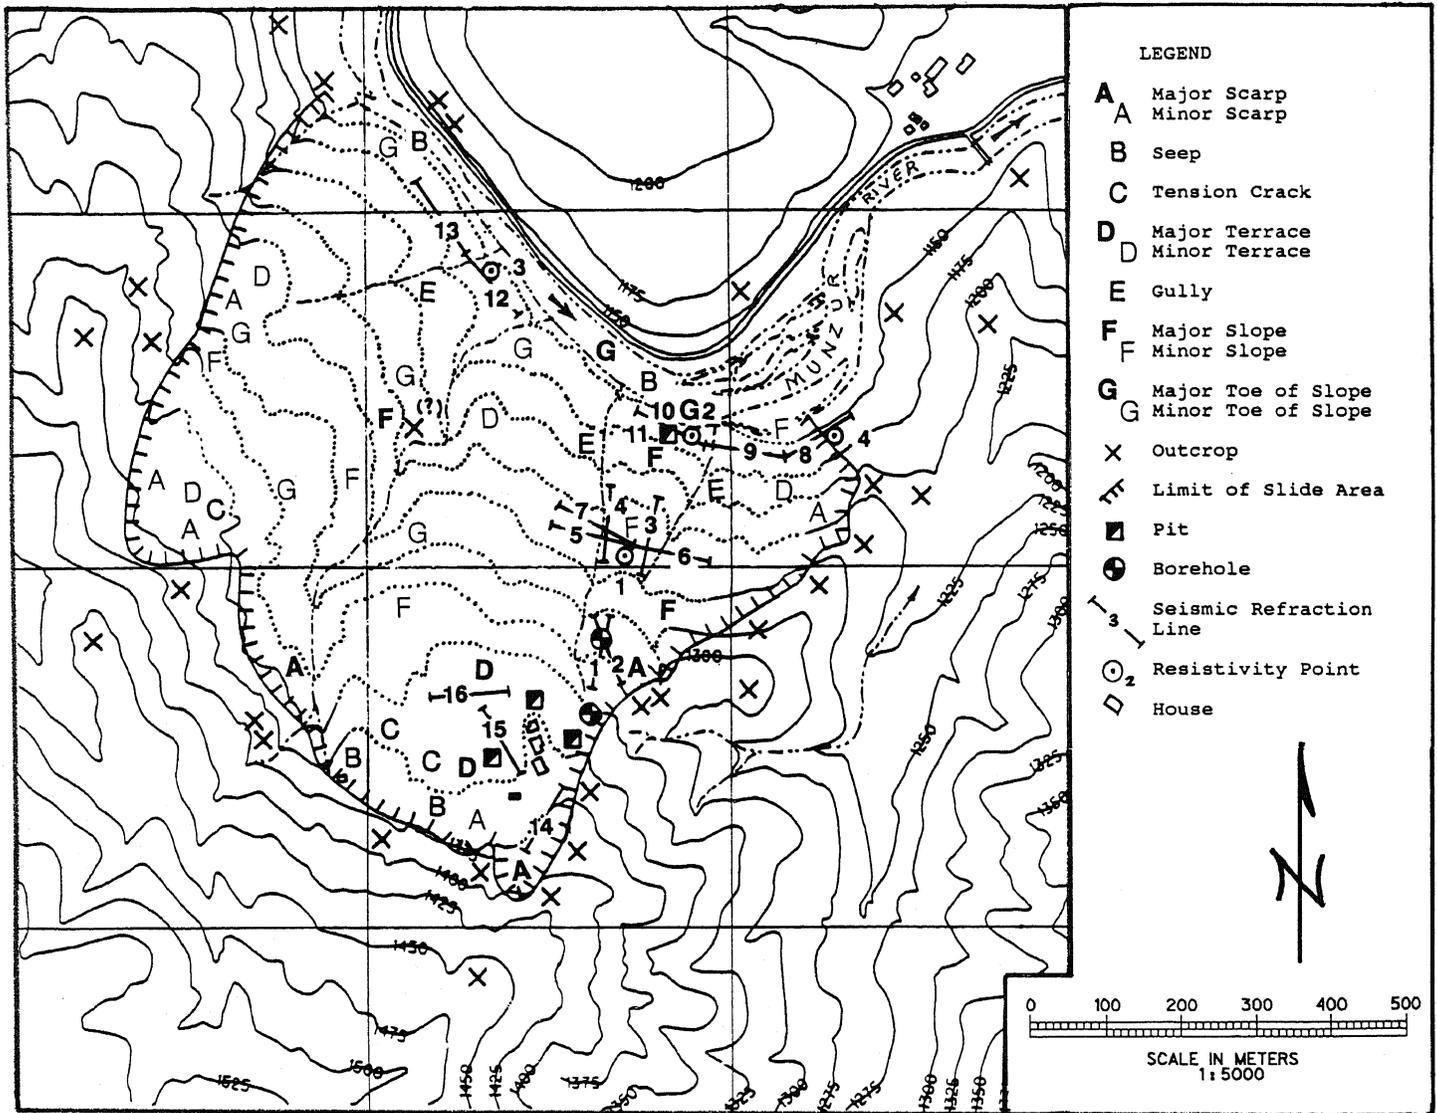
Figure 1. General Map of the slide area, geologic-morphologic features, and locations of exploration activities

The morphological features of the slide were used to plan line placement in order to investigate the thickness of disturbed materials at different locations (Figure 1). The majority of the survey lines were oriented approximately parallel to the strike of the slope in order to minimize the adverse influence of elevation changes. Where that orientation was not possible and the slope inclination was reasonably constant, the lines were oriented approximately perpendicular to the slope. Refraction and resistivity lines were situated on the scarps, terrace, slopes, and the toe of the slide complex.

Two borings, SA-1 and SA-2, were drilled on the slide (see Figure 1) to confirm its nature and extent using N-size equipment, standard split spoon sampling, and diamond coring. Boring locations were chosen on the bases of morphologic features, geophysical interpretation, and physical restrictions imposed by the terrain (Figure 1). Boring SA-1 was sited to determine the depth to the basal failure surface in an area near a scarp, and boring SA-2 was sited to verify the depth to bedrock at the intersection of two crossing refraction lines.
