## Earthquake Damage Done at Right Angles to Epicentral Direction

**Makoto Nasu**

Chief, Geotechnical Engineering Laboratory, Railway Technical Research Institute, Tokyo, Japan

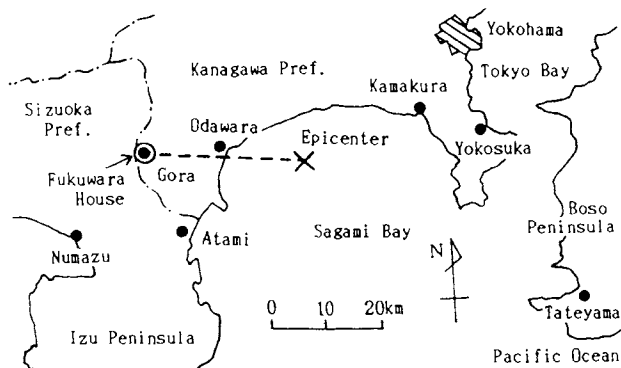
Fig.1 Damaged site of The Fukuwara House (1923 Big Kanto Earthquake)<sup>8) 10)</sup>

(a) The Fukuwara House in Hakone Gora  
This house failed on a small valley on the north slope.<sup>7) - 10)</sup> The ground seems to be made of a talus cone deposit. The flow line of this slope runs approximately at right angles to the epicentral direction, as shown in Fig. 1.

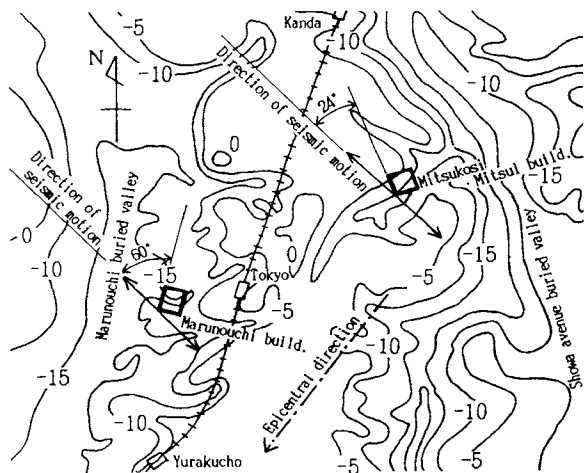
Fig.2 Equi-Depth Line (T.P., m) of Alluvium Bottom near the Tokyo Station (1923 Big Kanto Earthquake)<sup>7) 8) 11)</sup>

(b) The District near Tokyo station  
In the Marunouchi Building and the Mitsukoshi-Mitsui Building, as shown in Fig. 2, the direction of the predominant seismic force to the former building coincided with that to the latter, and two had worked approximately at right angles to the epicentral direction and to two buried valleys lines of the Marunouchi buried valley and the Showa-Dori buried branch valley.<sup>7) - 11)</sup> In the Marunouchi district, the ground had been said to tend to shake in the east-west direction. Namely the ground was liable to shake in the direction that alluvium deposit became thicker. The direction coincided with the seismic motion direction and so in the comparatively large valley of the former the damage seems to have turned out heavier than in the latter valley.<sup>6) - 12)</sup>

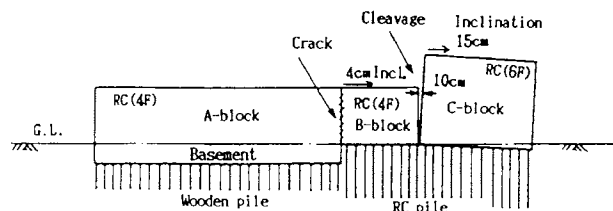
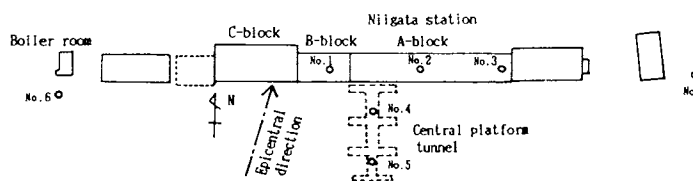
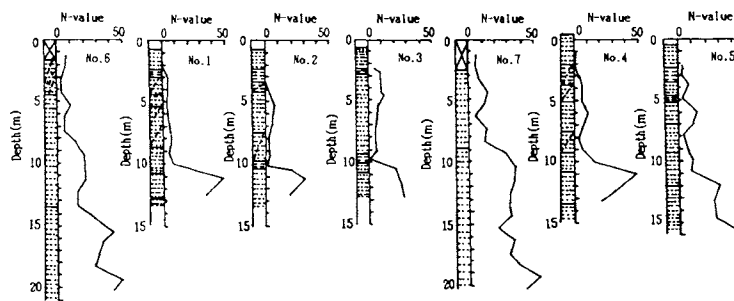
Fig.4 The Niigata Station (1964 Niigata Earthquake)<sup>2) 7)</sup>

As shown in Fig. 4, the soft ground bottom under the non-damaged A-block of this building was approximately horizontal. And B-block and C-block on the inclined bedrock tilted in the inclined direction of the bedrock<sup>2)</sup>. This inclined direction is approximately at right angles to the epicentral direction.<sup>7) - 14)</sup>

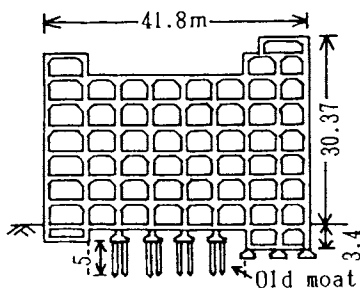
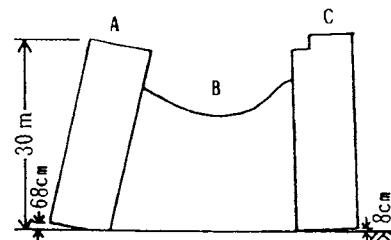
Fig.3 The Daiwa Department Store (1948 Fukui Earthquake)<sup>2) 7)</sup>

In the Daiwa Department Store building with different foundations, as shown in Fig. 3, the ground under the center part with pile foundation which was deformed largely was a reclaimed land of an old moat which extended from east to west, and was softer than the ground under both outside parts of the building with spread foundation.<sup>2)</sup> Also, the old moat extended approximately at right angles to the epicentral direction as shown in Fig. 2.<sup>6) - 7) - 13)</sup>

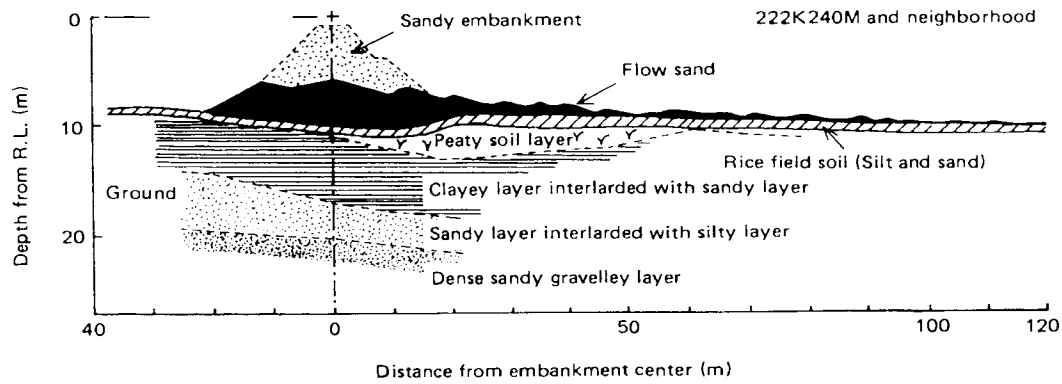
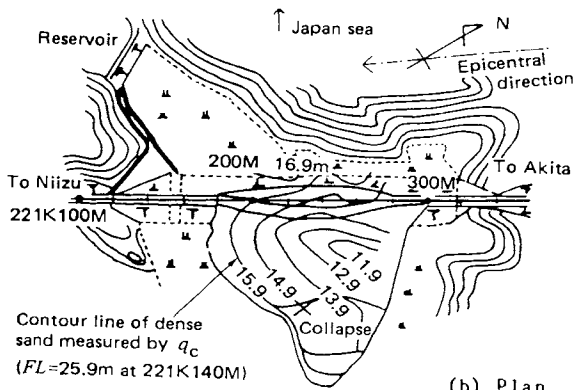
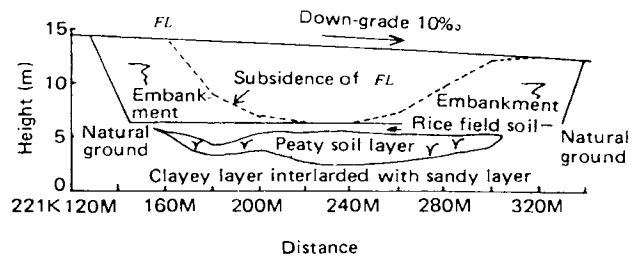
Fig.5 Railway Embankment in Deto (1964 Niigata Earthquake)<sup>1) 7)</sup>

As shown in Fig. 5, this embankment soil flowed out 120m long approximately at right angles to the epicentral direction.<sup>1)</sup> This embankment straddled soft ground of peaty soil and hard ground, and this peaty layer and soil layers under it had been inclined in the flowing direction of the embankment soil. Also, the deformed zone of this embankment coincided with the existing zone of peaty soil.<sup>6) - 7)</sup>

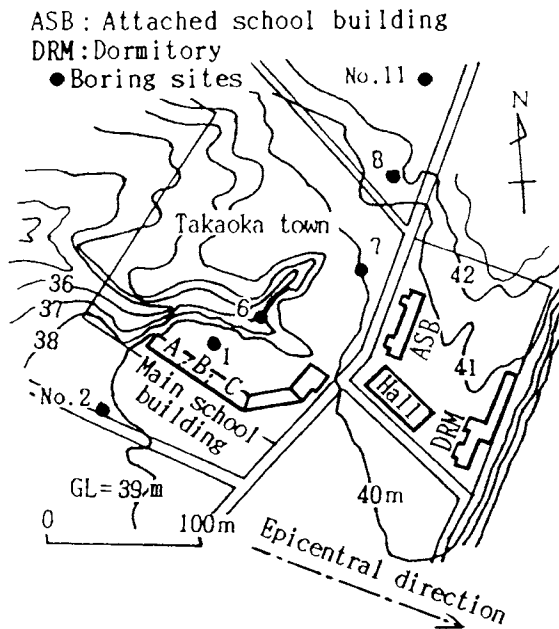
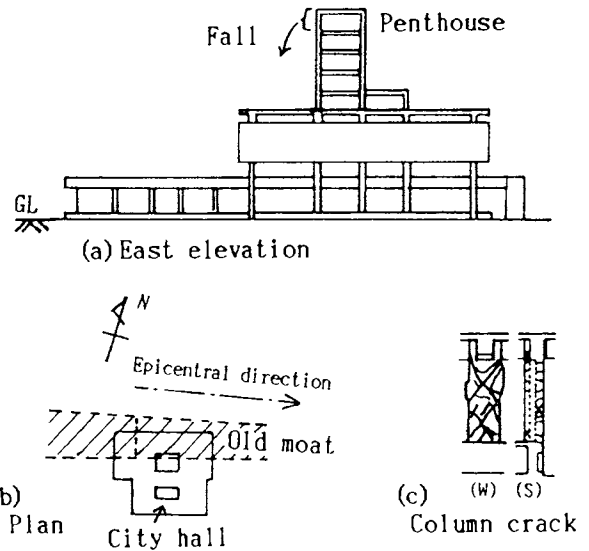
Fig.7 The Hachinohe City Hall (1968 Tokachi-Oki Earthquake)<sup>2)</sup>

(b) The Hachinohe City Hall  
The ground under the northern part of the building with pile foundation which had been damaged by both this earthquake and Iwateken-Chubu earthquake in 1987, is a reclaimed land of an old moat, as shown in Fig. 7.<sup>2)</sup> Predominant

seismic force direction in the former earthquake is estimated to have worked in the south-north direction with column crack etc., and also the top story the penthouse fell down in the southern direction of which the ground was good. The direction of the predominant seismic force in this case is approximately at right angles to the epicentral direction.<sup>6) 7) 19)</sup>

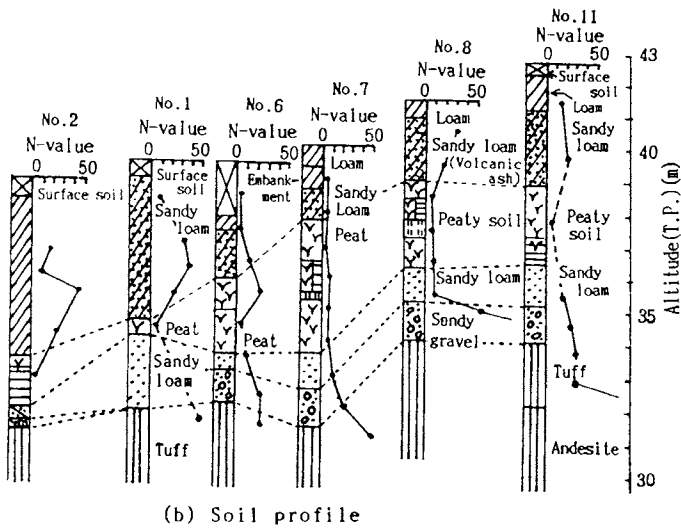
Fig.6 The Hakodate University (1968 Tokachi-Oki Earthquake)<sup>2) 12)</sup>

As shown in Fig. 6, the ground just beneath central part B close to the long side of main school building with spread foundation, which had collapsed extremely, was softer than right and left side grounds A, C, had inclined soil strata including peaty soil layers<sup>2) - 5)</sup>. Its span direction is approximately at right angles to the epicentral direction.<sup>6) - 7)</sup> They say that

first this building shook largely in the span direction approximately at right angles to the epicentral direction, and next did largely in the ridge direction. Nevertheless, the attached school building with spread foundation about 70m apart from the main building, was nearly intact on sandy loam ground.<sup>12)</sup>

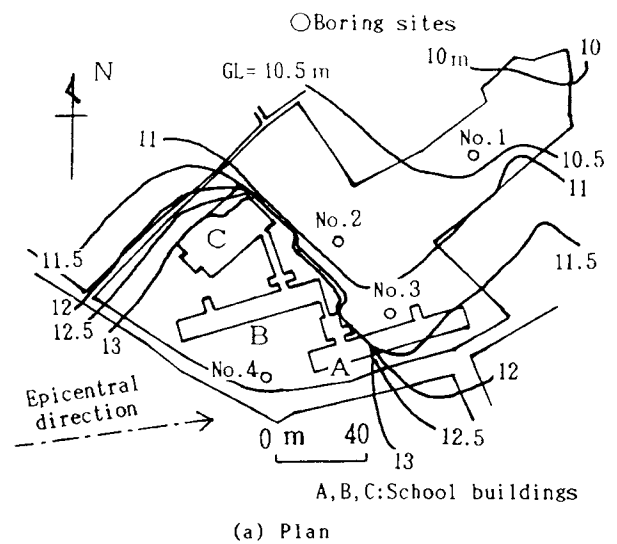
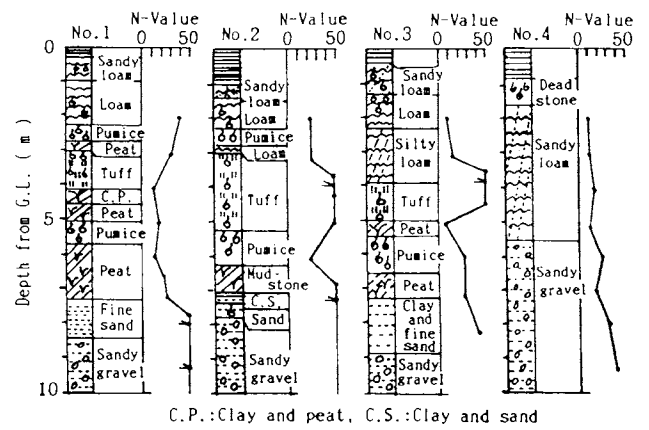
Fig.8 The Hachinohe East Senior High School (1968 Tokachi-Oki Earthquake)<sup>2) 7)</sup>

(c) The Hachinohe East Senior High School (with different foundations)  
As shown in Fig. 8, the ground under the east part with pile foundation of A-building, which was heavily damaged, had the deposits of swamp

soil including peat or peaty soil layer.<sup>2)</sup> The predominant seismic force to the east part of the A-building had worked approximately at right angles to the epicentral direction, and the building was twisted from the original ground surface.<sup>6) 7)</sup>

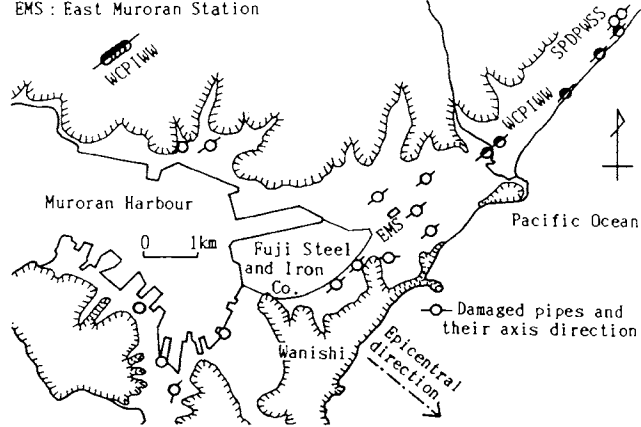
Fig.9 Main Damage of Pipe Lines of Industrial Water Works and Water Supply System in Muroran City (1968 Tokachi-Oki Earthquake)<sup>1,2)</sup>

(d) In Hakodate, Muroran and Tomakomai Cities, the service pipe lines and distributing pipes of water supply system and water conveyance pipes of industrial waterworks, pipes buried approximately at right angles to the epicentral direction had been damaged mostly, as shown in Fig. 9.<sup>13)</sup>

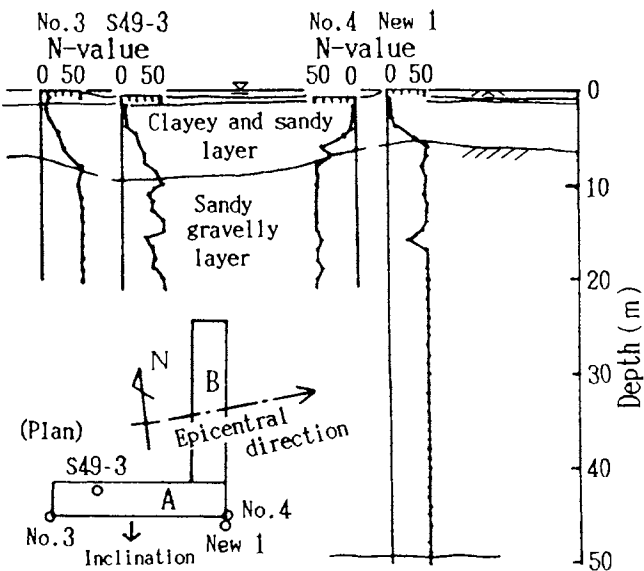
Fig.10 Ground of the Nagamachi Koriyama Housing Complex (1978 Miyagiken-Oki Earthquake)<sup>2),7)</sup>

(a) The Nagamachi Koriyama Housing Complex  
In the southern end of the reclaimed land of an old swamp which extends long in the north-south direction, as shown in Fig. 10. A building with pile foundation was inclined in the span direction, namely to the south. This inclination had occurred in such a direction that the inclination bedrock surface becomes shallow<sup>2)</sup>, and it was at right angles to the epicentral direction.<sup>6) 7) 19)</sup>

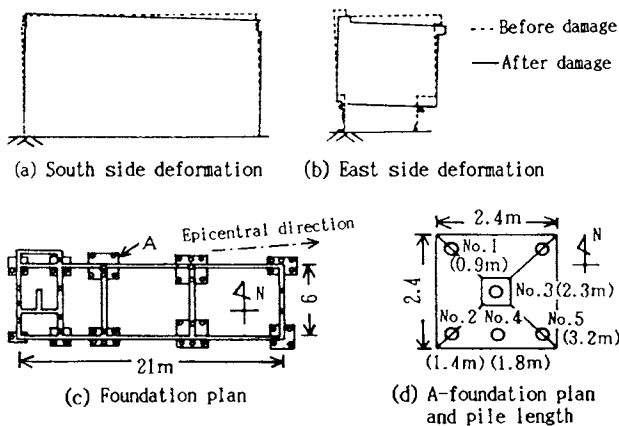
Fig.11 The Maruyoshi Building (1978 Miyagiken-Oki Earthquake)<sup>2),7)</sup>

(b) The Maruyoshi Industrial Building  
In this building with pile foundation, piles in one foundation had various lengths as shown in Fig. 11.<sup>2)</sup> The ridge direction approximately follows the epicentral direction, and especially the inclination of the building is larger in the span direction, being approximately at right angles to the epicentral direction, than in the

ridge direction.<sup>6) 7)</sup> Also, the inclination of the span direction is such that piles become short and the bedrock surface does shallow.<sup>19)</sup>

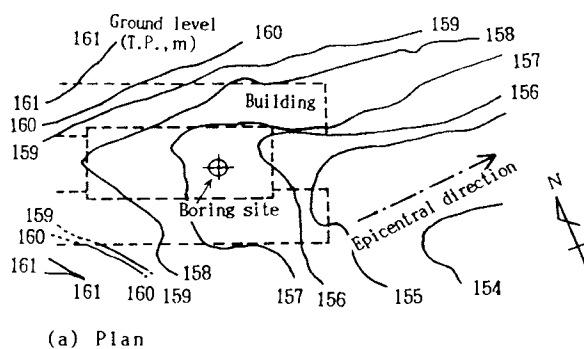
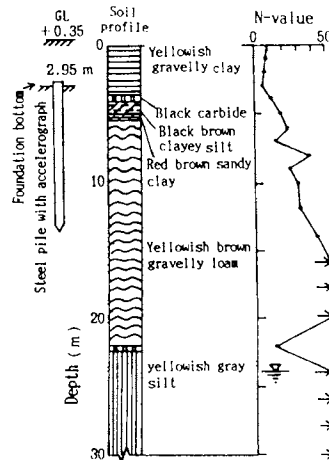
Fig.12 The Tohoku University Building (1978 Miyagiken-Oki Earthquake)<sup>2),7)</sup>

(c) The Tohoku University Building  
As shown in Fig. 12, the ground underlying this building had shown a small valley type topography on a terrace, and ridge direction was approximately parallel to valley axis. This building had been constructed straddling the valley, and shear cracks had occurred both in the east gable and the west gable.<sup>2)</sup> This ridge direction approximately coincides with the epicentral direction, and a predominant seismic force works approximately at right angles to the epicentral direction.<sup>6) 7)</sup>

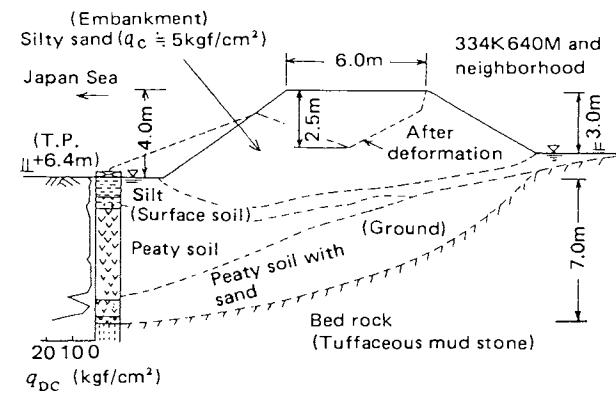
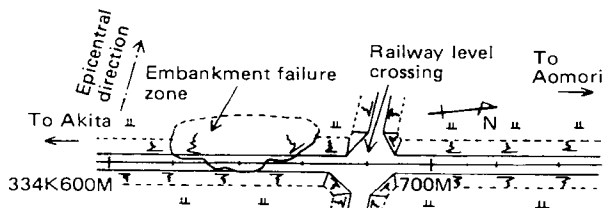
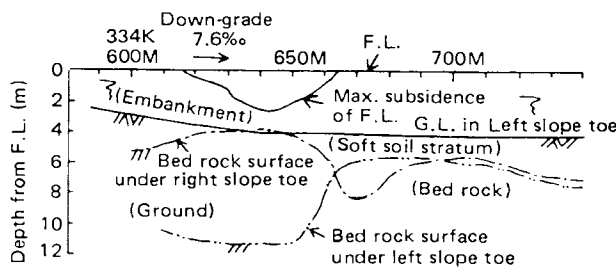
Fig.13 Railway embankment in Koikawa (1983 Nipponkai-Chubu Earthquake) <sup>1) 7)</sup>

(a) The railway embankment between Koikawa and Kado on the Ou Line  
This embankment failed on the ground in which the bottom of the soft soil stratum including a thick peaty layer greatly tilted, as shown in Fig. 13<sup>1)</sup>. Considering the damaged zone and the ground structure, it is estimated that the soft soil stratum bottom near 334K680M inclined

toward embankment axis and toward the starting point rather than the soft soil stratum bottom inclined at right angles to embankment axis influenced the failure first,<sup>6) 7)</sup> whereas a neighboring 334K720M embankment underlaid with very soft and almost horizontal soil layer did not subside nor was it deformed.<sup>1)</sup>

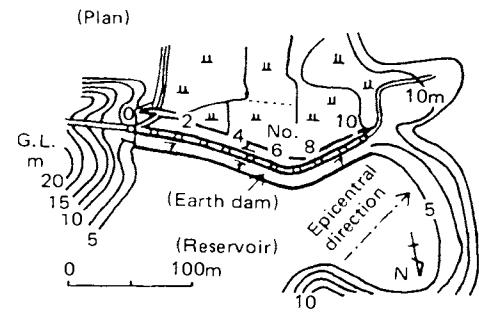
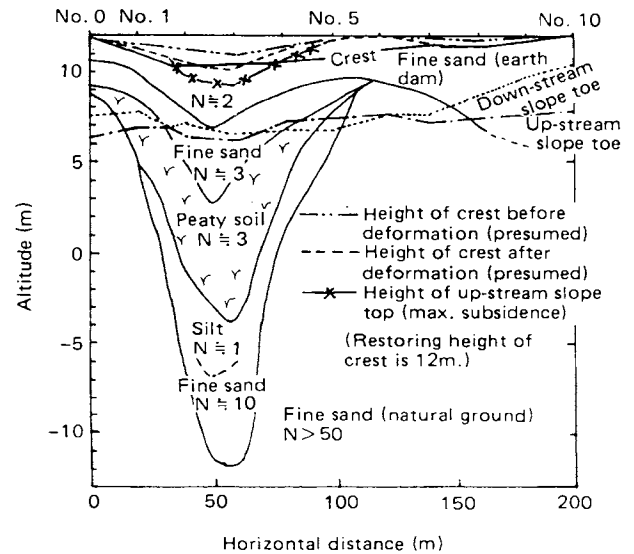
Fig.14 Relationship between earth dam subsidence and ground condition in Kansuke reservoir (1983 Nipponkai-Chubu Earthquake, revised original figure) <sup>1) 7)</sup>

An embankment near the left shore of which the up-stream side subsided especially largely, crossed the valley line that approximately coincided with the epicentral direction, and the inclination of both side slopes of its valley was comparatively steep, as shown in Fig. 14.<sup>1)</sup> Also, an embankment on hard ground near the right shore had deformed in the inclined direction of the embankment bottom and approximately at right angles to the epicentral direction.<sup>1) 6) 7)</sup>

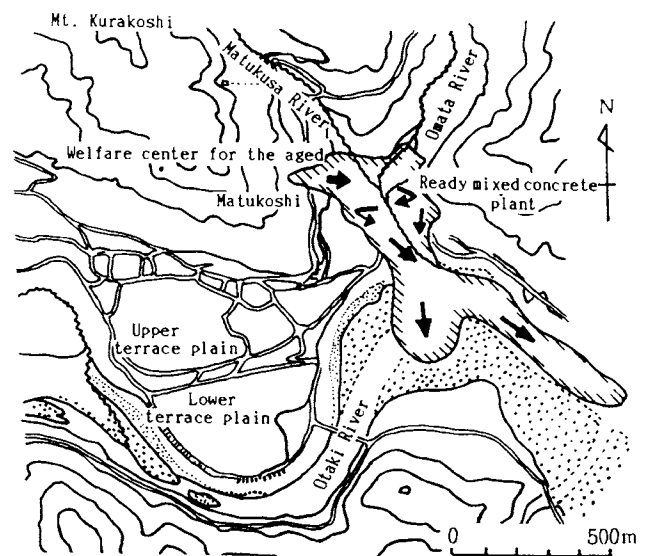
Fig.15 Slope Collapse in Otaki Village Matukoshi (1984 Naganoken-Seibu Earthquake) <sup>7) 14)</sup>

Additionally, natural slopes in Nakagi(1974) and Otaki Village Matukoshi(1984, see Fig. 15), embankments in Kotobukiyama(1978) and the Mochikoshi mine(1987) have collapsed exactly or approximately at right angles to the epicentral direction.<sup>6),7),14)</sup>

(1) The epicenter is exactly north from collapsed site.  
(2) Arrows show the flowing direction of collapsed soil.

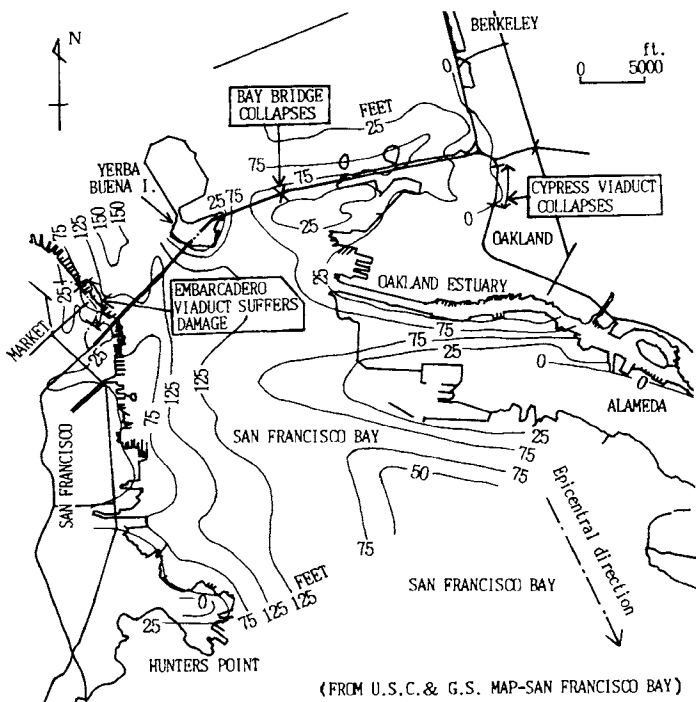
Fig. 16 Equi-depth line of Bay Mud base in San Francisco Bay (1989 Loma Prieta Earthquake)<sup>7) 15) -17)</sup>

The bridge axis direction of the San Francisco-Oakland Bay Bridge in which upper and lower decks fell down, and the directions at the right angles to the bridge axis of the collapsed Cypress viaduct, of the Embarcadero Viaduct of which piers were damaged, and of the Struve Slough Bridge of which girders and piers were damaged, were commonly approximately at right angles to the epicentral direction, as shown in Fig. 16.<sup>7),15)-19)</sup> Namely, the predominant

(b) Both the Embarcadero Viaduct where shear cracks have occurred in some piers at right angles to the bridge axis and the remarkably collapsed Cypress Viaduct has crossed the buried valley in the neighborhood of its exit to the Bay. As shown in Fig. 16, the bottom of the soft Bay Mud overlying these buried valleys was inclined toward the Bay.<sup>3) 16) 17)</sup> Especially, the ground of the zone where the Cypress Viaduct collapsed remarkably was a soft ground reclaimed from the swamp, and the most of it seems to be old river beds or old lagoons, and there is included a very soft clayey or silty layer etc. within the ground.<sup>17) 19)</sup>

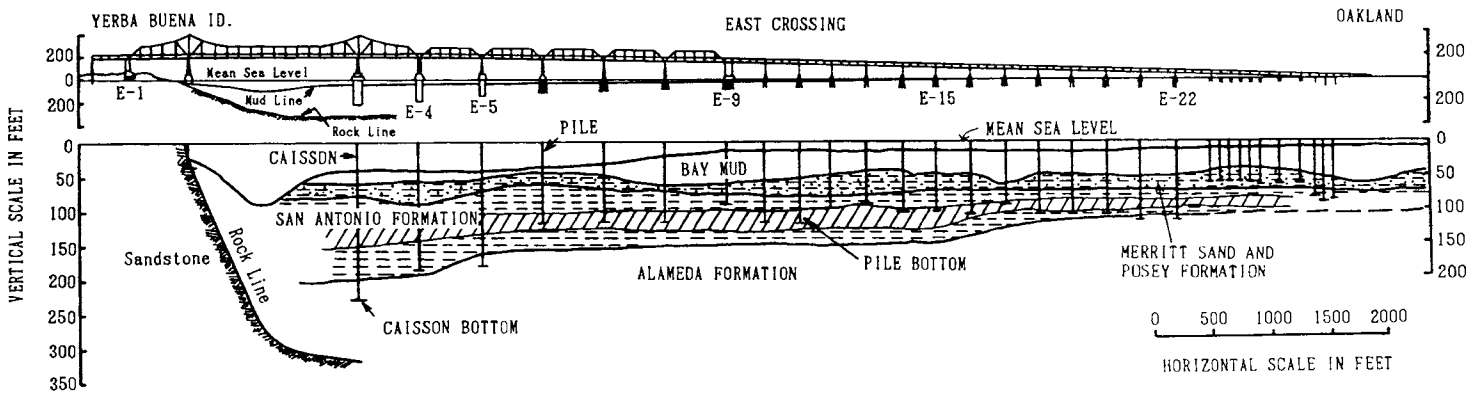
Fig. 17 The San Francisco-Oakland Bay Bridge (revised original figure)<sup>3) 15) 16) 19)</sup>

(a) Because the damaged Bay Bridge had been constructed straddling both thick and thin parts of soft Bay Mud in the bridge axis direction as shown in Fig. 17 <sup>15) -17) 19)</sup> and a differential displacement occurred largely in its direction, the bridge decks are considered to have fallen down. <sup>3)</sup> Moreover, the Bay Bridge moved largely at right angles to the bridge axis, <sup>17)</sup> namely in the radial direction of the equi-depth line of the Bay Mud. This can be expected from Fig. 15 showing the equi-depth line of the Bay Mud base. <sup>3) 16)</sup>

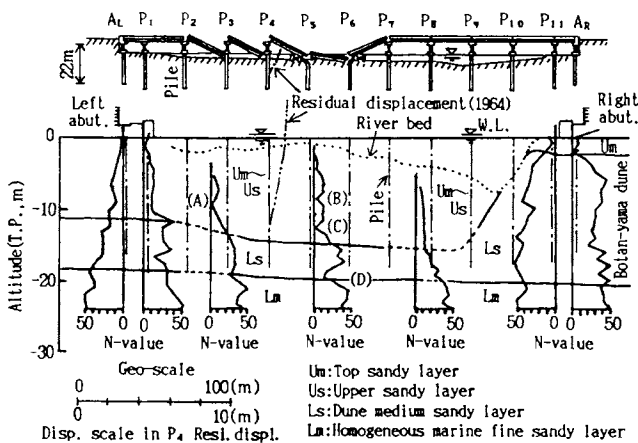
Fig. 18 The Showa-Ohashi Bridge (1964 Niigata Earthquake)<sup>3) 20)</sup>

Bridge (see Fig. 18),<sup>20)</sup> the Yachiyo Bridge (1964, commonly), the Kin-o Bridge (1978) and so on were deformed in the bridge axis direction. Many of them had been constructed straddling thin part and thick part of soft soil layer,<sup>1) -3) 6) 7)</sup> and their grounds were similar to the Bay Bridge ground.<sup>19)</sup>

In Japan, in grounds whose subsoil layers include soil layers(A ~D in Fig. 18) of less strength than about 15 in N-value like the Showa-Ohashi Bridge(1964)<sup>20)</sup> or the Hakodate University(1968), earthquake-induced damage has occurred in many spots, and most of the grounds had inclined sedimentary structures.<sup>1) -3) 19)</sup> Also, the grounds of the Marina district, of the district along the Market Street and of the South Market district in San Francisco where various damages occurred during the Loma Prieta Earthquake(1989), have included clayey soils with soft peat etc., or the soft Bay Mud.<sup>17) 19)</sup>
