The Loma Prieta Earthquake: Implications of Structural Damage

S.A. Mahin

Professor of Civil Engineering, University of California, Berkeley

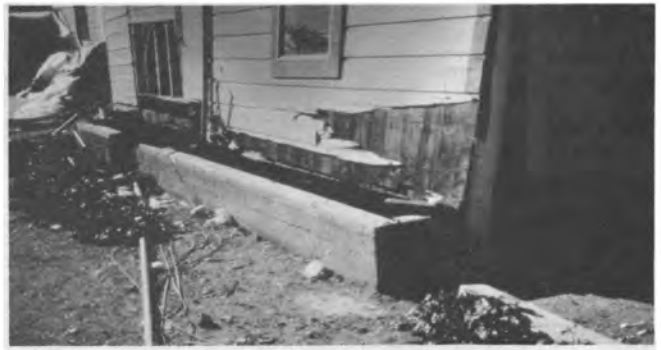
As indicated previously nearly 20,000 dwelling units were damaged during the Loma Prieta earthquake and 10,000 individuals were forced to relocate as a result. A majority of these displaced people lived in wood frame houses and apartments. Many homes located in the Santa Cruz mountains, in the immediate epicentral region, were damaged. Damages ranged from fallen chimneys and porches to partial or complete collapse. Many wood frame buildings in the hardest hit areas were overwhelmed by the seismically induced inertia forces. Sadly, the majority of the damage occurred in older wood frame buildings where the structures were simply not connected to their foundations. During the earthquake, as they have in innumerable past earthquakes, the structures simply shifted off their foundation with resultant vertical dislocation (Fig. 2).

Fig. 2 Damage to House Not Bolted to Foundation

The unfortunate aspect of both of these forms of damage is that simple and economical retrofit procedures, if implemented prior to the earthquake, could have prevented or significantly reduced the severity of the observed damages. Repair following the earthquake was generally extremely expensive as a result of not only the required structural repairs, but because of wide spread damages to architectural, electrical and mechanical features. Pre-earthquake retrofits to these walls and foundations were seen to be effective in several instances in Santa Cruz and elsewhere.

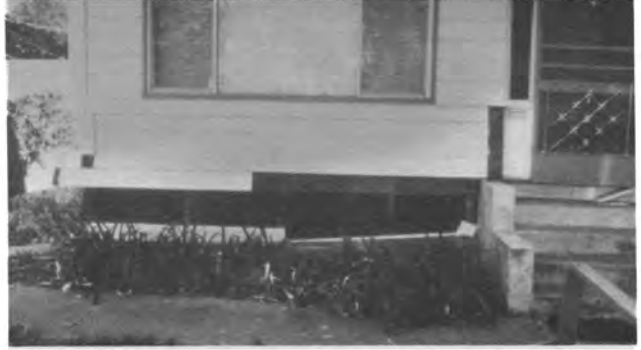
Another common type of failure that was observed related wood frame dwellings built upon short pony or cripple walls. These short walls provided a two to four foot tall access space that was used for storage, ventilation and to accommodate sloped sites. In many older buildings the framing between the ground floor and the foundation consisted of vertical studs and horizontal siding. Even though diagonal braces were provided in the upper levels to resist lateral loads, the braces were typically omitted from the pony walls. In addition, the horizontal siding covering these walls in most cases had badly deteriorated and effectively provided little or no lateral resistance (Fig. 3). The failure of these short support walls resulted in large vertical and lateral displacements of the supported structures (Fig. 4).

Fig. 3 Damage to "Pony" Wall

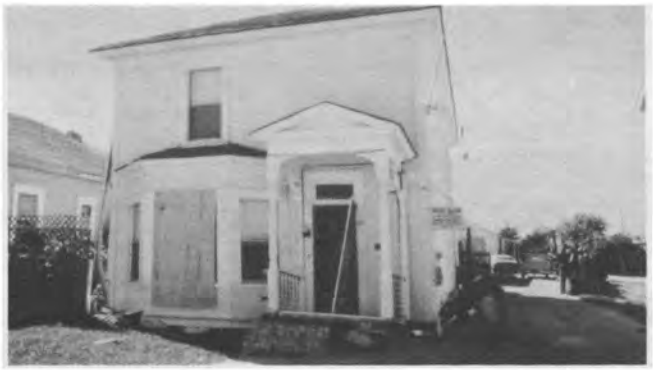
Fig. 4 Collapse of Home on "Pony" Walls

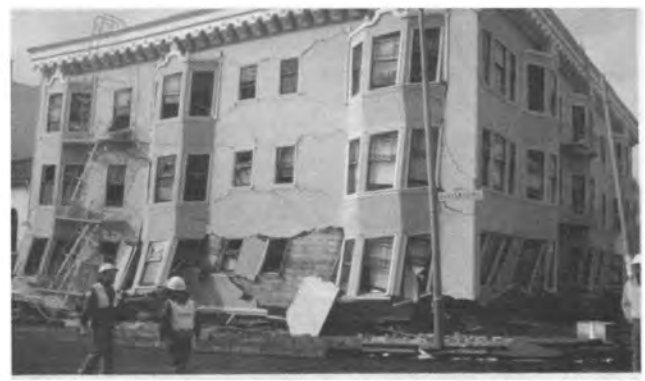
Many wood buildings were damaged or collapsed in this area. However, a detailed inspection of the damages indicates that the collapses concentrate in three or four story apartment buildings (Fig. 5) located on the corners of blocks (or where a structure was not sandwiched between two other adjacent buildings with little or no separation). These older apartment buildings were generally constructed with relatively massive apartment floors supported over a level of garages (Fig. 6). The bottom level thus was largely open to allow for multiple garage door openings. Typically, parking stalls were several cars deep and often extended out though the back of the building to provide for even more parking. This situation resulted in a soft first story. Lateral load resistance was provided by horizontal wood sheathing (covered by brick veneer) placed over only a few walls. This sheathing was observed to have decayed severely in many cases during the life of the structure.

The amplified seismic motions in the Marina District resulted in the collapse of the lower level of these corner apartment buildings in many cases. It is significant to note that these types of apartment complexes are quit common throughout San Francisco. Some apparently identical buildings located only a few blocks away from the heavily damaged area, but on firmer ground, remained virtually undamaged following the earthquake. Nonetheless, the potential hazard posed by these structures during future more severe earthquakes should be carefully investigated.

Fig. 5 Collapse of Apartment in Marina District

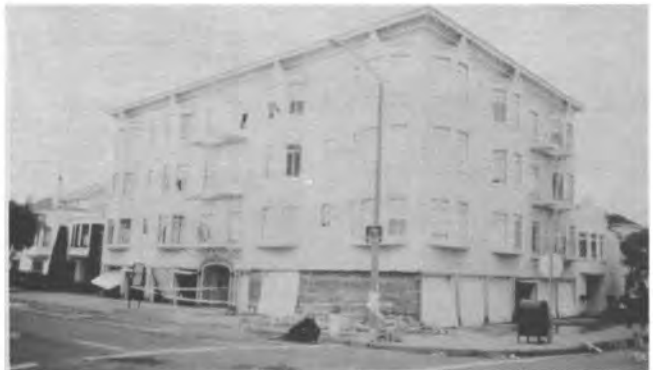
Fig. 6 Typical Marina District Apartment

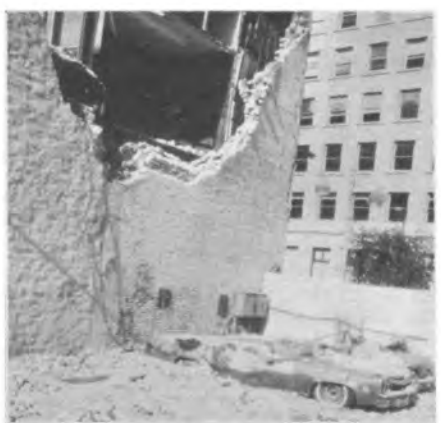
A particularly devastating form of damage resulted when the walls were not tied to the floor diaphragms. In many cases the walls failed out-of-plane, falling into the street (Fig. 7). In several notable cases the walls fell from upper floors of a building onto the roof of a lower adjacent structure (Fig. 8). The damage to the lower building resulted in two deaths in two separate buildings in Santa Cruz. In another instance, five casualties resulted as a wall collapsed in to the sidewalk area in front of an unreinforced masonry structure. For the level of shaking encountered, moderate amounts of tie

Fig. 7 Out-of-Plane Failure of Masonry Wall

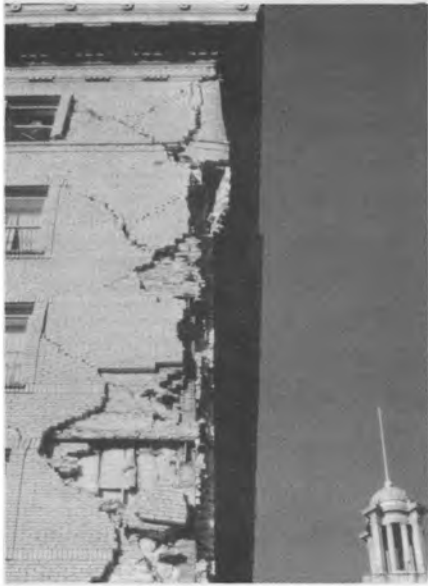
Another example, is the Hotel Oakland in Oakland. This is a steel frame building with extensive masonry infill panels. In retrofitting this structure new lateral load resisting elements were added and the exterior masonry elements were positively attached to the building to prevent large panels from falling into the street. As result of the earthquake nearly all of the masonry piers in the building developed distinctive x-shaped shear cracks. In addition, at a few locations masonry elements were dislodged from the building and fell to the street (Fig. 14). This building apparently preserved life safety as intended, but extensive and expensive repairs were required to restore the building fully to service.

Fig. 14 Damage to Retrofit Steel Frame Building with Masonry Infilled Walls

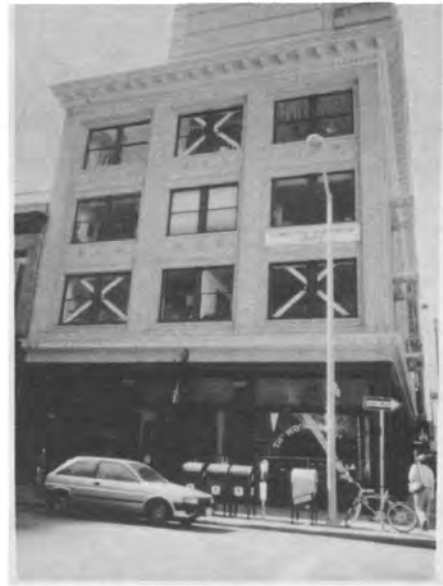
One of these structures (259 Front Street) was located at the corner of a block and it was heavily braced along two street sides (Fig. 15). The added braces at the street level buckled out of plane significantly (Fig. 16), but no damage was actually found in the masonry portions of this four story building. The second structure (1051-1075 Battery Street) was also braced but the mortar in the existing masonry walls was apparently so poor that random sections of the exterior wall fell from the building. Another building (located at Sixth Street and Bluxome Streets) had apparently been partially retrofit by addition of wall anchors. Five people were killed as the upper level wall on one side of the structure fell onto the sidewalk and street. In all of these cases it is clear that the lack of a consistent, systems approach to the design of the retrofits had a detrimental effect and that a new class of potentially hazardous buildings (i.e., the inadequately retrofit structure) needs to be investigated.

Fig. 15 Retrofit URM Building with Steel Braces

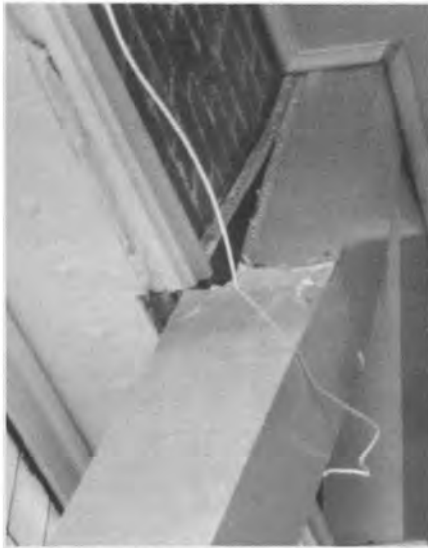
Fig. 16 Buckled Brace in URM Building

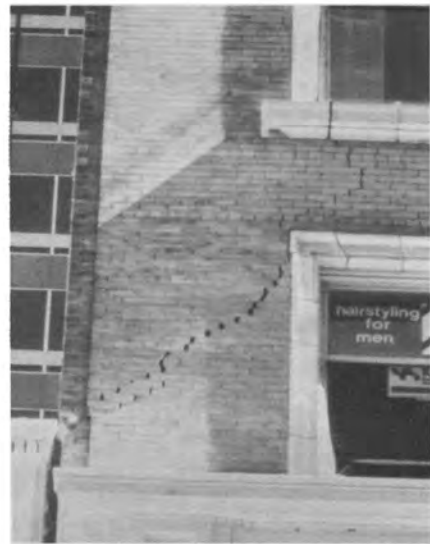
Fig. 17 Pounding Damage

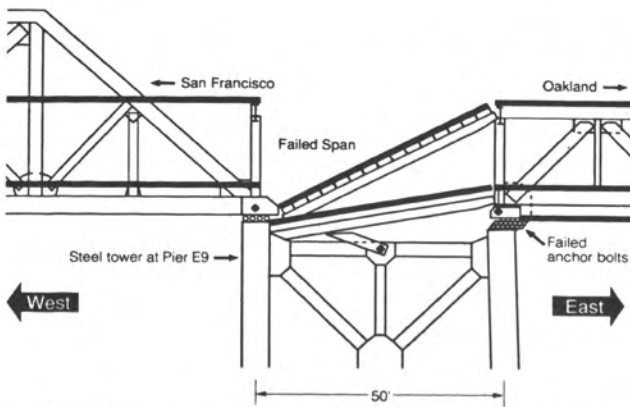
In addition, the bottom chords of the trusses were attached to the tower by means of twenty 1-in. diameter bolts. During the earthquake the bolts in the connection on the east side of the tower sheared completely and the bearing plate moved approximately 5-10 inches to the east. This was probably the proximate cause of the roadway beams slipping from their seats.

Fig. 18 Detail at Collapsed Section of Bay Bridge

The bridge was repaired by jacking the eastern segments back into place and providing new roadway beams and supports. The support seats were constructed about 50% longer than in the original design. A more extensive study is currently under way by Prof. A. Astaneh and his colleagues at the University of California, Berkeley and by Caltrans to assess more reliable long term retrofits.

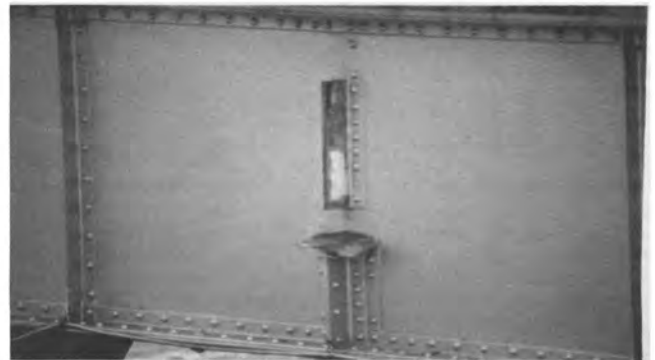
Fig. 19 Detail of Seat Connection on Bay Bridge

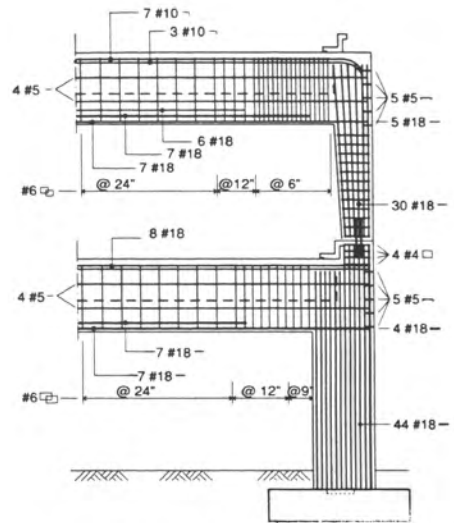
This bridge represented in many respects a substantial advance in the state of the art at the time it was built. Not only did it have two levels, it was one of the first major bridge structures in the U.S. to employ post-tensioning and large diameter reinforcing bars. In most cases the structural system incorporated a significant number of flexural hinges in order to simplify the future addition of access ramps, to reduce secondary forces resulting from deformations associated with post-tensioning and foundation settlement, to reduce computational effort and to control moments that could be transferred to the foundations. This resulted in a structure that was nearly statically determinate. In addition, detailing did not incorporate features needed to impart ductility to the elements (shear reinforcement sufficient to develop the flexural capacity of members, confinement of potential plastic hinge regions and inadequate development length on reinforcement), and joints were neither confined nor designed to resist the shear forces associated with realistic lateral loadings. Details of a typical transverse bent are shown in Fig. 21. In addition, in the longitudinal direction, frame action depended on the

Fig. 21 Detail of Typical Bent [from Housner (1970)]

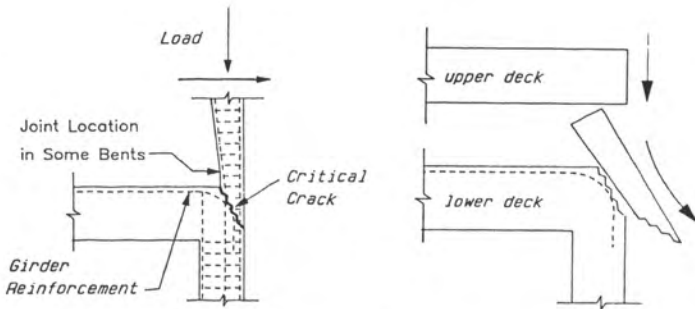
The dominant features of the typical collapse mechanism are shown in Fig. 22. Shear cracks in the pedestal supporting the hinged upper level columns were able to extend downward into the joint region following the projection of downward bending hooks on the end of the transverse girder's (cap's) top level reinforcement. The lack of shear reinforcement in the joint allowed this inclined crack to act like a slide, with the resultant pancake collapse of the upper level.

Fig. 22 Postulated Failure Mode

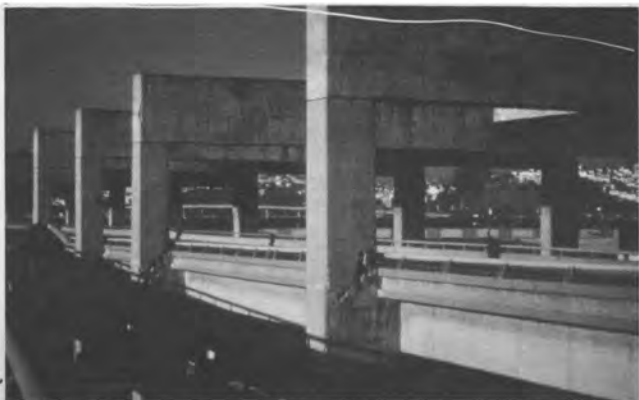
Upon construction of the Cypress Street Viaduct a series of six other double deck viaducts were designed and constructed in the Bay Area. All of these suffered damages during the earthquake. Each suffered characteristic distress in the lower joint regions similar to that developed in the Cypress Street structure. An example of this is the Southern Freeway portion of Interstate 280 located near the southern border of San Francisco (Fig. 24).

Fig. 24 Damage to Southern Freeway

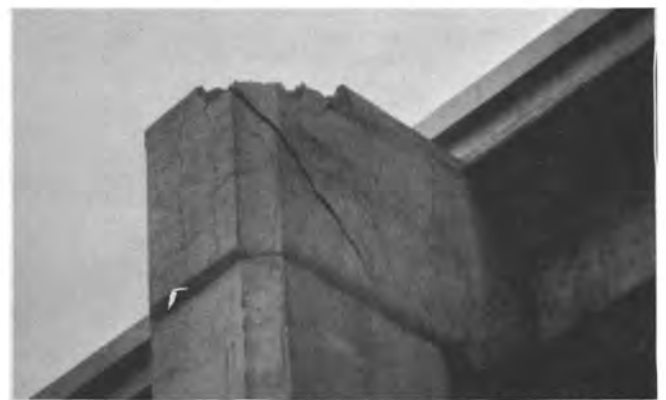
Fig. 25 Damaged Knee Joint in New Freeway

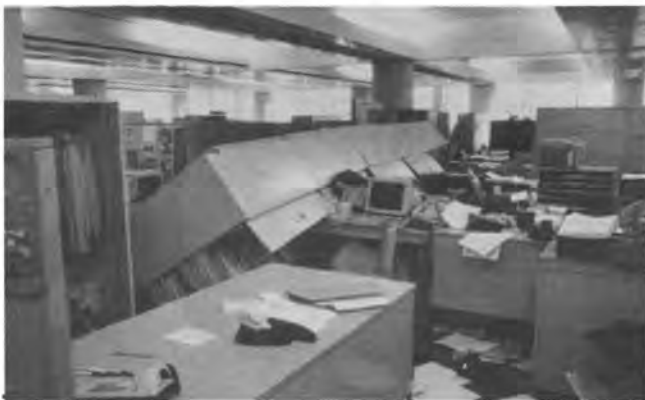
Fig. 28 Damage to Building Contents
