## Phase 1 Inspection Report: National Dam Safety Program. Mississippi - Kaskaskia - St. Louis Basin. Cadet Mine Tailings Dam, Washington County, Missouri

CADET MINE TAILINGS DAM  
WASHINGTON COUNTY, MISSOURI  
MO 30715

## PHASE 1 INSPECTION REPORT NATIONAL DAM SAFETY PROGRAM

FEBRUARY 1980

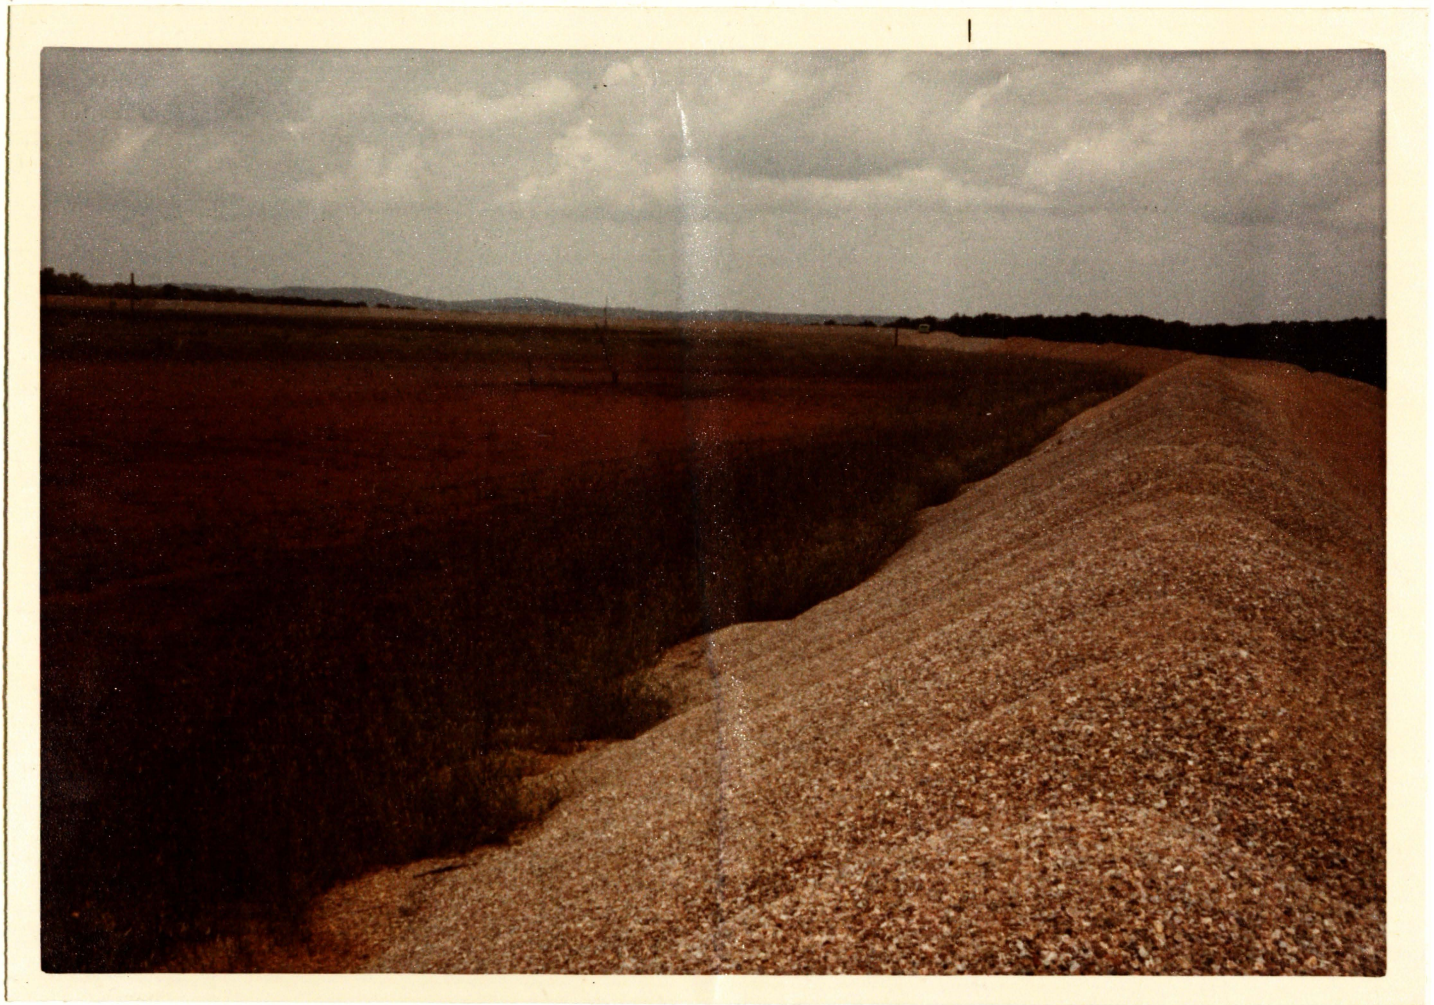
OVERVIEW OF CADET MINE TAILINGS DAM - I.D. NO. 30715  
FROM CREST OF EAST LEG TOWARD NORTH LEG

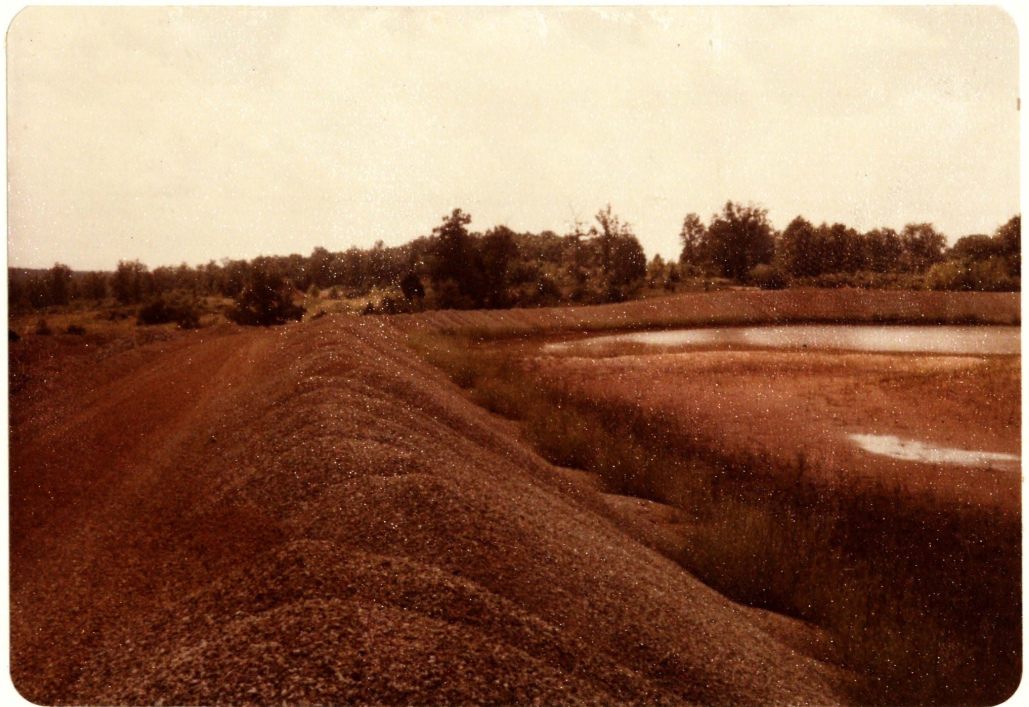
| <u>Photo No.</u> | <u>Description</u> |
|---|--|
| 6 | View south along crest of east leg of dam at south end of impoundment. The low point in the dam crest and the widened crest at Station 8+00 are visible at the left side of the photograph just before the curve in the crest. |

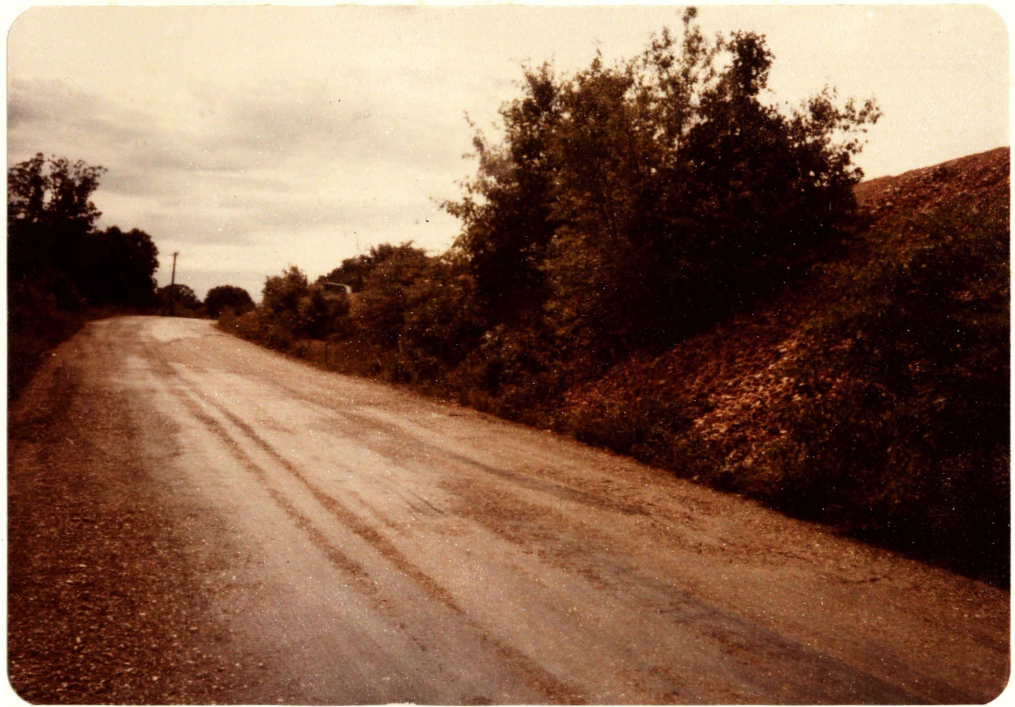
The embankment has encroached onto the paved road at the south end of the impoundment. The roadside drainage ditch has been blocked and runoff in this ditch could cause erosion of the embankment toe in this area.

| <u>Photo No.</u> | <u>Description</u> |
|---|--|
| 7 | Encroachment of the embankment fill onto the paved road adjacent to the south end of the impoundment near Station 6+00. |
