## Phase 1 Inspection Report: National Dam Safety Program. Mississippi - Kaskaskia - St. Louis Basin. Carden Lake Dam, Crawford County, Missouri

CARDEN LAKE DAM

MO 30987

## PHASE 1 INSPECTION REPORT NATIONAL DAM SAFETY PROGRAM

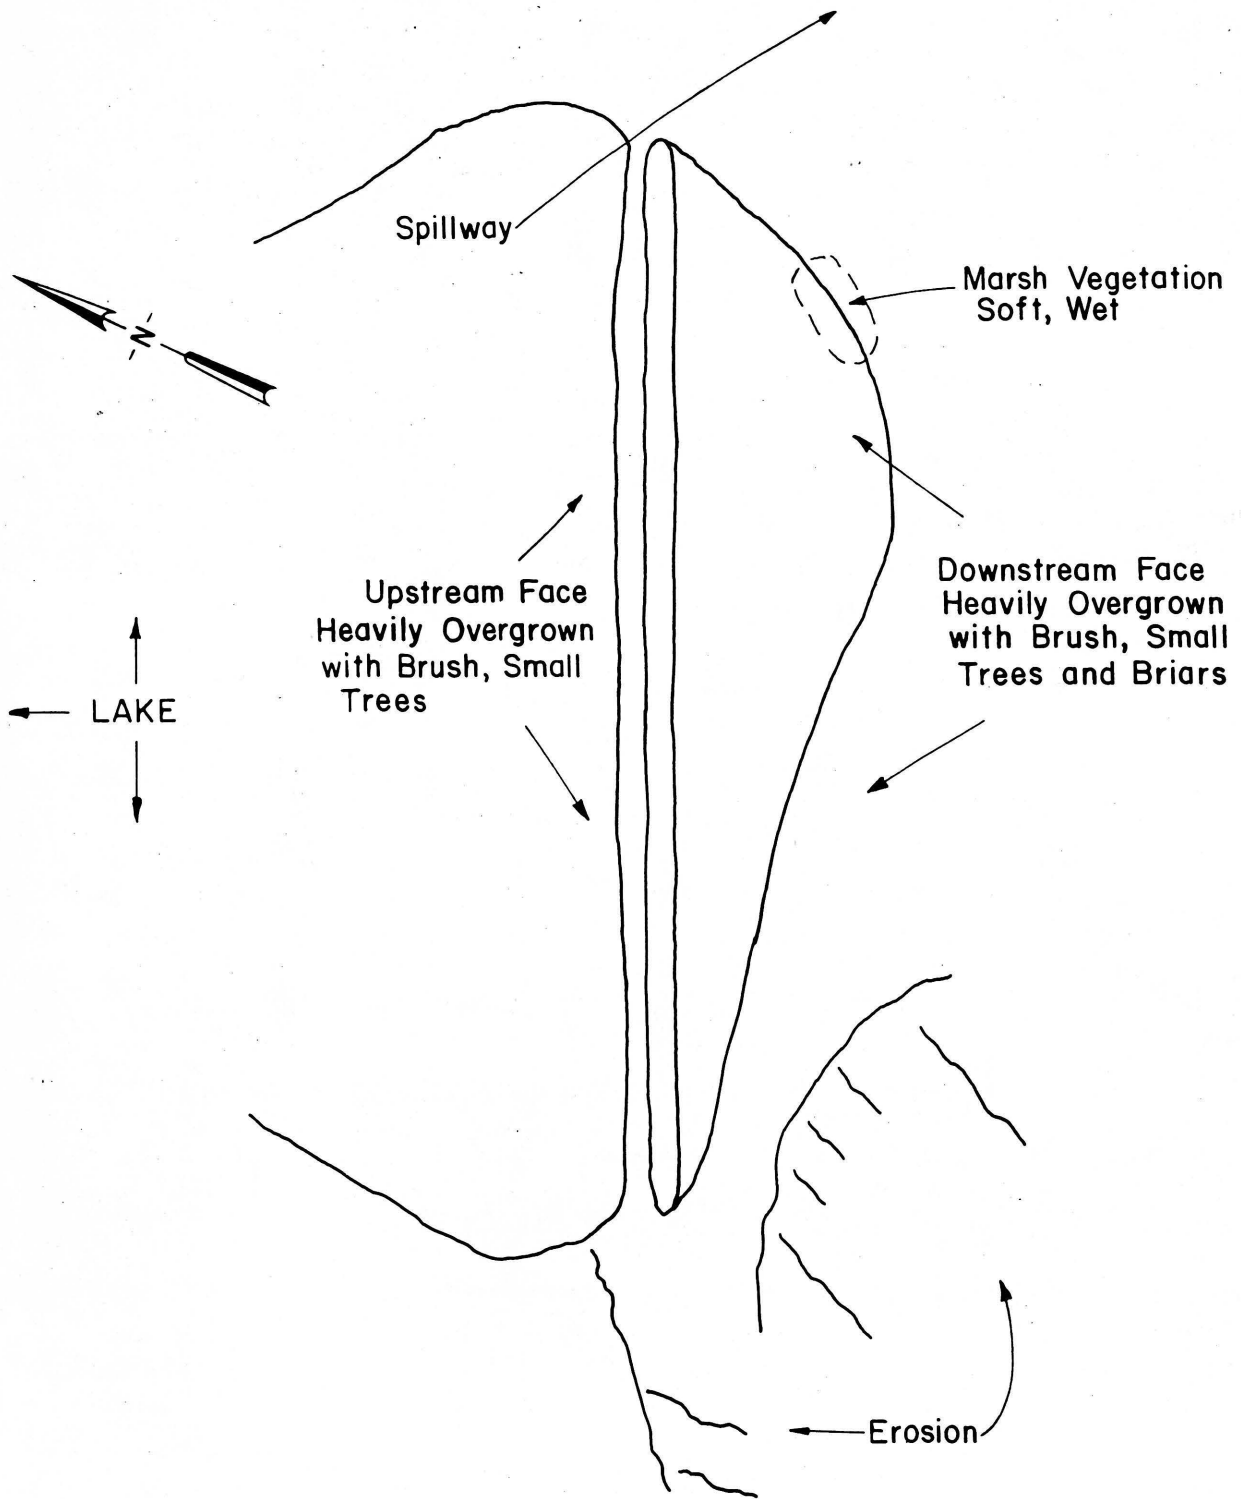
PLAN SKETCH OF FEATURES

Soils in the embankment and in abutment areas near the dam are described as sandy silts with a trace of clay and rock fragments (ML). These soils are somewhat erodible as indicated by the erosional area in the right abutment near the dam (see Sheet 5 of Appendix A).

A large erosion area was noted in the right abutment (see Sheet 5 of Appendix A). This area is somewhat apart from the dam and would not appear to affect the embankment stability.

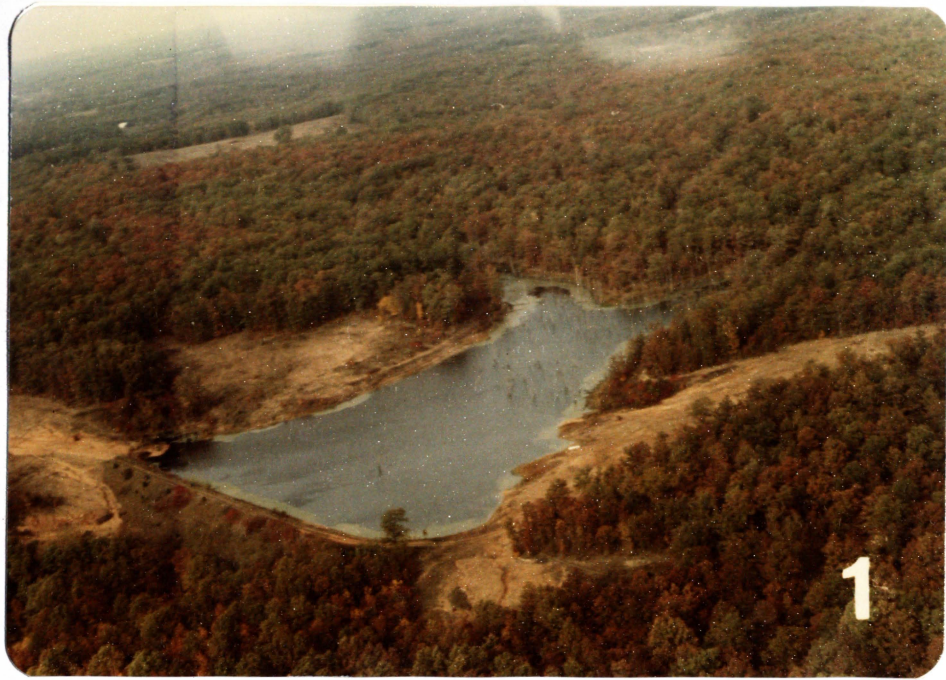
The watershed is generally heavily wooded with some cleared areas on both sides of the lake (see Photos 1 and 2). The slopes adjacent to the lake are moderate, and no sloughing or serious erosion was noted. No significant sedimentation was observed.

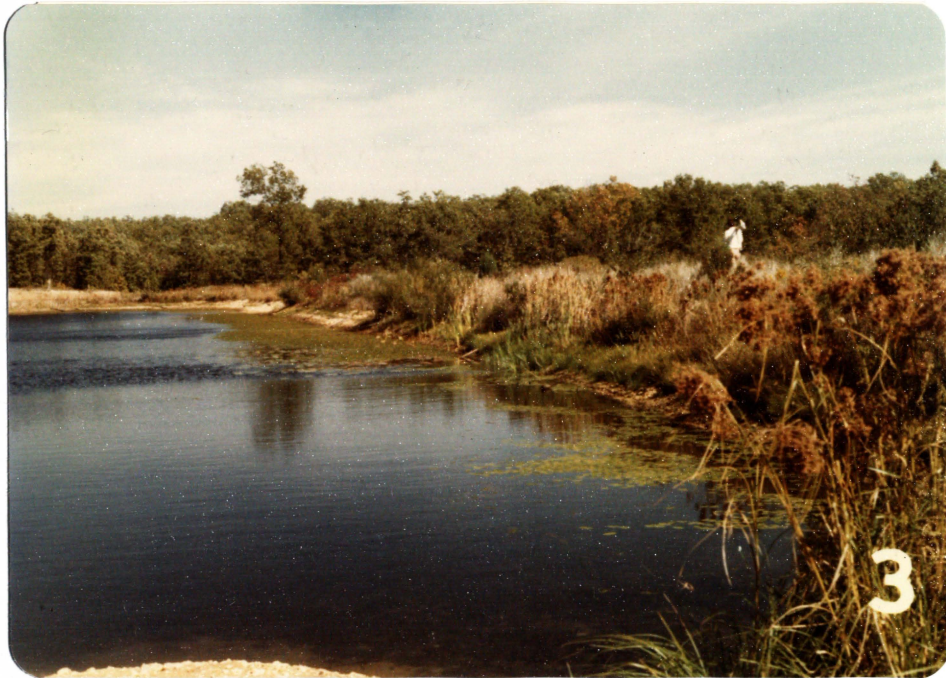
The dam appears to be in good condition. The upstream face is heavily overgrown with brush and small trees. There is no riprap, but there is a mixture of rocks left by moderate wave erosion. No significant sloughing was observed (see Photos 3 and 4).

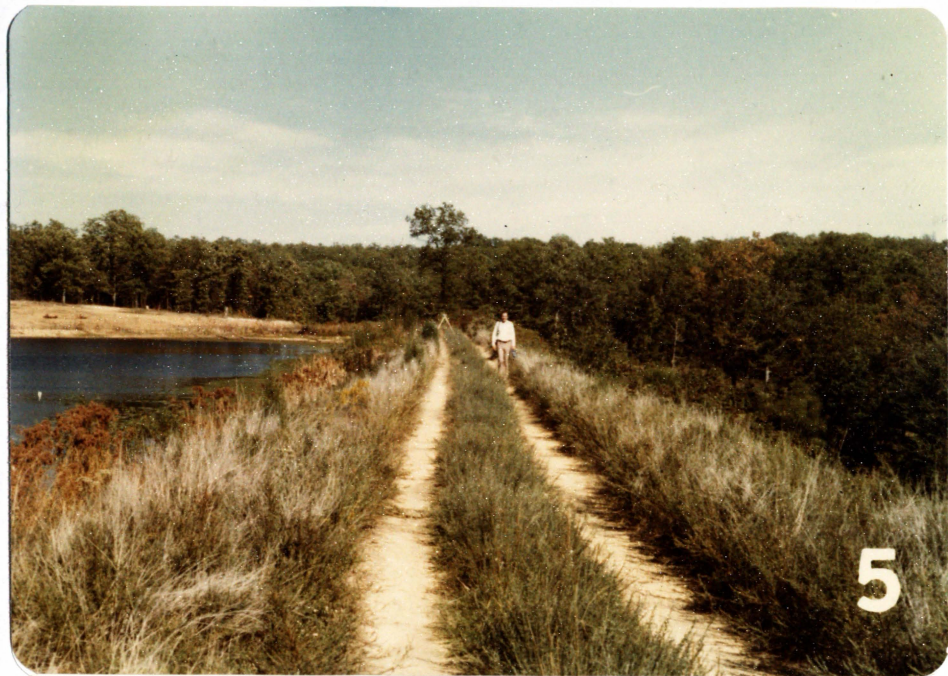
The crest of the dam is fairly clear with some weed growth. The horizontal and vertical alignment appeared good, and no surface cracking or unusual movement was obvious (see Photo No. 5).

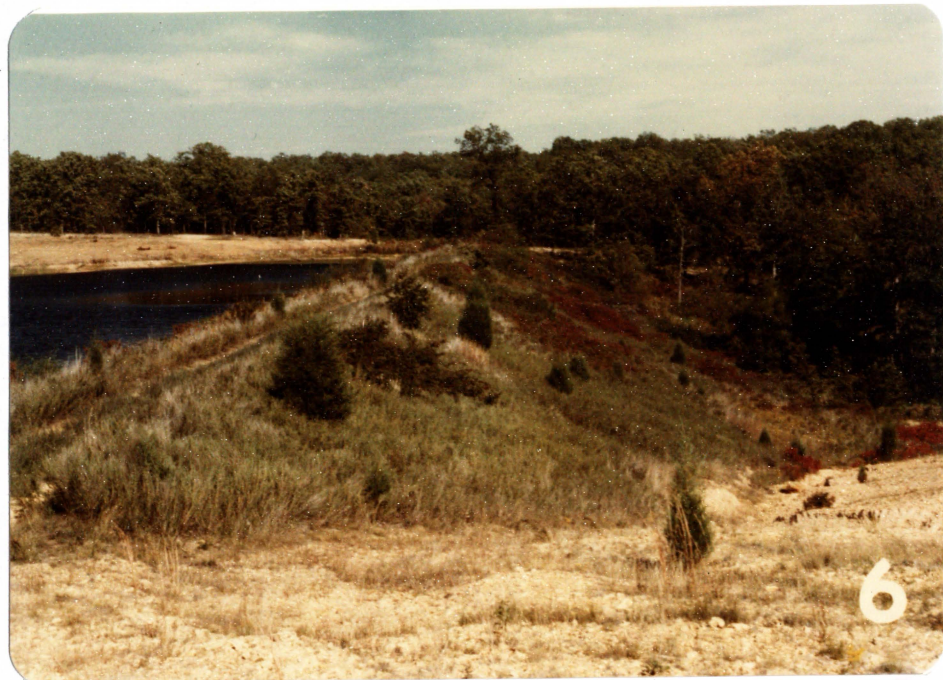
The downstream face was heavily overgrown with briars, brush, small trees, and high weeds making it difficult to inspect. No sloughing, animal holes, or significant erosion was noted (see Photos 6 and 7). The abutment-dam contacts were not significantly eroded.

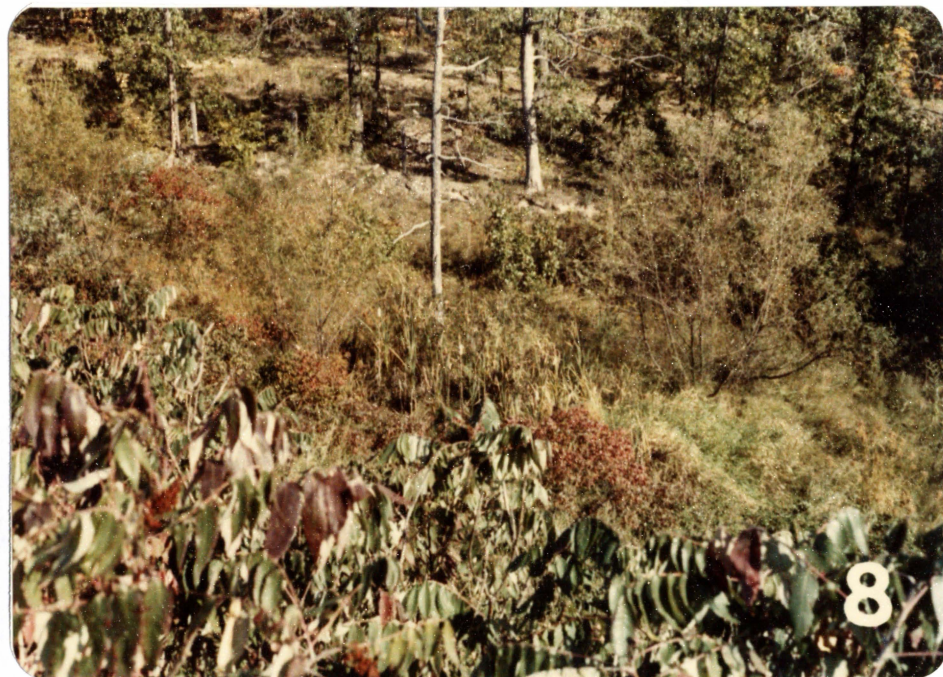
An apparent seepage area was noted at the left abutment-dam downstream contact (see Photo No. 8). This area was soft and wet with marsh vegetation. No measurable flows were seen.
