**Phase 1 Inspection Report: National Dam Safety Program.  
Mississippi - Kaskaskia - St. Louis Basin. Lac Benet Dam, St.  
Francois County, Missouri**

LAC BENET DAM

ST. FRANCOIS COUNTY, MISSOURI

## PHASE 1 INSPECTION REPORT NATIONAL DAM SAFETY PROGRAM

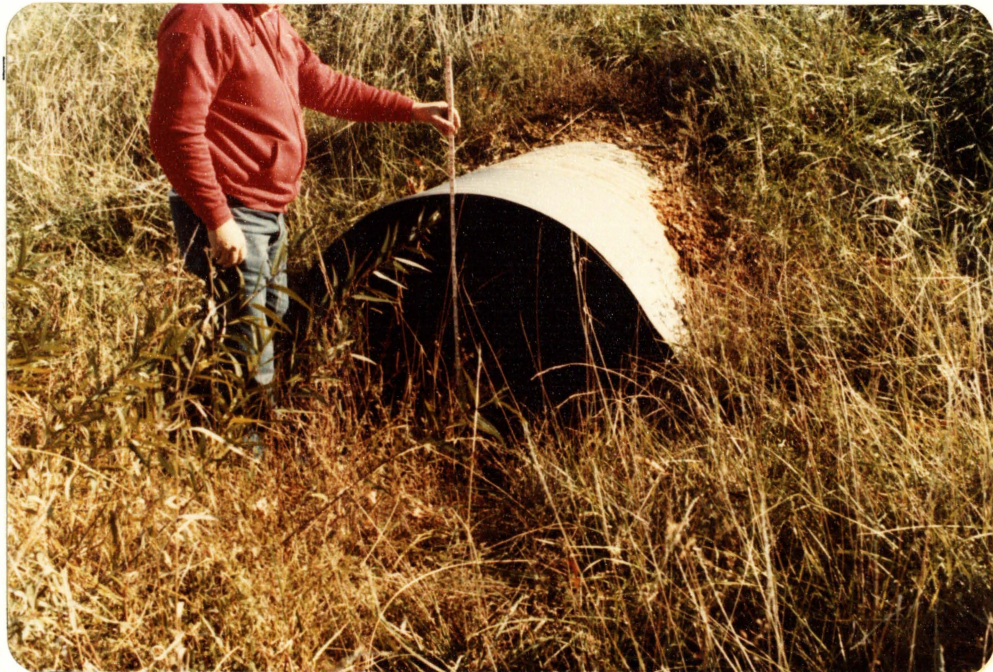
PHOTO NO. 11- INLET TO THE PRINCIPAL SPILLWAY PIPE

- (3) Crest. Measurements indicate the crest varies considerably in profile with the lowest elevations near the center of the dam. A well gravelled road traverses the top of the dam. No cracks, settlements or potholes were in evidence. Photo Nos. 3 and 11 show the crest.

- (a) Inlet. The projecting open-end inlet is in good condition with no bends or tears to obstruct the entrance. There is no debris guard. Photo No. 11 shows the inlet end of the spillway.
- (b) Conduit. The conduit appears to be straight and in good condition throughout.

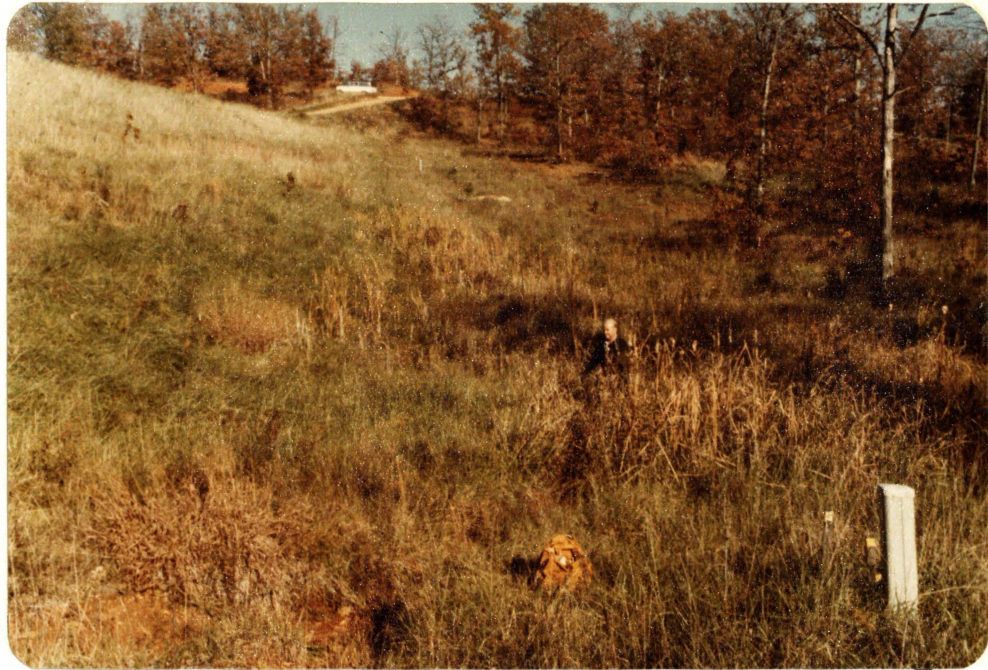
Groundwater moving under the embankment is ponding at the toe with a flow of less than 2 gpm. Phreatophytes, cattails and marshgrasses are evidence of the constancy of the seepage. The flow is "perched" on the bedrock.

PHOTO NO. 14 - CATTAIL AREA AT TOE OF DAM  
(STA. 3+00 to 3+50)

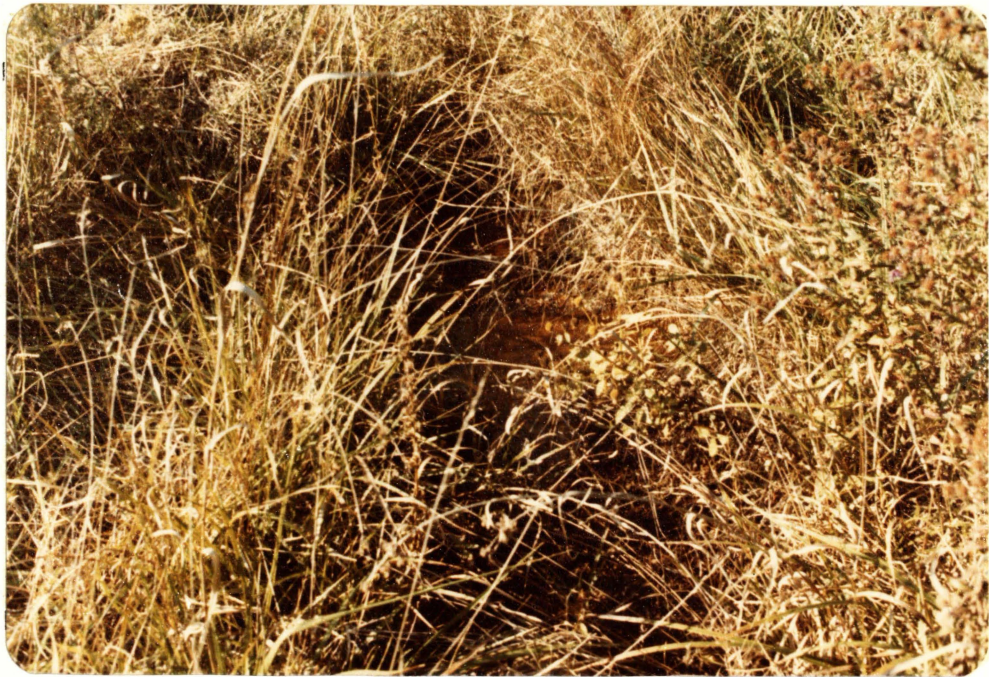
PHOTO NO. 15 - SEEPY AREA AT BASE OF RIGHT ABUTMENT TROUGH

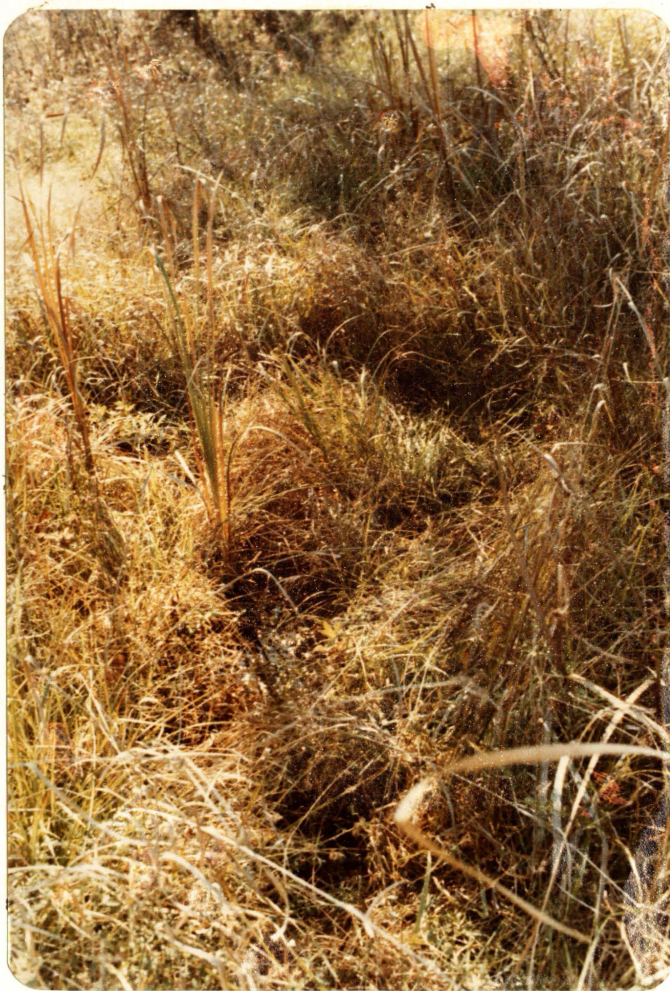
PHOTO NO. 16 - WATER  
STANDING IN CATTAIL  
AREA (STA. 3+20)

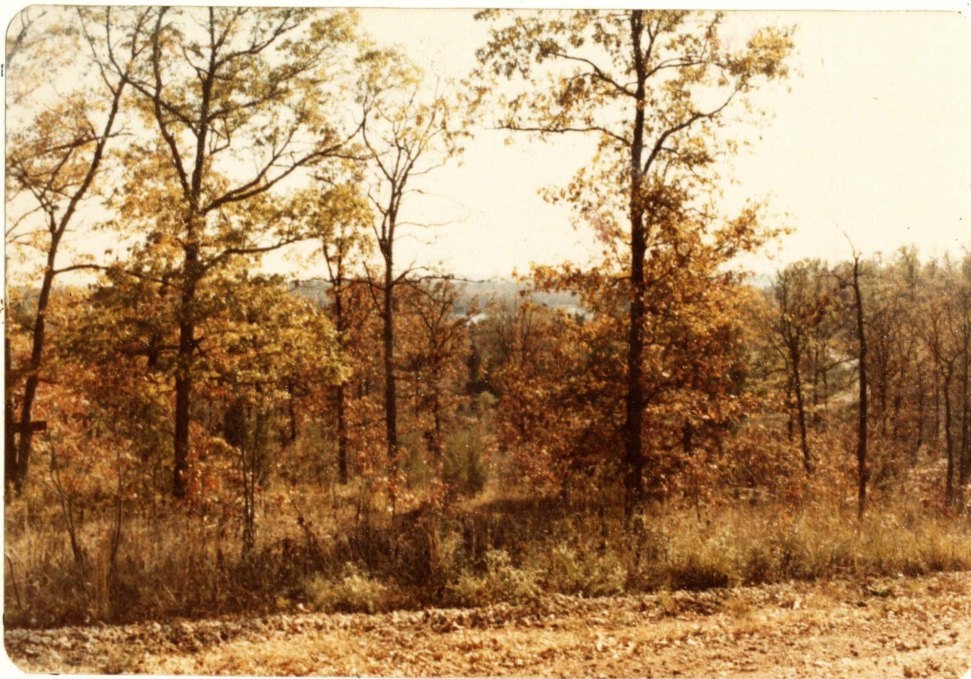
PHOTO NO. 17 - LOOKING DOWNSTREAM AT LAKE AREA BELOW LAC BENET

Aerial photographs of the downstream damage zone of this dam were taken in October, 1980. These photographs were used as reference in the field observations of the damage zone which were made during the inspection. Based on the field observations and on the referenced guidelines this dam is in the High Hazard Potential Classification. The estimated damage zone extends approximately one mile downstream of the dam. Within the damage zone are three dwellings and a lake and dam. Photos 17, 18 and 19 show the downstream damage area.

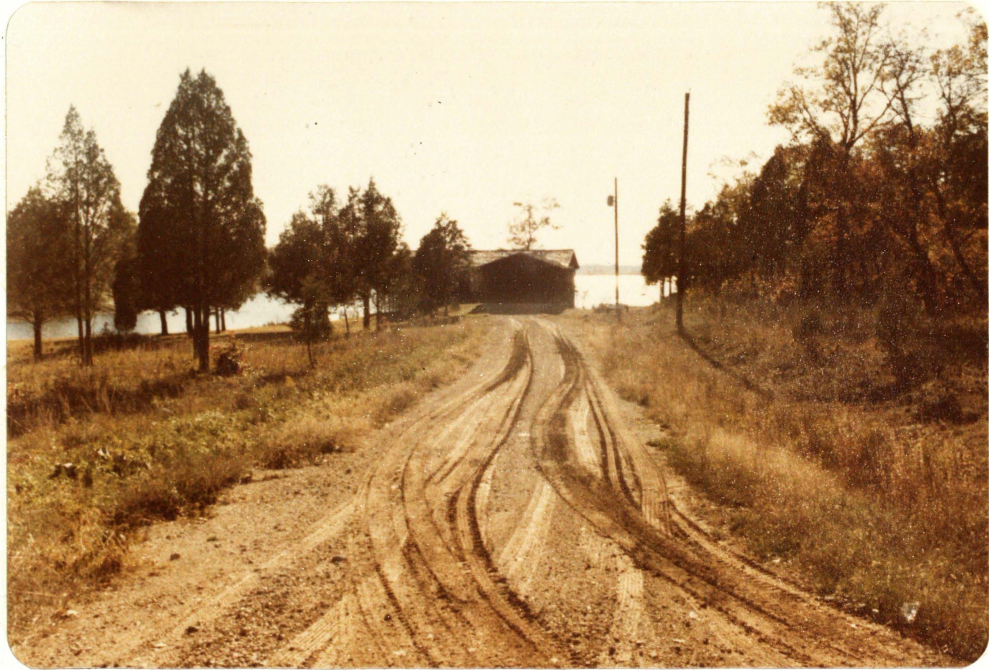
PHOTO NO. 18 - DOWNSTREAM HAZARD JUST ABOVE LOWER LAKE

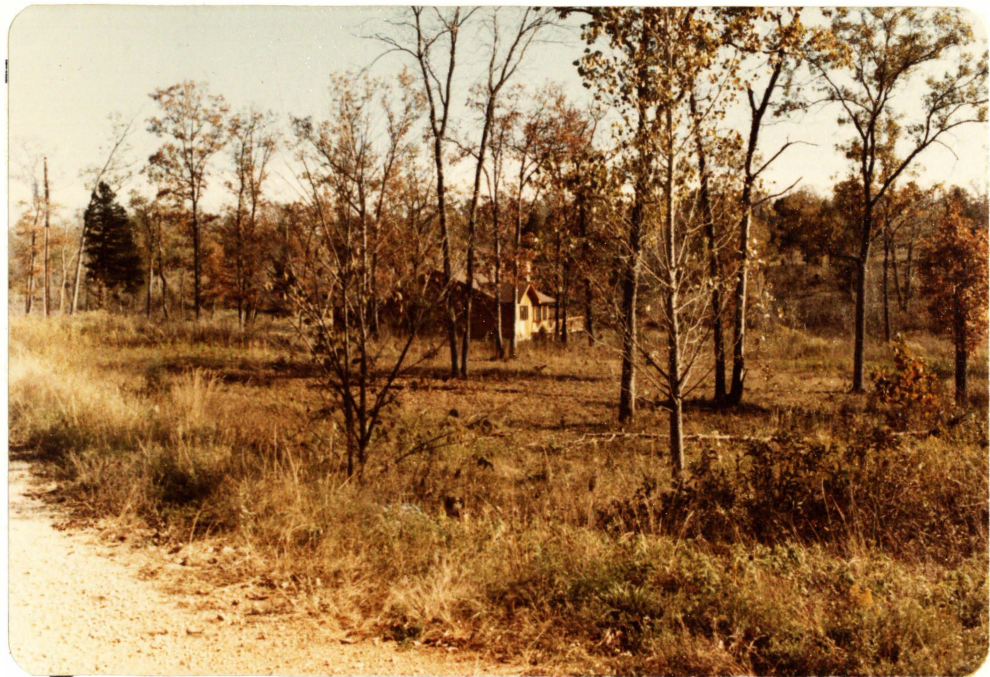
PHOTO NO. 19 - ANOTHER DOWNSTREAM HAZARD AT UPSTREAM END OF LOWER LAKE

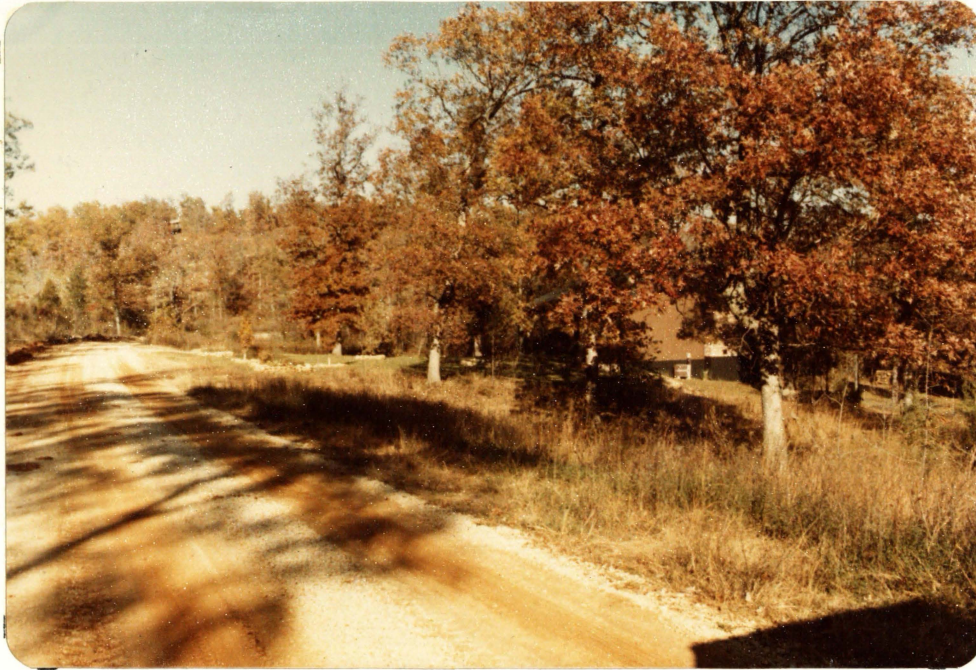
PHOTO NO. 20 - HOUSE JUST BELOW DAM ON RIGHT SIDE OF CHANNEL
