**Phase 1 Inspection Report: National Dam Safety Program.  
Mississippi - Kaskaskia - St. Louis Basin. Lac Marseilles Dam, St.  
Francois County, Missouri**

Woodward-Clyde Consultants, Chicago, Illinois

LAC MARSEILLES DAM  
ST. FRANCOIS COUNTY, MISSOURI  
MO 30282

## PHASE 1 INSPECTION REPORT NATIONAL DAM SAFETY INSPECTION

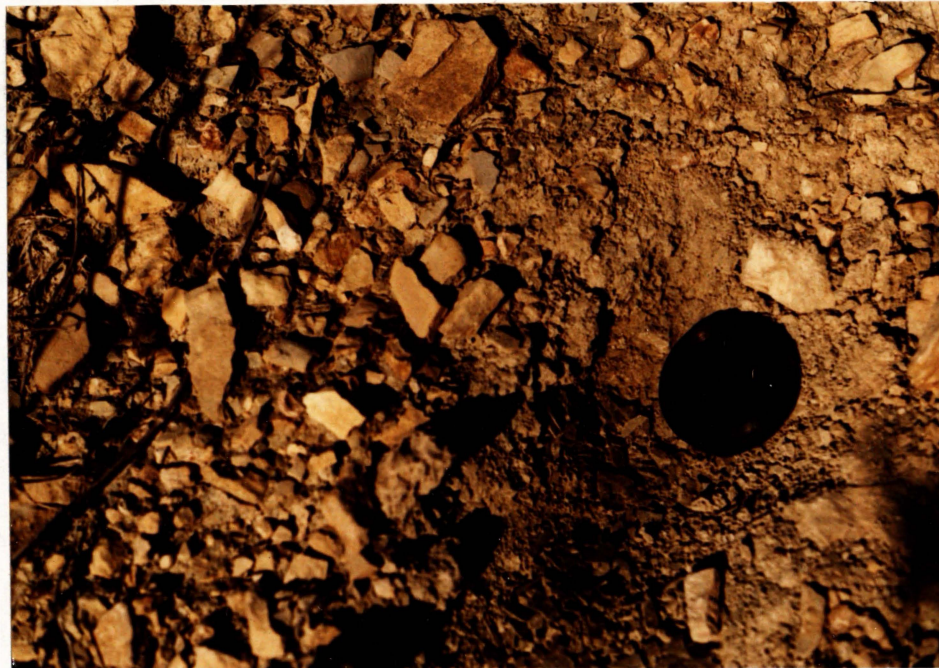
1. Stoney soil used in dam construction. View of downstream face. Lens cover for scale.

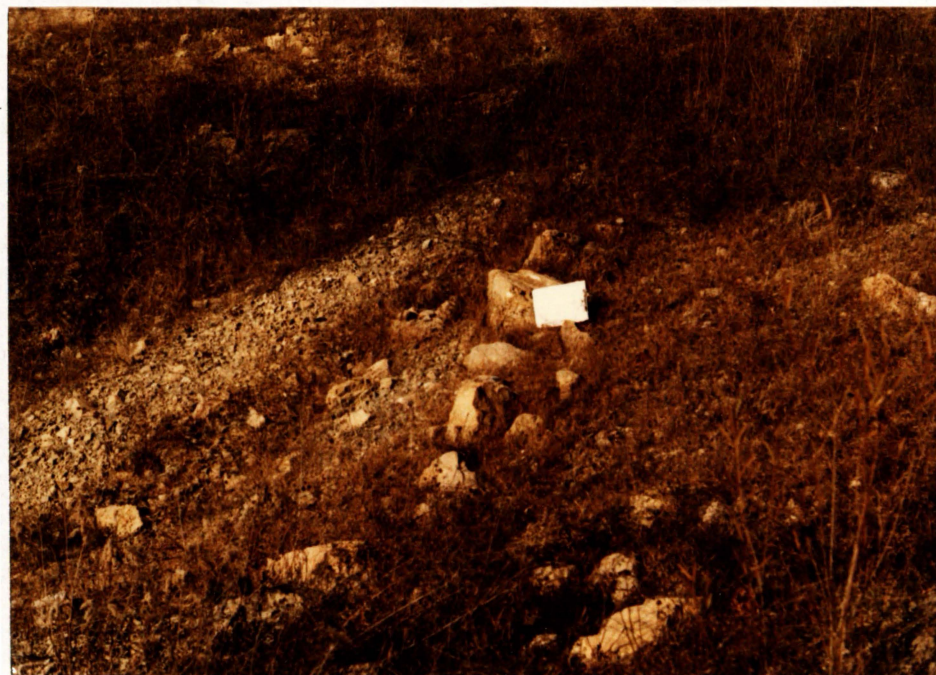
Minor rill erosion was noted but there did not appear to be any significant erosion of the downstream face of the dam. The downstream face is partially vegetated with grass and weeds. The erosion potential in the event of overtopping is judged to be moderate.

2. Downstream face of dam showing minor rill erosion and material used in construction of dam. Note also variation in density of vegetation cover. Clipboard for scale.

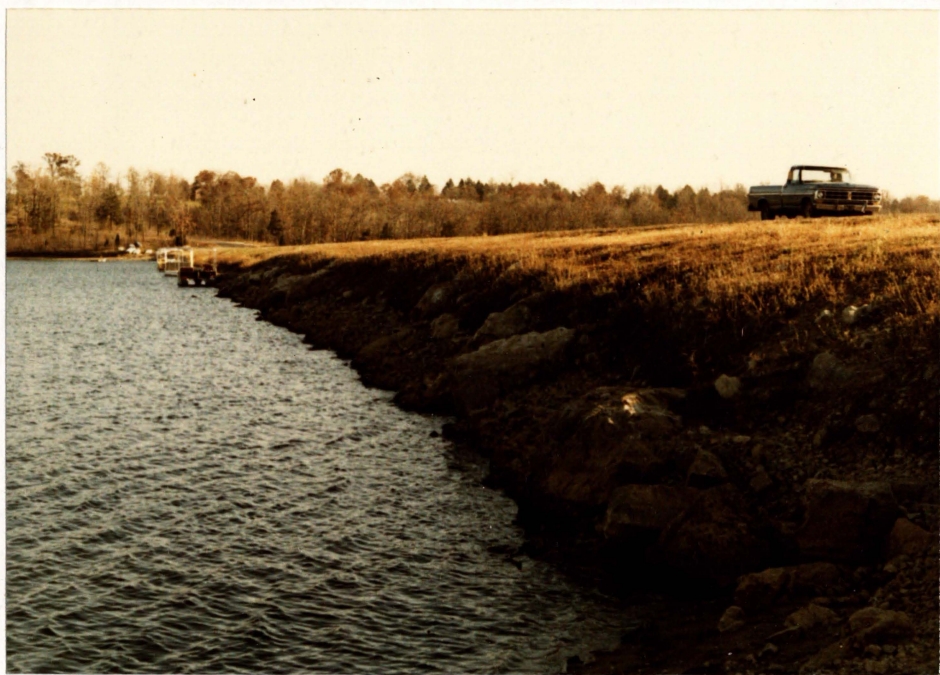
The upstream face of the dam has large riprap erosion protection along the length of the dam (Photos 3 and 4). The central third of the dam has a concrete wall on the lake side of the riprap (Photo 4), for use as a boat mooring facility. The riprap appears to be in good condition and there is little potential for significant erosion of the upstream face of the dam.

3. Riprap shore protection on upstream slope of dam. Looking southeast from right abutment.

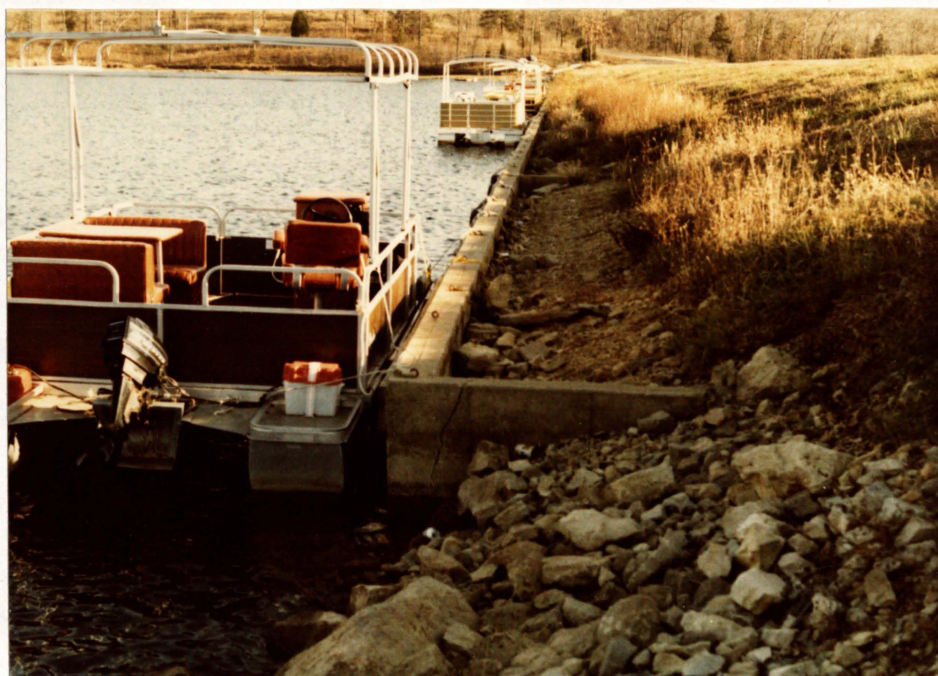
4. Concrete mooring wall along center third of dam. Looking southeast.

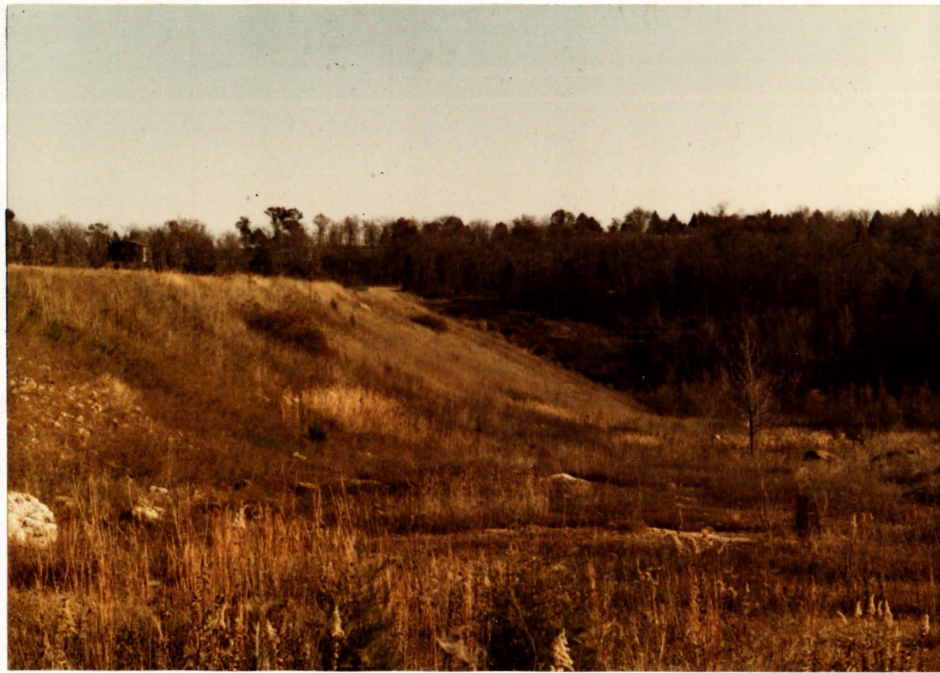
5. Downstream slope of dam showing grass and weed cover. Looking southeast.

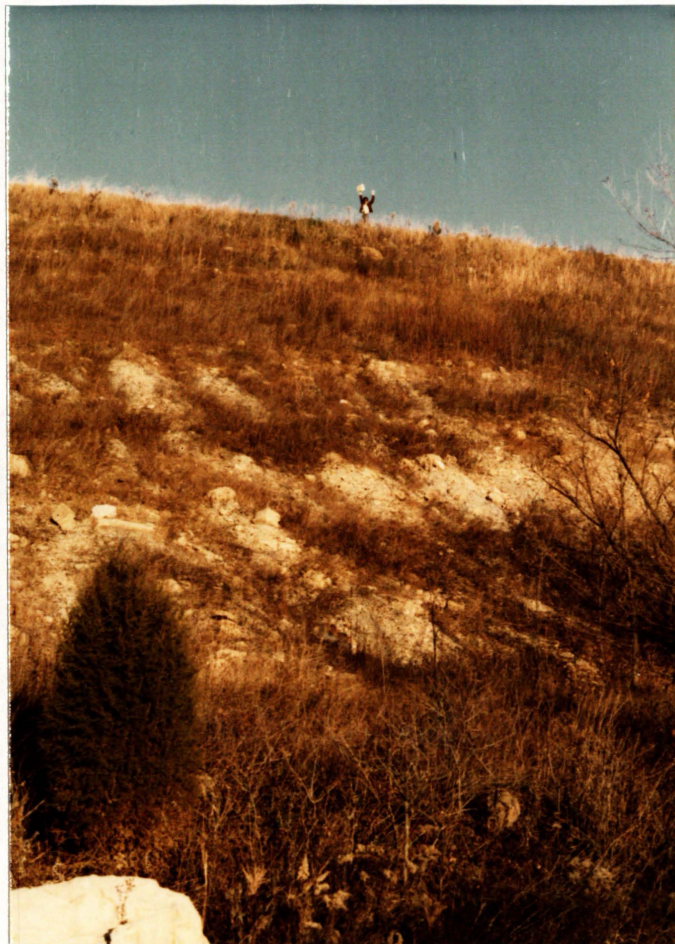
6. Downstream slope of dam showing scattered bare areas and minor rill erosion. Looking northeast from toe of dam.

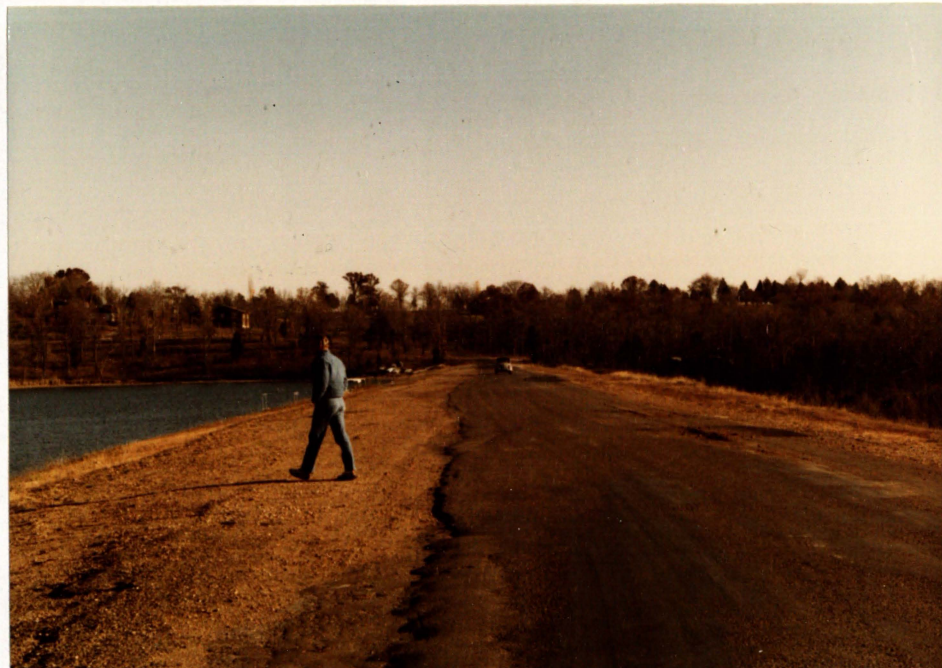
The dam crest is about 50 ft wide and did not exhibit any evidence of disruption of the vertical or horizontal alignment. A paved asphalt road follows the dam crest alignment and no evidence of cracking could be detected (Photo 7). Some areas of apparent pavement failure have been patched (Photo 12). There was no evidence of sliding or slumping of the embankment slopes, and no evidence of sinkhole development, animal burrows or detrimental settlement.

7. Asphalt road on crest of dam. Note broad dam width and lack of any disruption of vertical or horizontal alignment. Looking southeast.

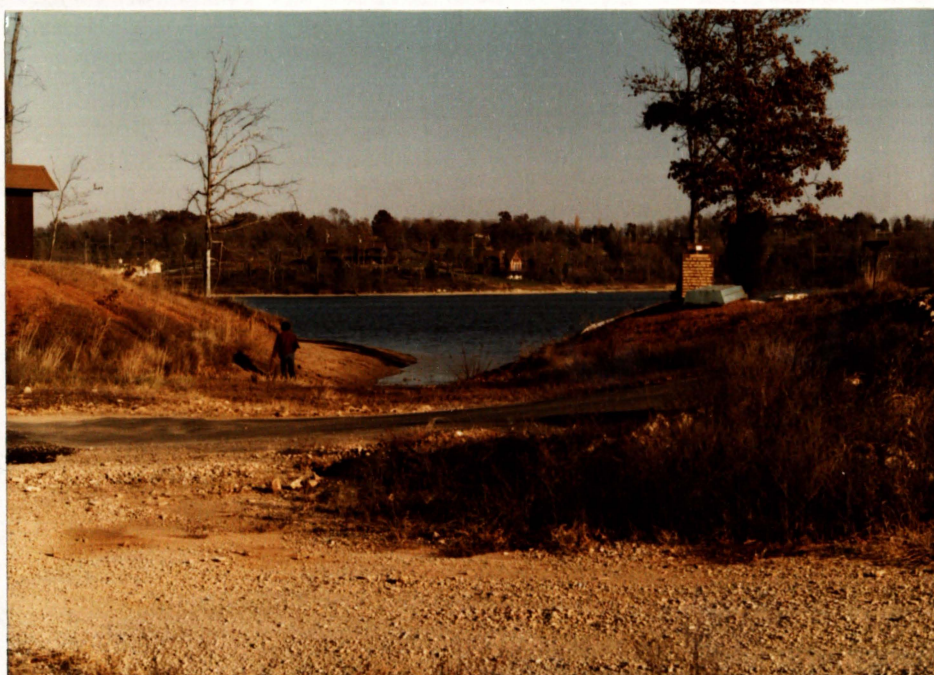
Significant erosion of the spillway discharge channel is considered unlikely due to the shallow depth to bedrock. Erosion of the spillway could occur during flooding and cause the paved road which crosses the spillway to be washed away, but such erosion would not be likely to pose a safety hazard to the dam due to the distance from the main embankment and the direction of the discharge flow.

8. Spillway located at right (north) abutment. Note asphalt road across spillway. Looking east from head of discharge channel.

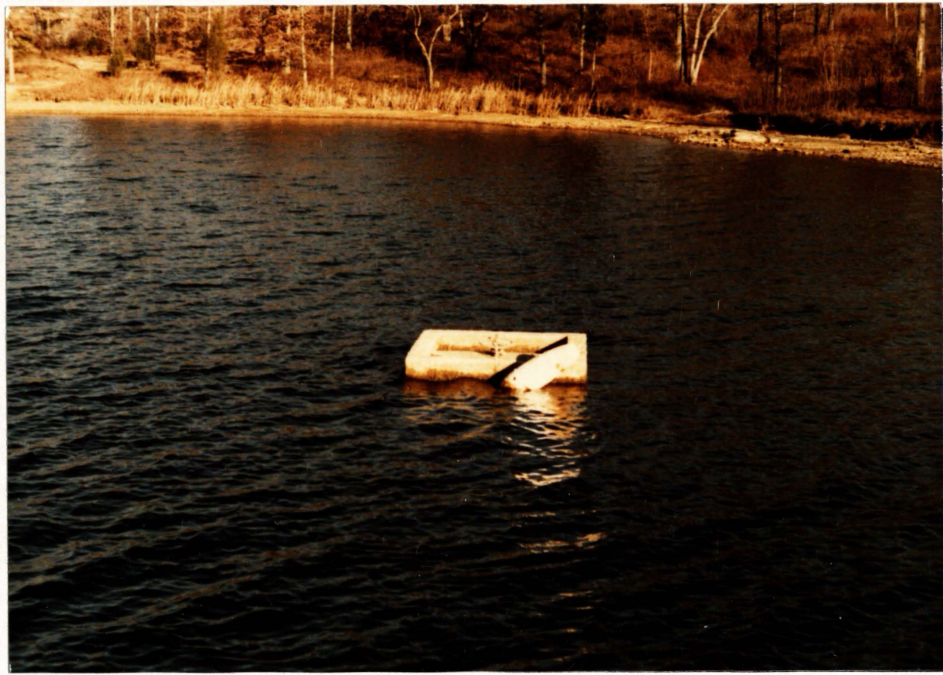
2. Low-level Outlet. A pipe outlet facility was observed at this dam, consisting of a square concrete tower near the left abutment in the reservoir (Photo 9). Discharge flows through an 18-in. dia iron pipe (Photo 10) which exits the dam near the junction of the embankment with the left abutment approximately one third of the way down the dam (el. 821 ft). The control for this outlet is at the upstream end of the discharge pipe within the concrete tower. We have been informed that due to some damage to the sluice gate mechanism the valve cannot be completely closed, resulting in a small steady discharge from the pipe. Gully erosion has occurred where this discharge

9. Top of concrete inlet tower for pipe outlet facility near left (south) abutment. Looking northeast from crest of dam.

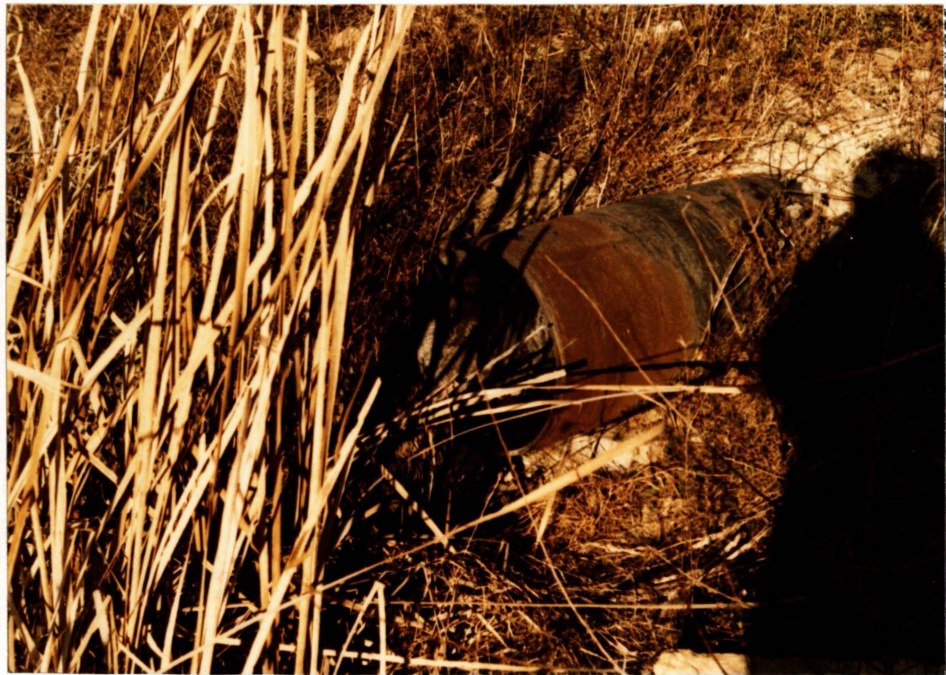
flows down the embankment-abutment contact, but is too small to be considered a safety hazard to the dam at the present time. At the time of the visual inspection, this discharge outlet was flowing at a rate of approximately 20 gal/min.

The only facility requiring operation is the 18-in. diameter pipe outlet facility. This was not operated during the visual inspection. A discharge flow of approximately 20 gal/min was noted at the discharge end. We were informed by Mr Bennett that minor damage occurred to the sluice gate mechanism. The operation of this facility appears to have no significant impact on the safety aspects of this dam.

10. 18-inch outlet pipe for outlet structure at left abutment. Pipe flow estimated at 20 gal/min. Looking north.

2. Determine the feasibility of a practical warning system to alert downstream residents in the event unsafe conditions develop at this dam.
- c. **O & M procedures.** It is recommended that a periodic inspection and maintenance program be initiated for this facility. This program should include but not be limited to the following:
1. Checking for evidence of slope instability such as cracks, deformation on the dam face, or settling of the dam crest;
  2. Checking the amount and turbidity of seepage, if any;
  3. Maintaining the spillway discharge channel free of potential obstructions;
  4. Evaluation of the condition and an assessment of the need for repair of the sluice gate mechanism in the pipe outlet facility at the dam.

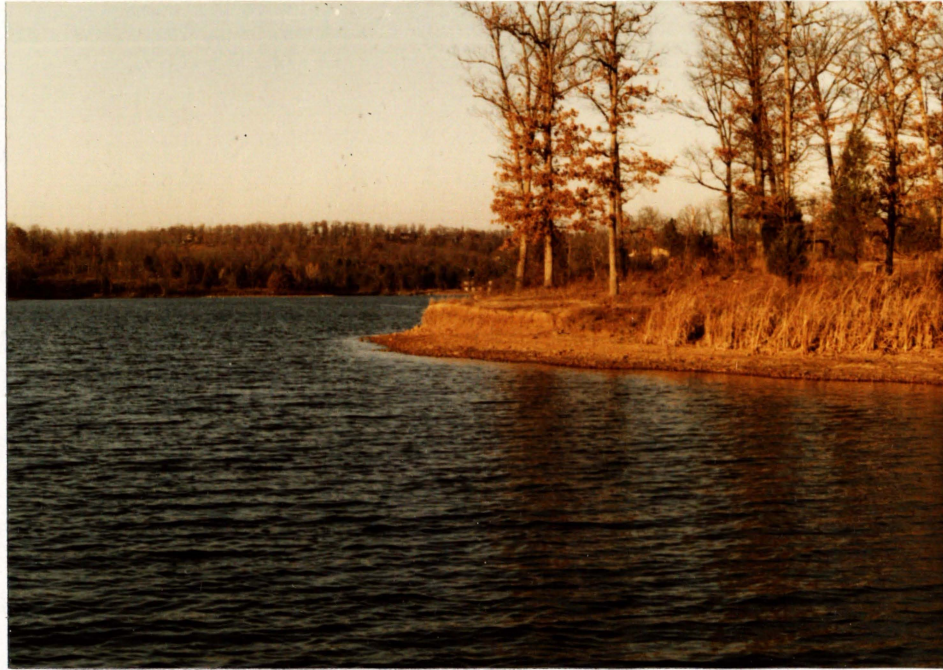
11. Wave-notched shoreline. Eroded to shallow bedrock, approximately 3 ft. Looking north from left abutment.

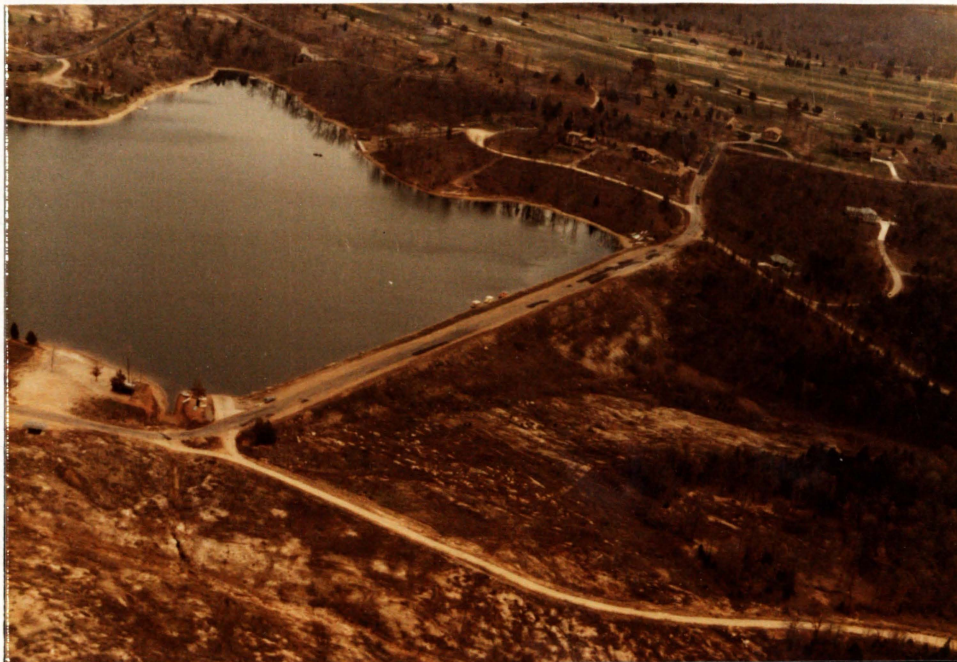
The spillway and discharge channel appear to be in good condition. Erosion is unlikely in either of these facilities due to shallow depth to rock. Any erosion in the spillway or discharge channel would not likely pose a safety hazard to the dam due to distance from the main dam embankment and the direction of flood flows.

12. Discharge channel area in lower left of photo. Channel flows on exposed bedrock for most of its length. Note that discharge is routed well away from toe of embankment. Looking east.

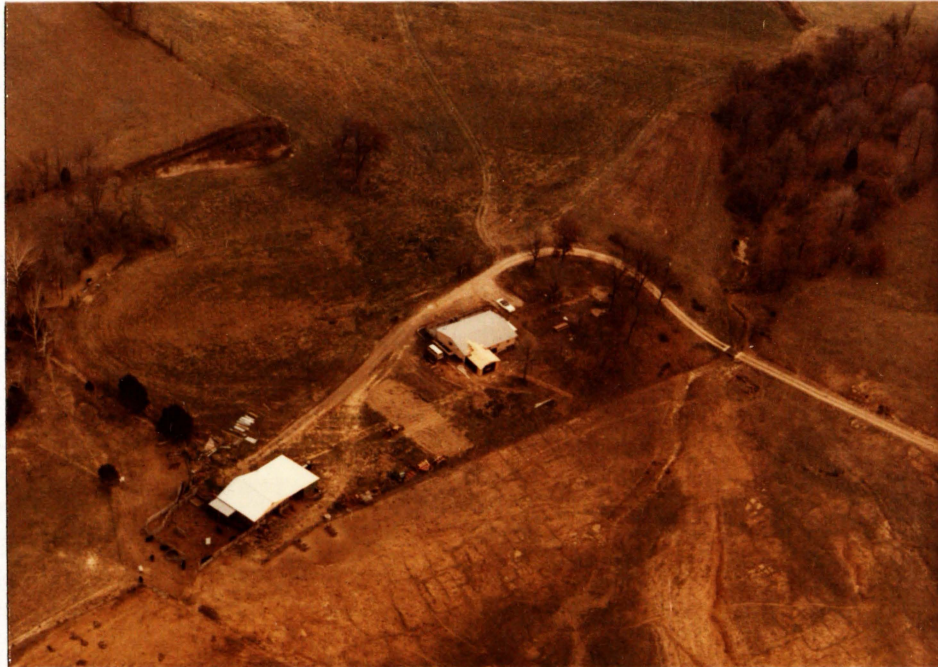
13. Typical structures in downstream damage zone. Located about 1 mile downstream of dam.
