**Phase 1 Inspection Report: National Dam Safety Program.
Mississippi - Kaskaskia - St. Louis Basin. Little Indian Creek Dam,
Washington County, Missouri**

LITTLE INDIAN CREEK DAM
WASHINGTON COUNTY, MISSOURI
MO. 30718

PHASE 1 INSPECTION REPORT NATIONAL DAM SAFETY INSPECTION

SEPTEMBER 1980

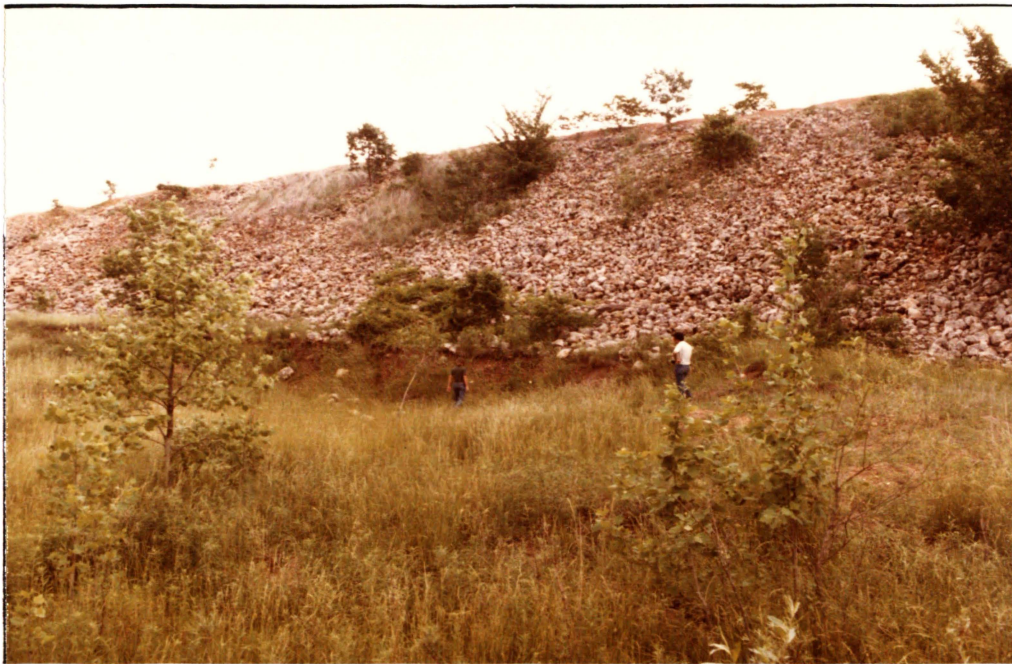
sloughing of the face of the embankment has occurred. Mining activities at the toe of the dam have left cut faces which have reduced the apparent stability of the embankment. The downstream face of the dam appears steep, 33 to 35 degrees, and future stability of the slope is questionable if small changes occur to conditions observed during the inspection.

1. Bullrock (coarse tailings) on face of dam. Note mining cut face at toe of dam, left center. Looking northeast.

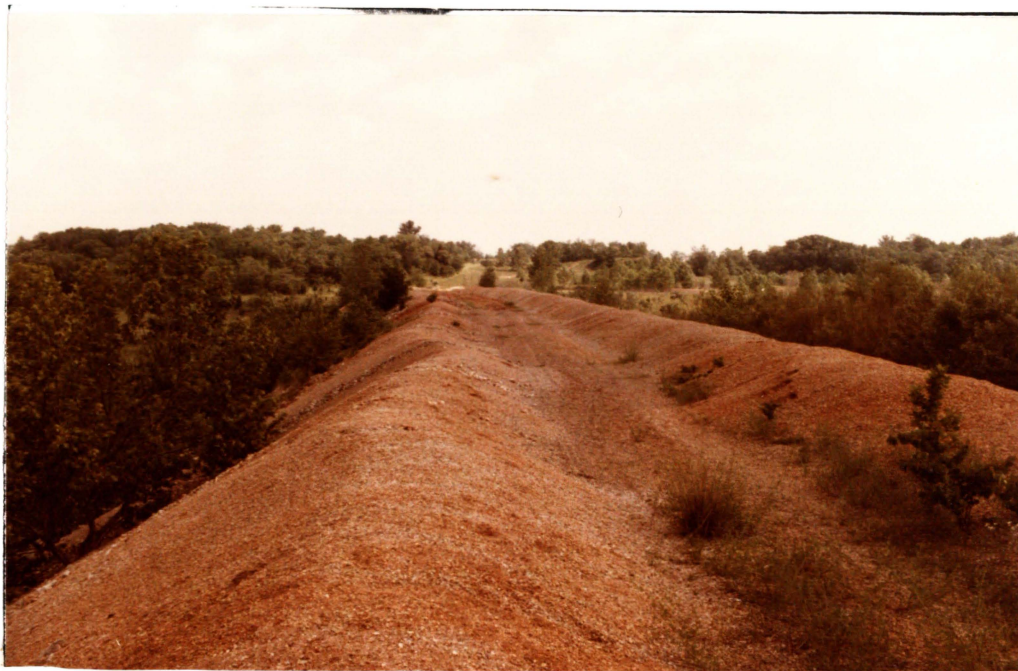
2. Roadway on crest of dam. Impoundment area to the right. Looking north.

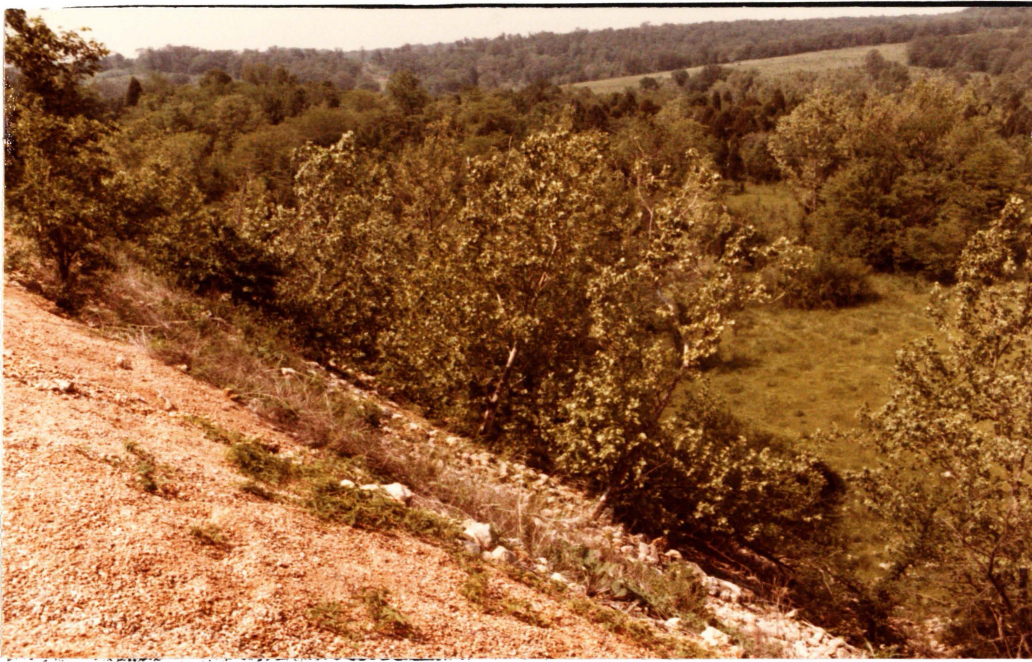
Our evaluation indicates the dam is in a generally unsatisfactory condition. There is evidence of some surface sloughing on the downstream slope. Seepage at present does not contain soil particles and is not excessive, but could increase in the future and cause further slope instability.

3. Downstream face of dam. Note leaning trees indicating possible slumping of slope face. Looking southwest.

1. Construct a spillway to minimize storage behind the dam and to pass the appropriate design flood.
2. Construct a discharge channel so that erosion of the toe of the embankment will not occur.
3. Make seepage and stability analyses of the dam comparable to those required in the recommended guidelines. These analyses should be made for appropriate loading conditions, including earthquake loads.
4. Implement a program of periodic inspections to detect any changes in seepage rate and turbidity of seepage water and to identify areas of slope instability, such as slumping and erosion of the face of the dam.

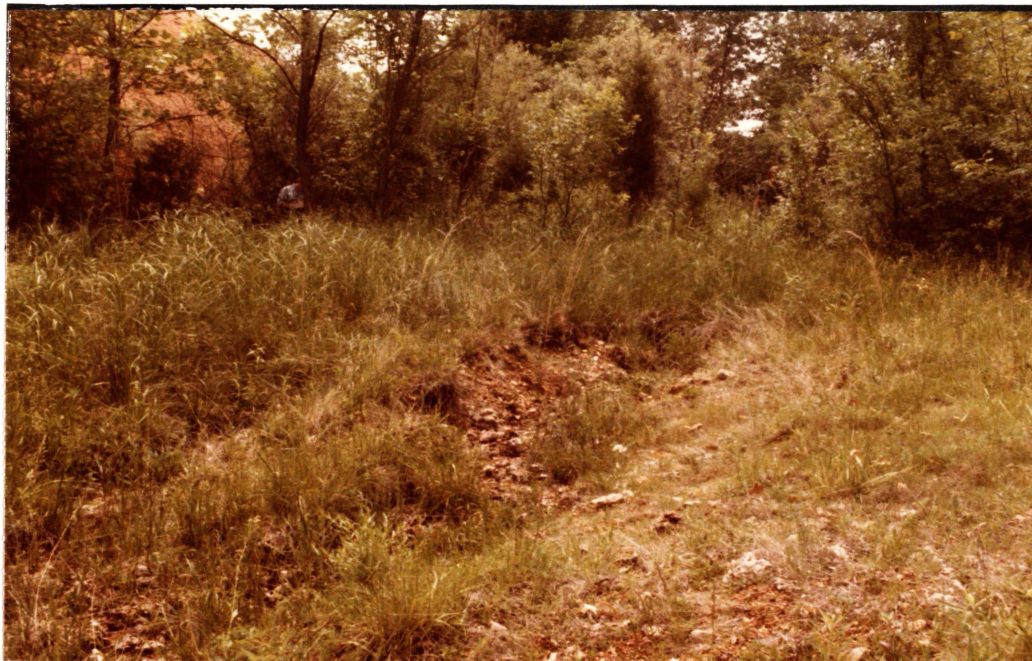
4. Overland drainage gully at toe of dam. Looking east.

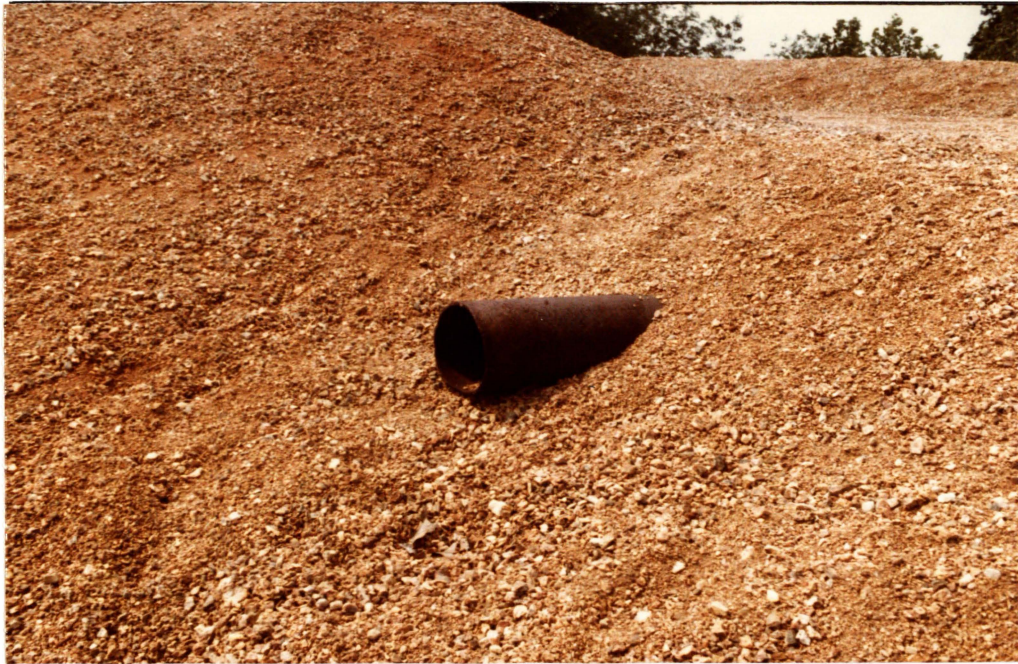
5. Inoperative outlet pipe near south end of embankment. Looking south.

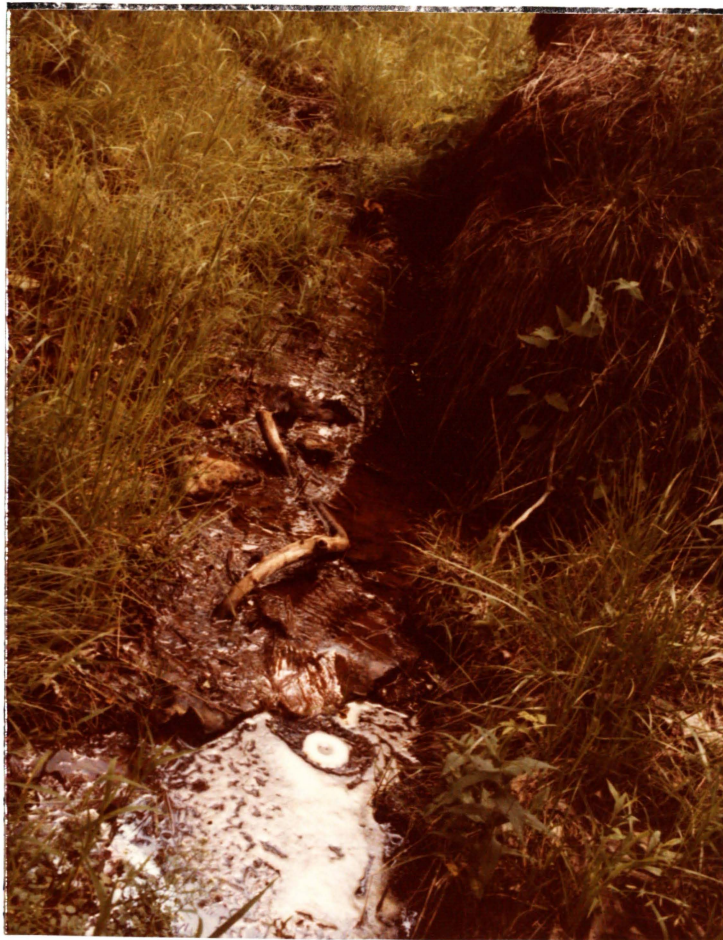
Seepage noted along the toe of the left abutment (as the observer faces downstream) was estimated at about 5 gal/min. Away from the toe of the dam, the small stream which collects both seepage and overland runoff was estimated to be carrying about 15 gal/min. The seepage water did not appear to be carrying any fine soil particles.

6. Total seepage and overland drainage below toe of dam. Looking east.

c. **Operation and maintenance procedures.** A program of periodic inspections should be initiated to identify evidence of slope instability and increases in the amount of seepage flow or turbidity of the seepage water. Reports of inspections and any recommended maintenance should be made a matter of record.

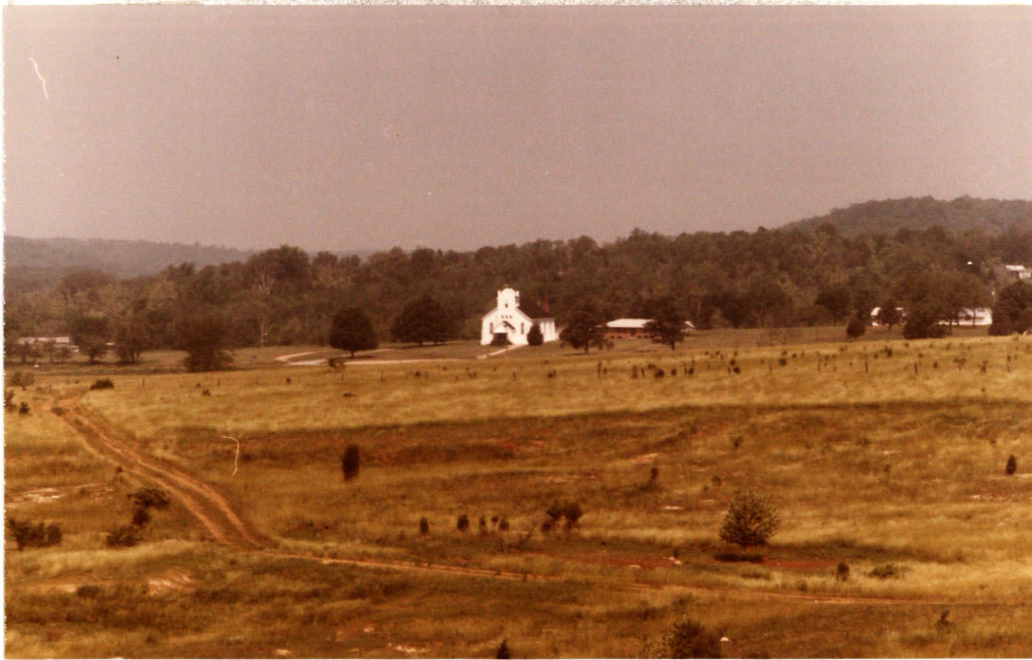
- d. **Hazard classification.** The St Louis District, Corps of Engineers has classified this dam high hazard; we concur with this classification. The estimated damage zone extends approximately ten miles downstream of the dam. Within this damage zone are nine dwellings and several trailers.

7. Downstream hazards, west end of town of Richwoods. Looking northwest from crest of dam.

2. The establishment of an effective, practical warning system for advising downstream residents should unsafe conditions develop at the facility.
