Phase 1 Inspection Report: National Dam Safety Program. Osage - Gasconade Basin. Little Prairie Dam, Phelps County, Missouri

LITTLE PRAIRIE DAM
PHELPS COUNTY, MISSOURI
MO 30090

PHASE I INSPECTION REPORT NATIONAL DAM SAFETY PROGRAM

Name of Dam: Little Prairie Dam
State Located: Missouri
County Located: Phelps County
Stream: Unnamed Tributary to Bourbeuse River
Date of Inspection: 24 August 1978

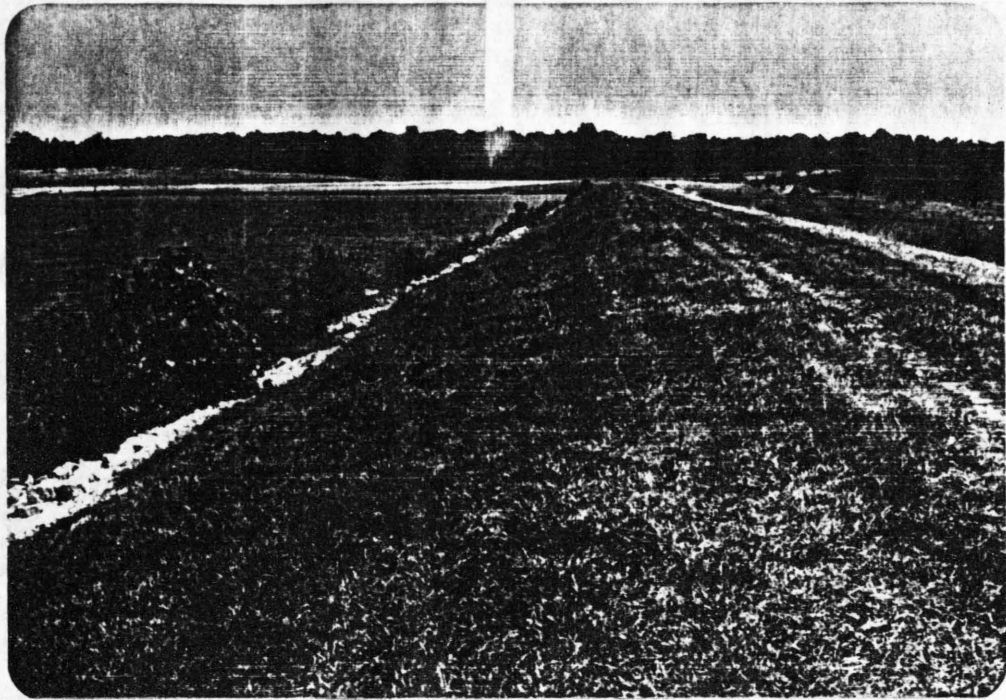
The horizontal alignment appeared as shown on the plans. No surface cracking or unusual movement was obvious. It should be noted, however, that the elevations along the top of the dam which were obtained in the field were approximately 0.5 ft to 0.8 ft higher than as indicated on the Plans for Construction (see Section 1.3.B of this report). All other elevations obtained in the field agreed fairly well with those indicated on the Plans for Construction.

Crest of Dam - Looking North

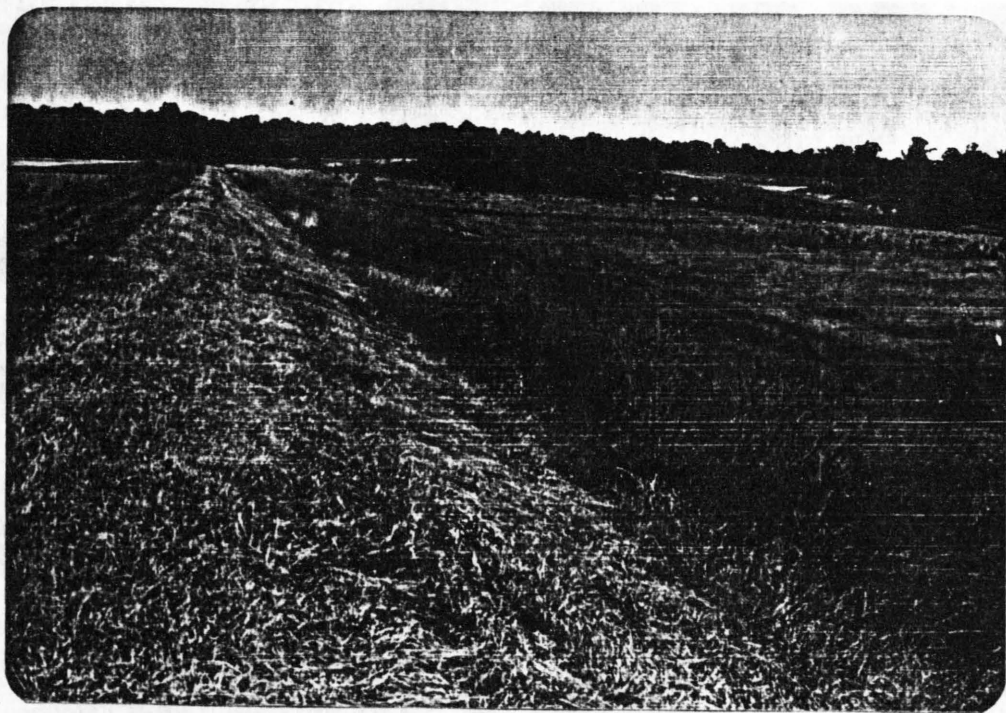
The embankment is grass-covered and appears in good condition. No sloughing of the embankment or seepage through or under the embankment was evident. No animal burrows were noted. There appears to be an area of slight seepage on the south abutment near the primary spillway discharge. The grass was green, and the ground slightly damp in this area.

The foundation drain outlet on the north side of the lake drain was dry. The foundation drain on the south side of the lake drain was slightly damp. There was some slight erosion at the downstream embankment-abutment contacts (more pronounced on the south abutment).

Downstream Face - Looking North

Tree and brush growth should be removed from the dam on a yearly basis. Although not serious now, erosional areas at abutment-dam contact will need some repair in the future. The use of riprap to prevent future erosion in these areas is a possibility. Riprap should be maintained around the plunge pool area. The area of apparent seepage on the south abutment near the primary spillway discharge may be the result of leakage around the primary spillway conduit. This area should be checked periodically to insure that seepage does not increase. Any increase in seepage should be brought to the attention of the owner's engineer.

- (3) Correct the minor erosion activity at the embankment-abutment contacts on the downstream side of the dam.
- (4) Check the downstream slope periodically for seepage and stability problems, especially in the south abutment seepage area and around the lake drain pipe. If slides, seeps or other evidence of distress are observed, immediate inspection by a qualified engineer is required, and frequent follow-up inspections will be necessary.

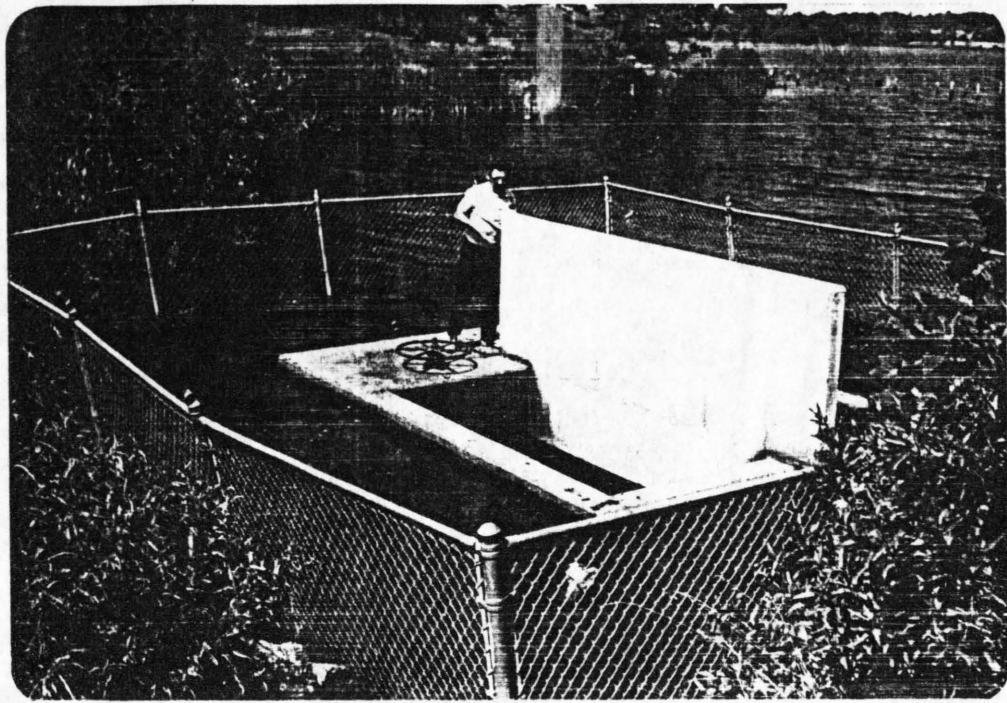
The riser structure was in good condition--no cracking or spalling of concrete was noted. The intake structure outside the chain link fence was surrounded on three sides by some brush. The two slide gates which are used for partial drawdown appeared to be in good condition on the dry side (the wet side could not be inspected). The lower slide gate (elevation 1024) appeared to have a small leak under the bottom.

Primary Spillway Structure

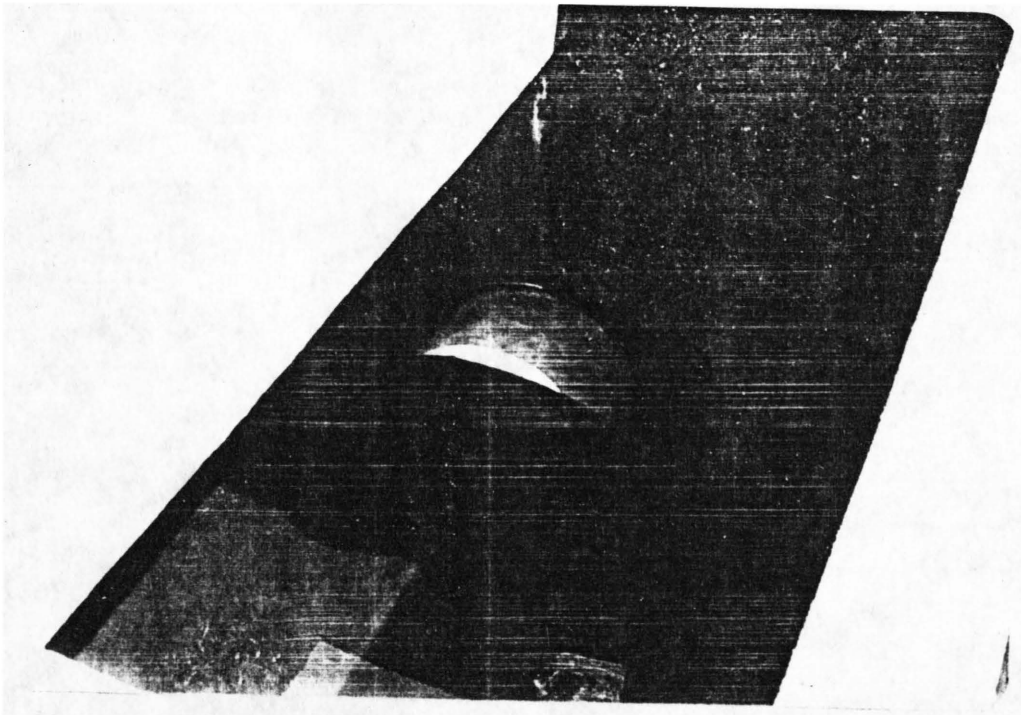
The outlet pipe was also in good condition. There was a very small flow dripping from the primary spillway outlet pipe, possibly coming from the leaking slide gate. Joint leakage could also contribute to the noted outlet flow.

A very small amount of water was exiting from the outlet pipe on the day of the inspection. The source of the water could be a leaking slide gate at the intake structure. However, there exists the possibility of some joint leakage in the outlet pipe. Although apparently not serious at this time, this condition should be monitored periodically in the future to detect any changes (increased flow or piping).

Primary Spillway - Outflow Pipe

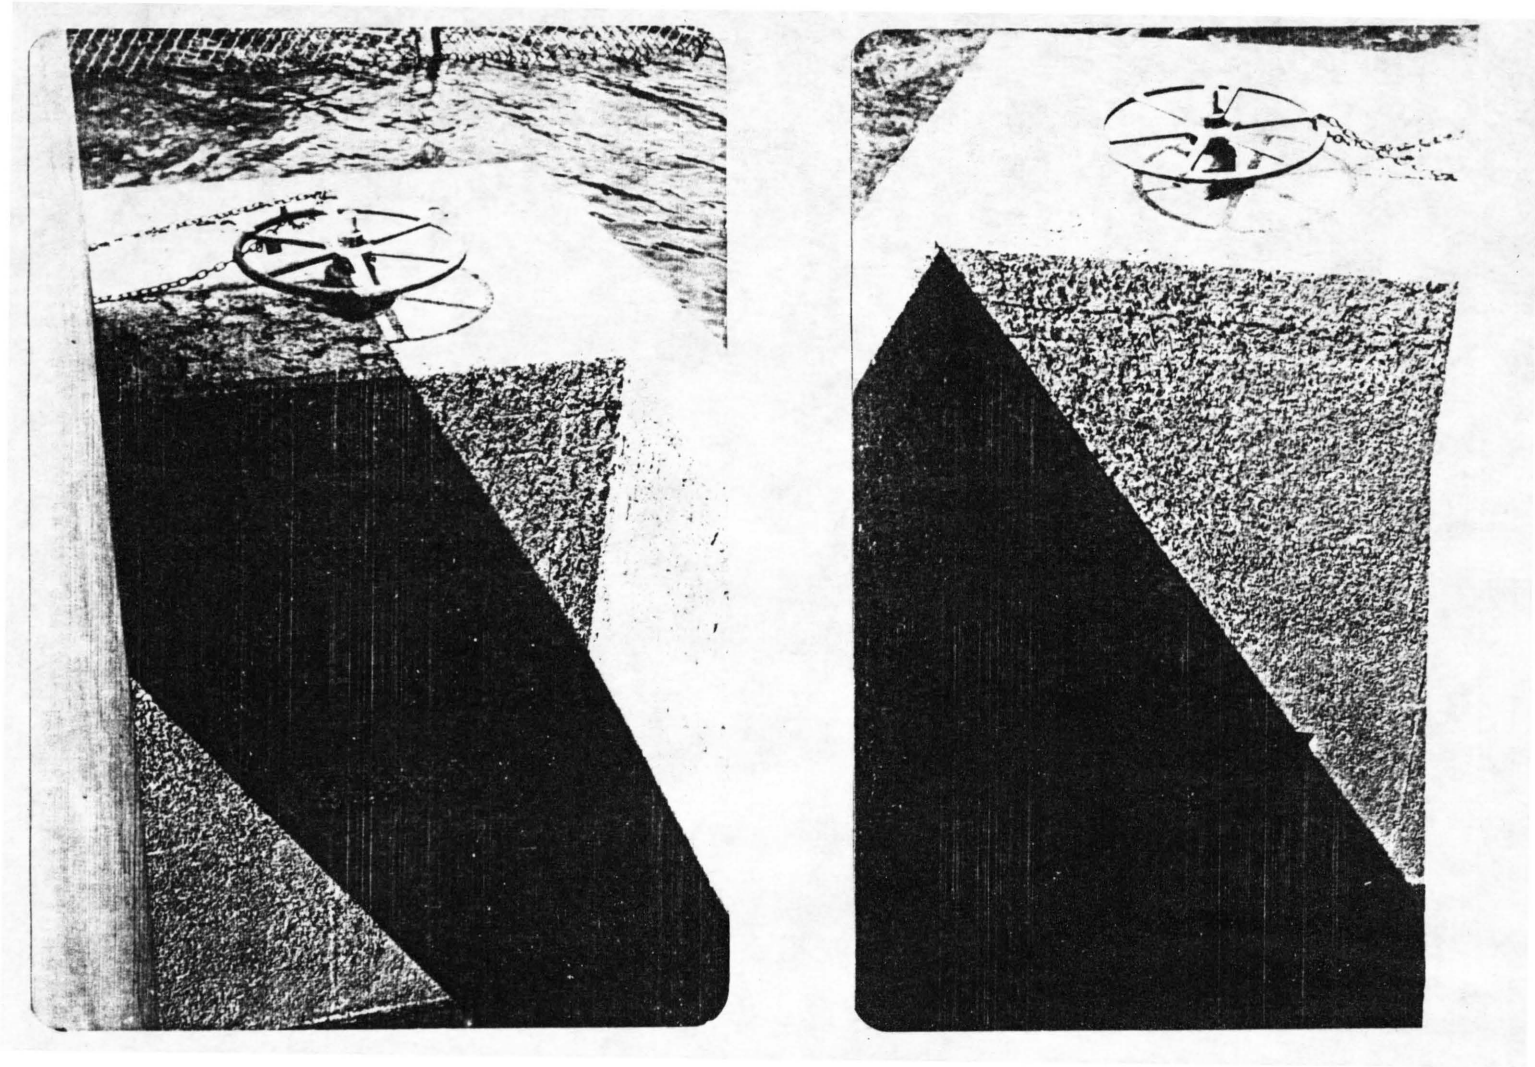
Primary Spillway - Upper and Lower Slide Gates

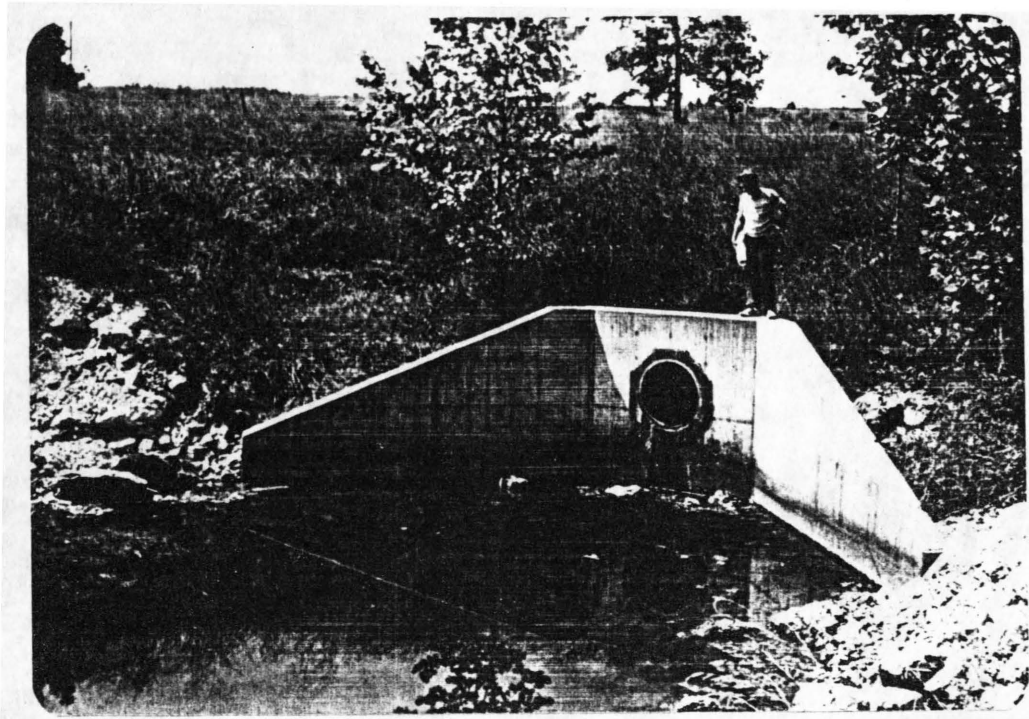
The plunge pool is lined with riprap, but some erosion and sloughing around the plunge pool was noticed. The outlet channel was in good condition. Some small trees and brush are present in the channel a few hundred feet beyond the plunge pool.

Outlet Structure - Primary Spillway

Small tree and brush growths noted in the discharge channel of the primary spillway should be removed, and all future growth should be removed on a yearly basis. Additional riprap could be placed around the plunge pool for protection during high discharge. Brush should be cleared around the primary spillway crest. Excessive growth in this area could cause entrance restrictions. Visually observed erosional areas are deficiencies which, if left uncontrolled or uncorrected, could lead to serious problems in the future. These deficiencies should be able to be corrected by normally scheduled routine maintenance.

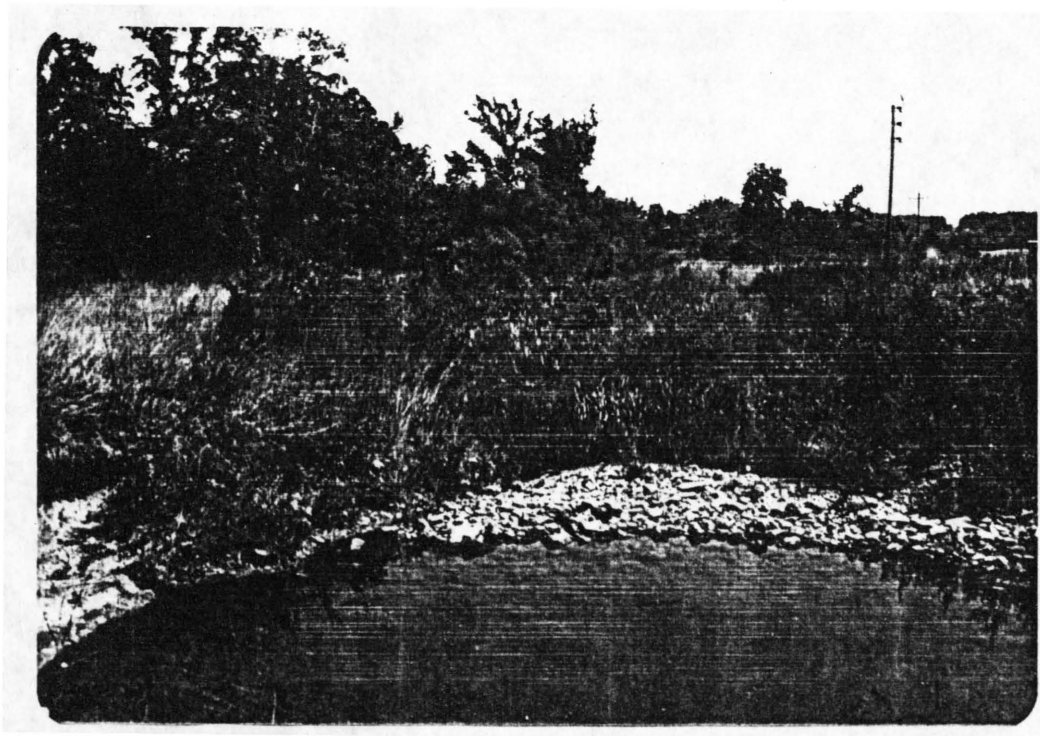
Outlet Channel - Primary Spillway

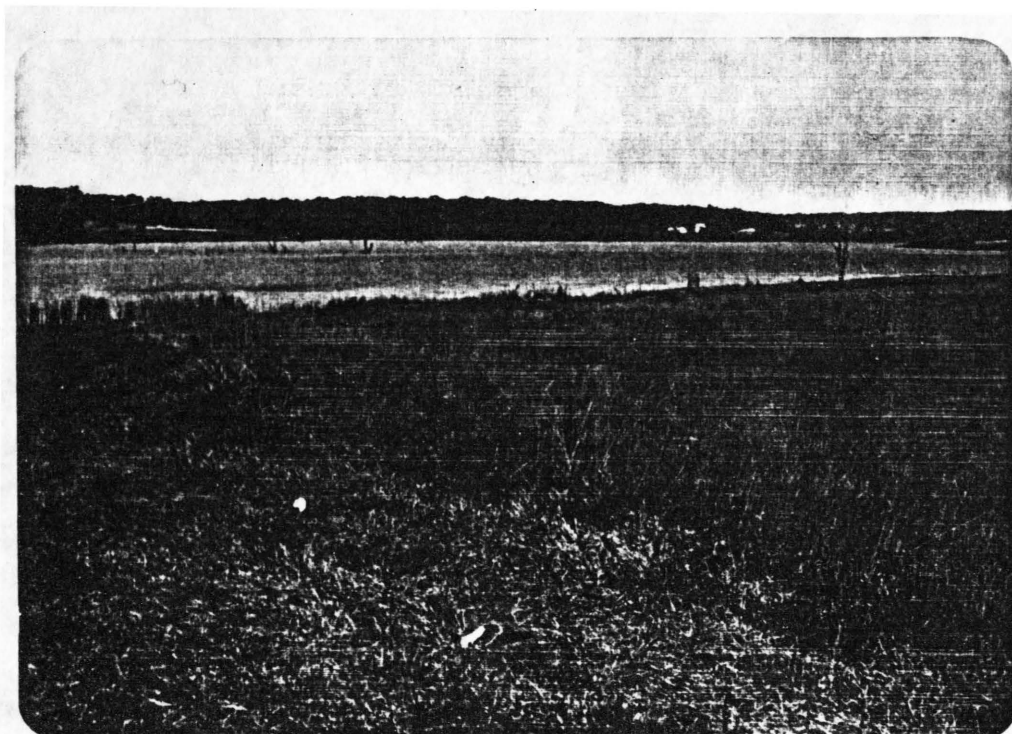
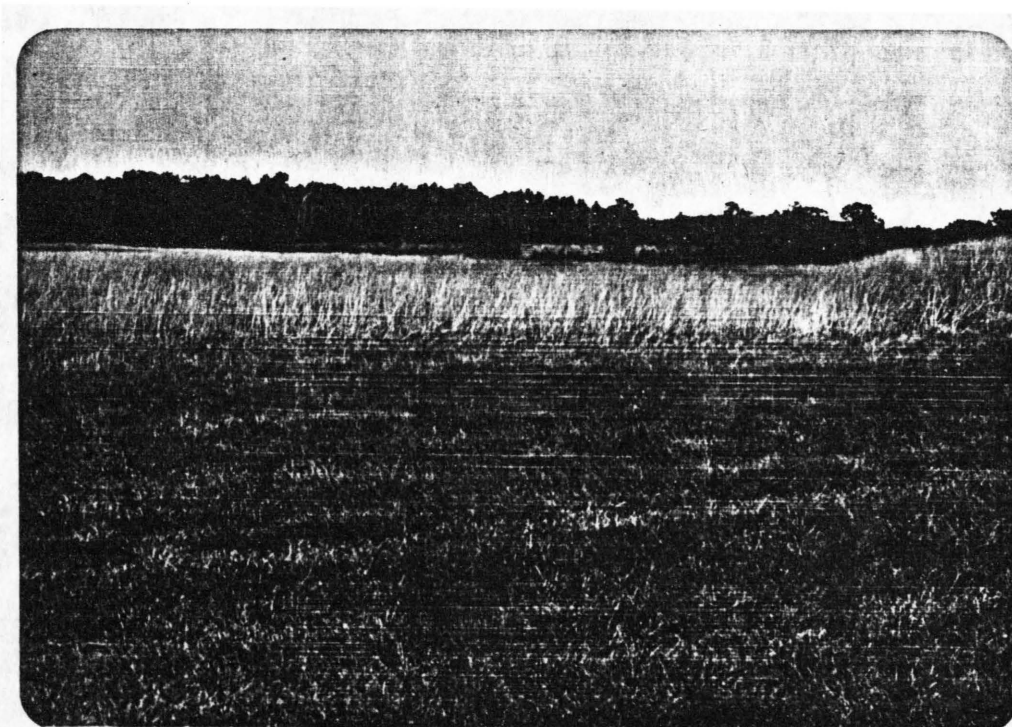
The emergency spillway is in good condition; it measures 200 ft in width with 4H:1V side slopes. The base and side slopes of the emergency spillway are grass-covered. No erosion was noted, and it appears that the emergency spillway has never been used.

Emergency Spillway - Looking Upstream

Emergency Spillway - Looking Downstream
